2023/24

Nashwaak Watershed Aquatic Connectivity Report

Nashwaak Watershed Association Inc

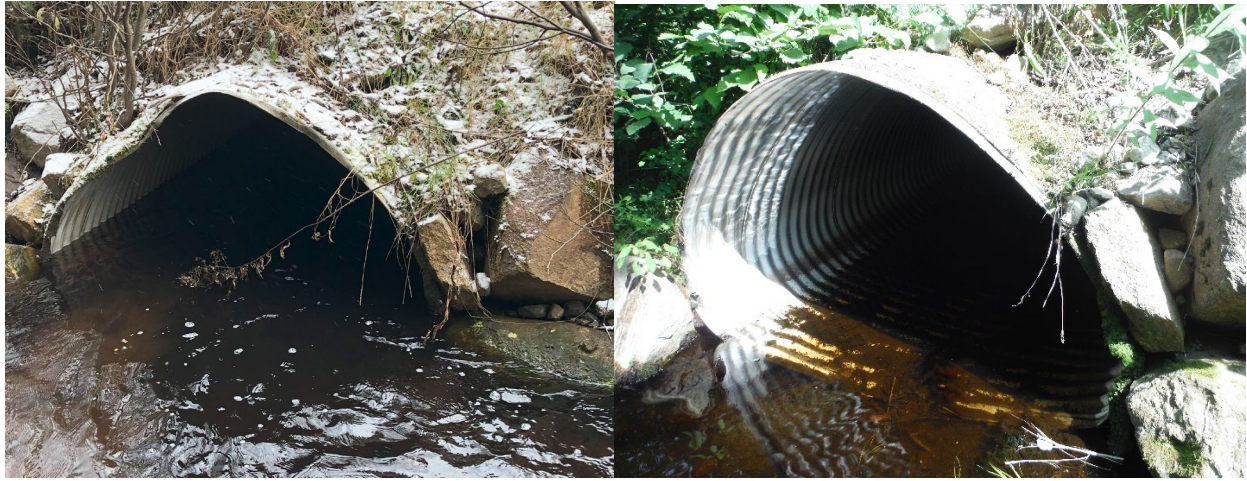
continued to degrade or collapse since the initial assessment (Figure 2). Over 20 road-stream crossings were visited in 2023.

Figure 2. EBN3 from Upstream 2023 (left) vs 2019 (Right)

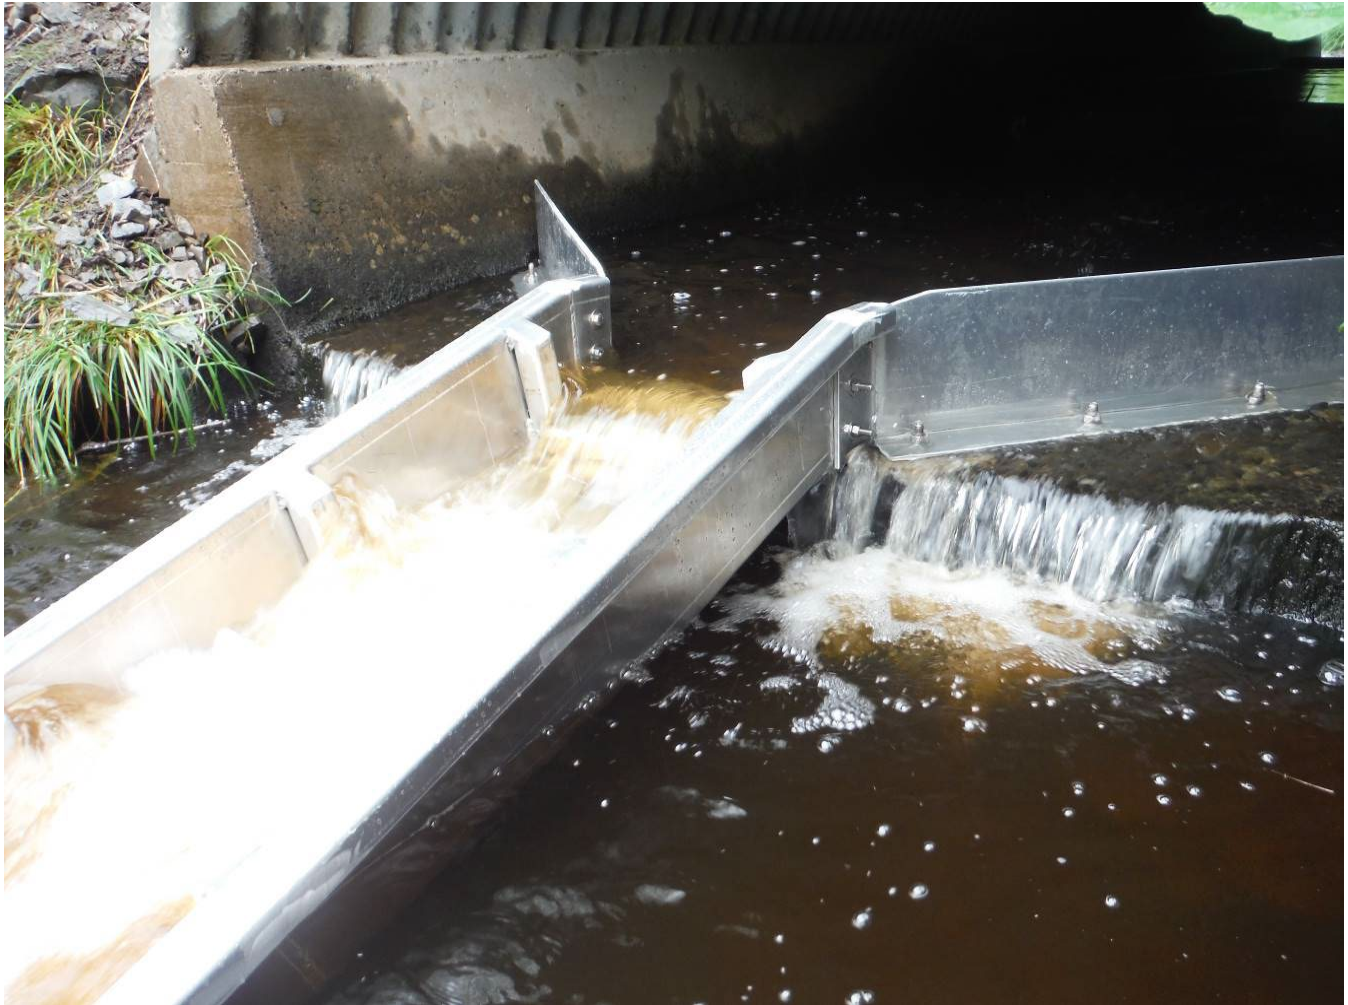
We have been regularly checking on the Manzer Brook fish ladder (Figure 2), installed in 2018. It survived the last four winters well and has not been catching debris. Electrofishing in August 2018 prior to remediation found seven species downstream and five species upstream (a total of 54 fish downstream and 55 fish upstream). Electrofishing in September 2020 found six species downstream and five species upstream (a total of 154 fish downstream and 104 fish upstream). In 2021, using a sweep and shock method, we determined there was an increase in fish movement upstream.

Figure 3. The Manzer brook fish ladder, installed in August 2018.

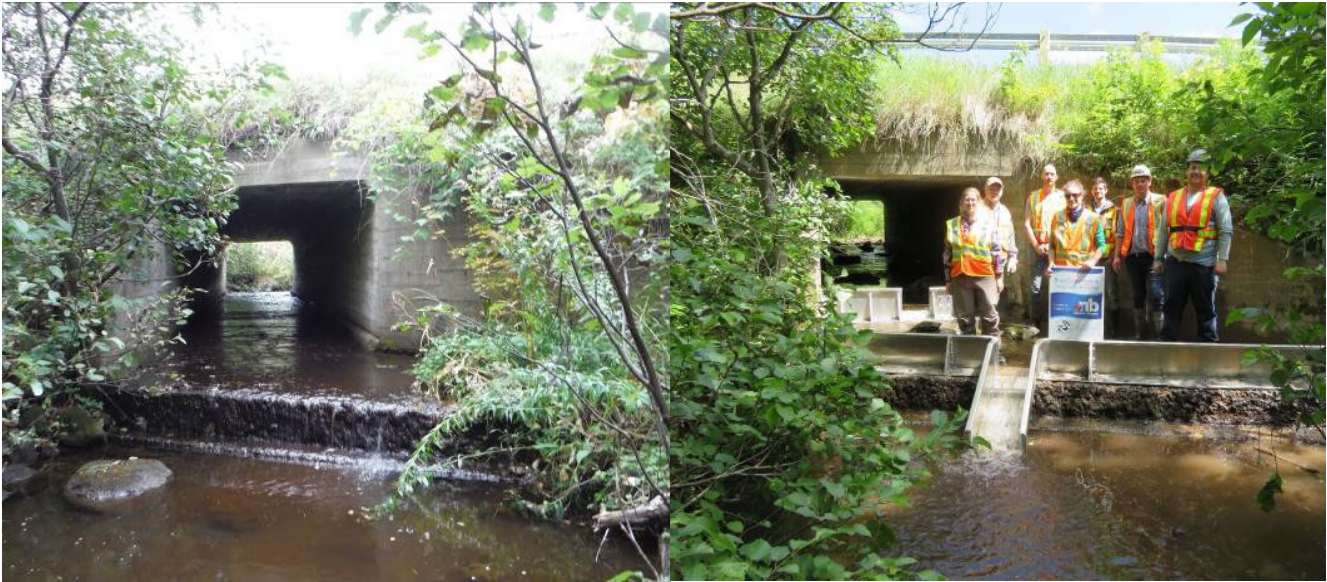
At East Ryan Brook, located along Route 107, a cast in place 2,750 x 1,800 mm concrete box was installed in the 1950s. The crossing was too steep (2.3% over 20 m) and had a 30 cm step at the outlet, preventing fish passage through the pipe. Water in the pipe was very shallow due to its wide, flat bottom. Electrofishing in 2019 showed that there were many brook trout using this cold-water stream along with a single American eel.

Figure 4. Before (left) and after (right) of the East Ryan Brook fish passage project.

The remediation took place in two phases: First, a baffle was placed at the end of the enclosed pipe and another just before the drop (Fig 3). Baffle height was 350 mm, and notch width and depth were 200 mm and 150 mm, respectively, for both. These allowed the water in the pipe to back-flood and velocity to decrease. A short chute was installed over the drop at the end of the structure. The chute contained roughness bars to prevent sheet flow. The second baffle was fitted with a small slide to allow fish to swim up and over. The second phase, installed a few weeks later, involved three shorter baffles that extended 4/5ths of the way across the pipe (Fig 4). We alternated which side of the baffle was opened to create a sinuous channel through the pipe. These helped back-flood the remainder of the pipe. Large rocks were placed throughout the pipe to create microhabitat, allowing water to eddy behind the rocks, providing protection for small fish.

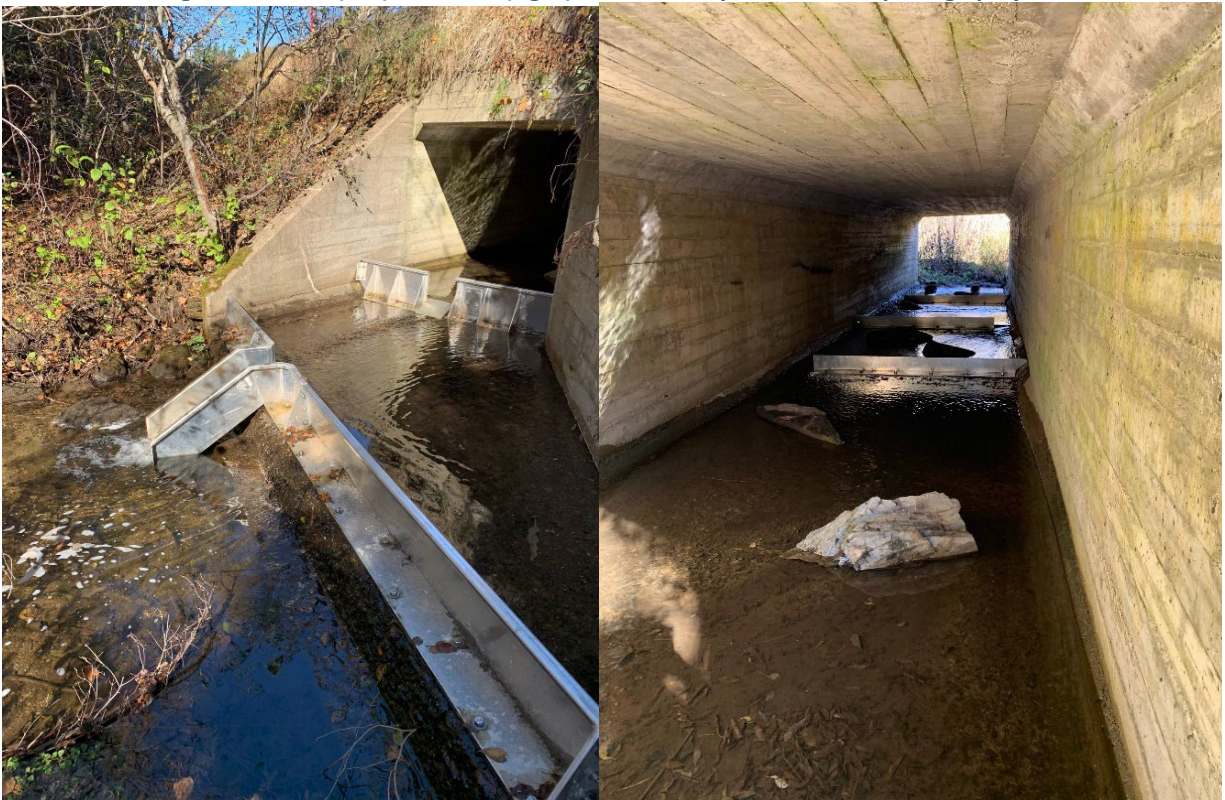
Figure 5. Details of the East Ryan Brook fish passage project showing the chute and first two baffles (left) and the upper three partial baffles (right) as well as the large rocks placed to provide microhabitat in the pipe.

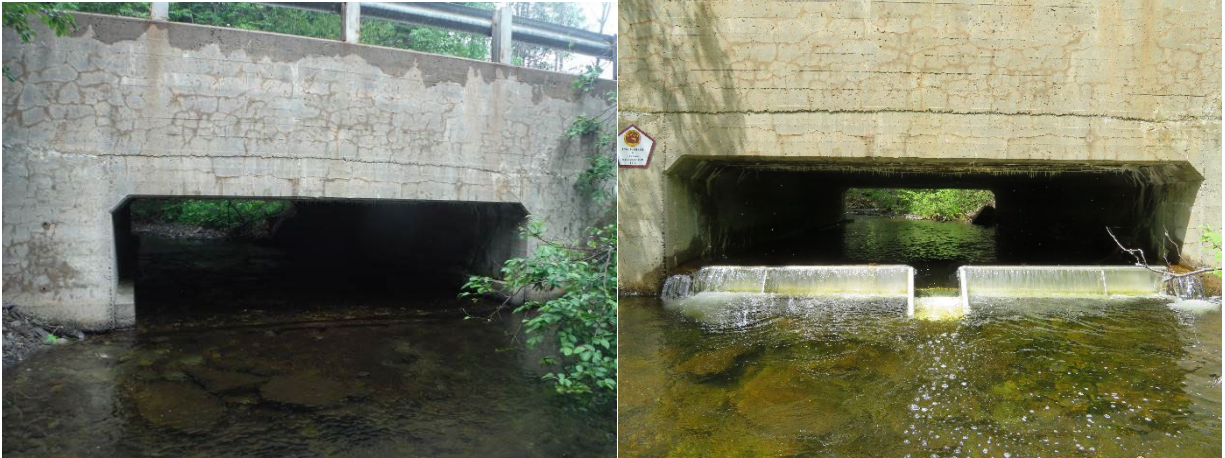
The McGivney Brook pipe is a cast in place concrete box (4,580 x 1,260 mm) on Route 625. The remediation work at this site was completed in October 2020. This culvert was slightly too steep (0.9% over 9.8 m) to allow for fish passage. Its wide, flat bottom meant that there were only a few millimetres of water depth during low flow. Pre-remediation electrofishing found three species downstream and four species upstream (American eel was found upstream but not downstream). Similar numbers of brook trout were found up and downstream but higher numbers of black nose dace and slimy sculpin were found downstream compared to upstream. A total of 43 fish were found downstream versus 25 upstream. A temperature logger installed over the summer of 2020 gave an average temperature of only 15.04°C and a peak temperature of 20.6°C between 21 June and 21 September, indicating that this brook is an excellent thermal refuge for salmonids in the summer.

Figure 6. Before and after of the McGivney Brook fish passage project. Picture on the right was taken during a site check in 2023.

Remediation work involved the installation of one aluminum baffle and chute at the outlet of the pipe. The baffle was 300 mm high with a notch width and depth of 400 mm and 300 mm, respectively. The chute was 400 mm wide and 615 mm long. The baffle allows water to back-flood in the culvert, becoming deeper and slower (and easier for fish to swim in). The chute allows fish to swim into the culvert during low flow and it was fitted with roughness bars to prevent sheet flow. This project opened 10.2 km² of habitat and 8,913 m of stream length above it.

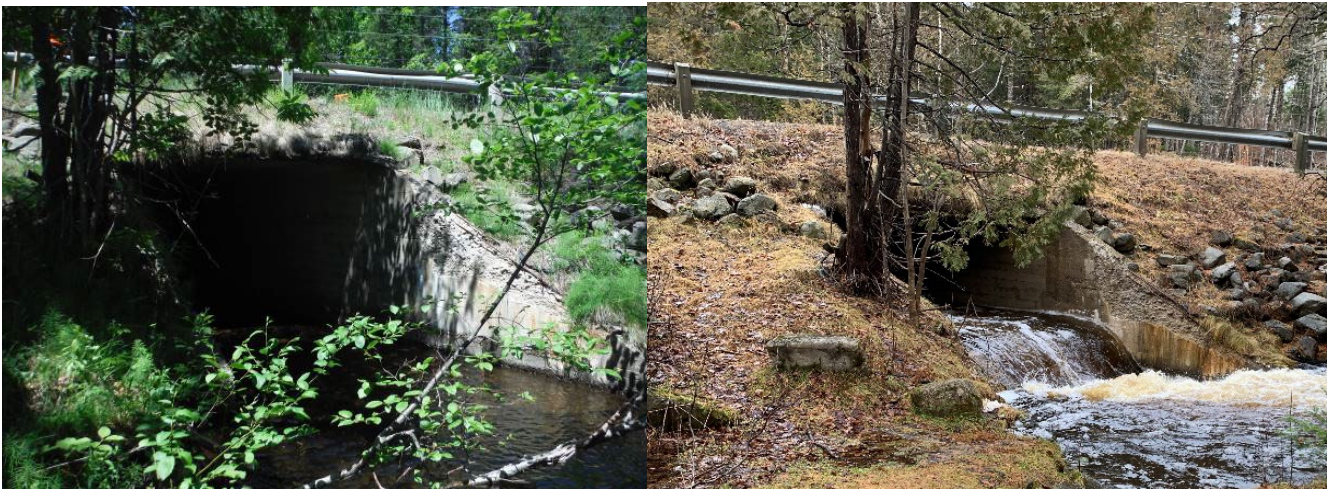
The Limekiln Brook pipe is a cast in place concrete box (3,000 x 2,400 mm) on route 620. The remediation work at this site was completed in October 2020. This culvert was too steep (2.11% over 28 m) to allow for fish passage. Its wide, flat bottom meant that there were only a few millimetres of water depth during low flow. Pre-remediation electrofishing found 4 species downstream and 2 species upstream. American eel and black nose dace were not found above the pipe. A total of 14 fish were found downstream versus 6 fish upstream. Post-remediation electrofishing will be completed in 2021. A temperature logger installed over the summer of 2020 gave an average temperature of 18.41°C and a peak temperature of 24.73°C between 21 June and 21 September, indicating that this brook would be an excellent thermal refuge for salmonids in early/late summer. However, in peak summer, it may be too warm (temperature exceeded 23°C on 20 days).

Figure 7. Road-stream crossing at Limekiln Brook in 2020 (left) before remediation and in 2023 (right) during high-flow after structure was installed in 2020.

The remediation involved the installation of four fish weirs spaced 7 m apart throughout the pipe. The baffles were 500 mm high, with a notch width and depth of 300 mm and 200 mm, respectively. This project opened 7.25 km² of habitat and 10,732 m of stream length above it.

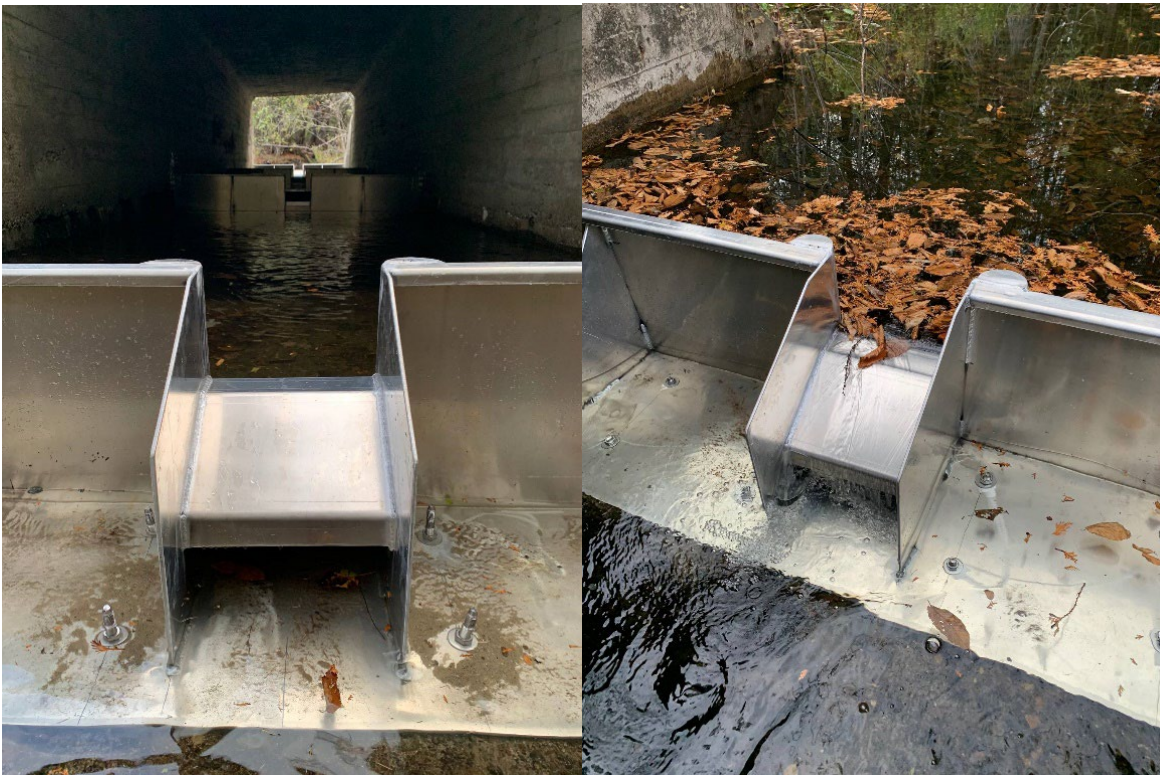
Figure 8. A close-up shot showing the weirs installed for the Limekiln Brook fish passage project in 2020. The weirs were not fully installed at this point, so water was just starting to flow over the chute.

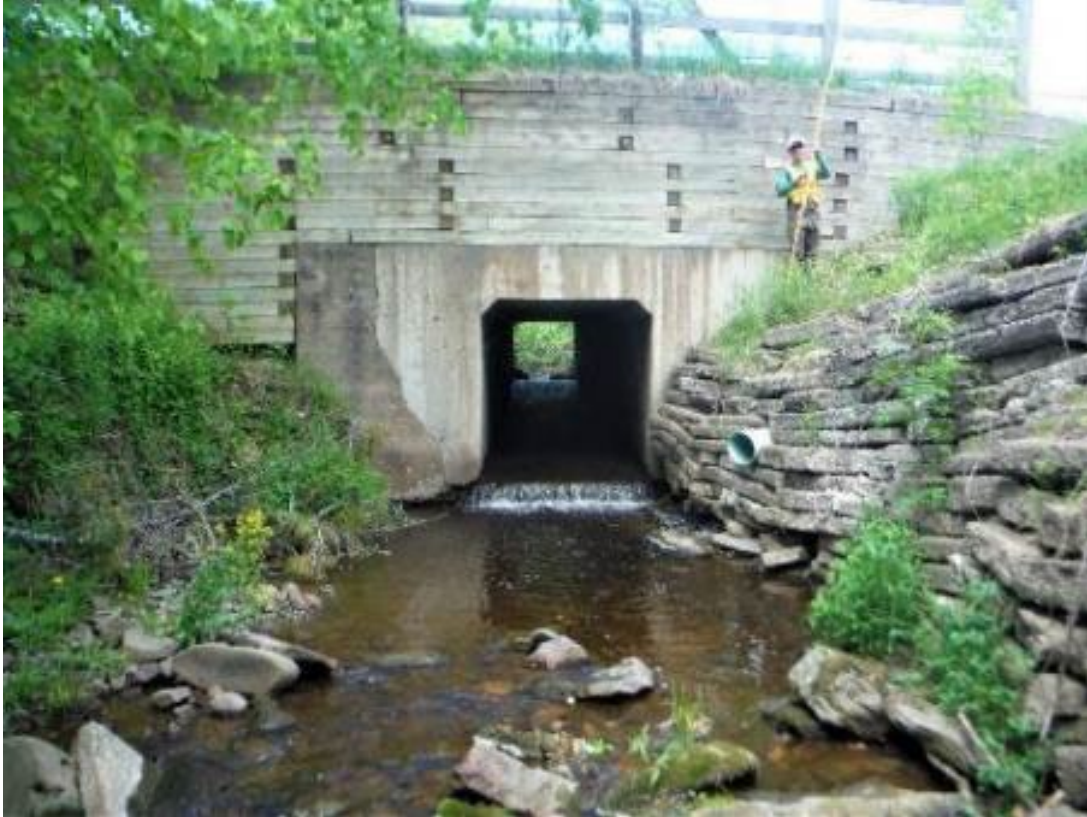
Figure 9. Picture looking upstream in McConaghy brook (MC01). This site is a full barrier to fish passage, blocking 4.2 km² of viable upstream habitat.

The second culvert (MC01), located at 45.9891, -66.5883 is a road-stream crossing at Canada Street (Route 148), a road located in the city of Fredericton. The culvert is a box culvert that is quite old and in poorer condition. The slope, at 6.5%, is too steep for fish passage, with a 0.29 m outflow drop. NWA is proposing that both barriers be remediated in tandem to provide maximum net habitat gain due to their proximity. Both have been identified as severe barriers regarding anadromous and diadromous fish passage. Preliminary engineering drawings have been created by HILCON Ltd. for the profile for MC02 (Figure 15). Design options for the replacement of MC02 will be available from the firm in 2024. Historic DFO consultations with the city have recommended a bridge structure to replace the existing culvert. Designs for MC01 have also been contracted to HILCON Ltd. and will be completed in 2024. Preliminary discussions at this location included a proposal for replacement, or a temporary remediation by installing a “naturally” replicated bottom. Boulders would be embedded into the base to imitate a meandering pattern and provide resting locations for fish. Landowner consultations are still in progress, but there is support and interest in the project from the City of Fredericton based on available funding.

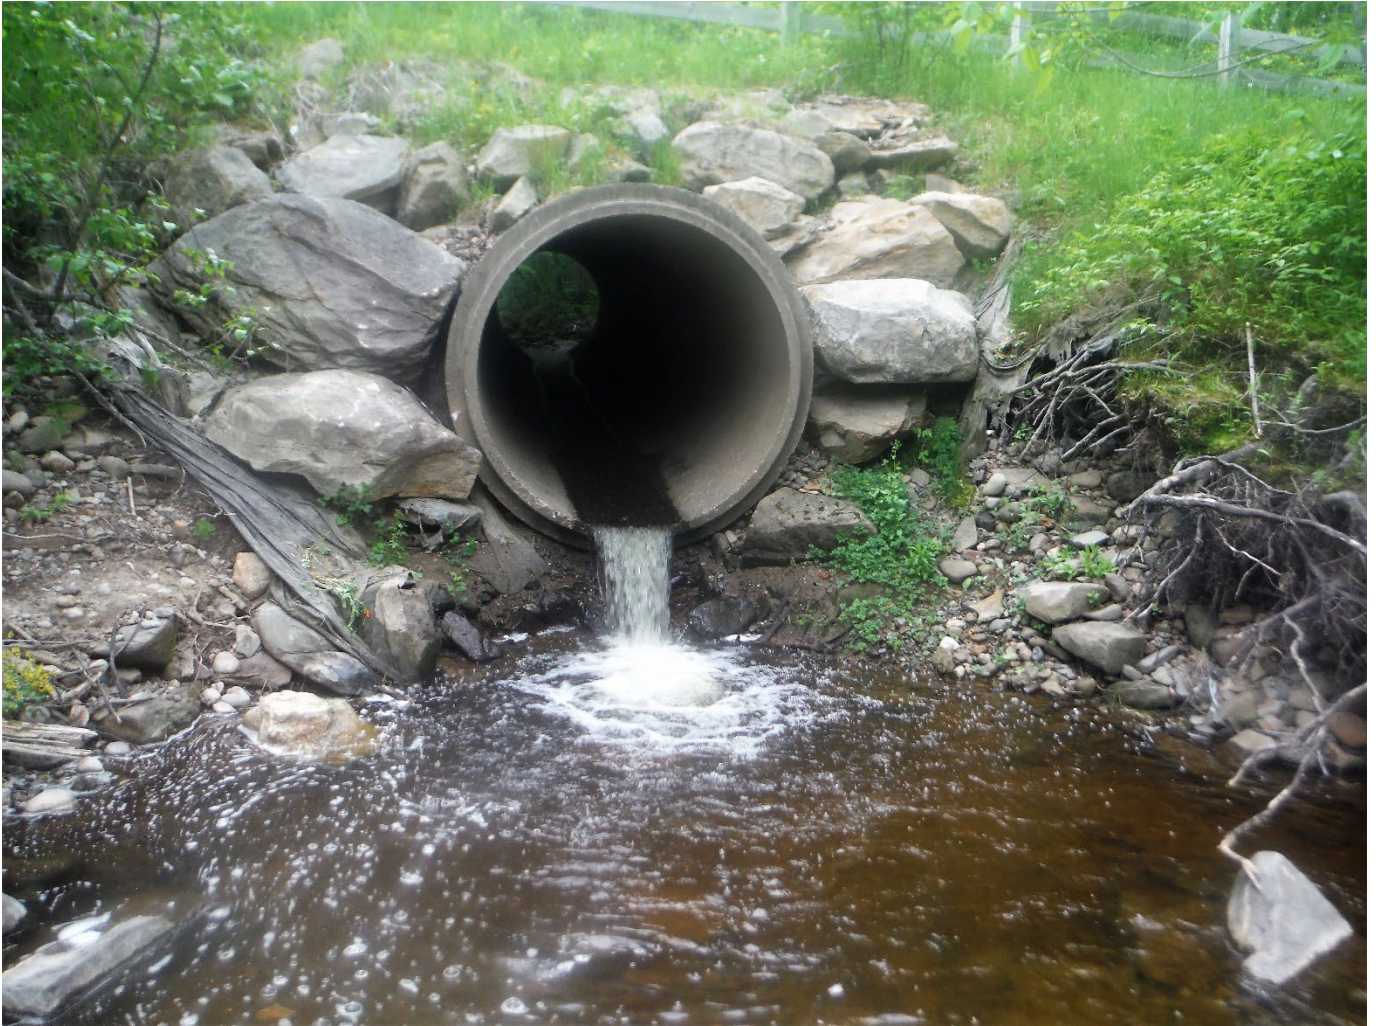
The two culverts of primary concern are both located on McConaghy Brook (Figures 13 and 14). Both are located on property owned by of the City of Fredericton. These barriers are blocking over 4200 m² of functional upstream habitat. When moving upstream from the mouth of McConaghy Brook, the first culvert (MC02) is located at 45.9875, -66.5879 and crosses the NB walking trail system. The culvert is newer and in good condition but is too steep with a slope of 9.32% for fish passage. Further to this, the outflow drop is also too high at 0.61m.

Figure 10. McConaghy Brook (MCC02) culvert outflow looking upstream. Picture taken in 2017.

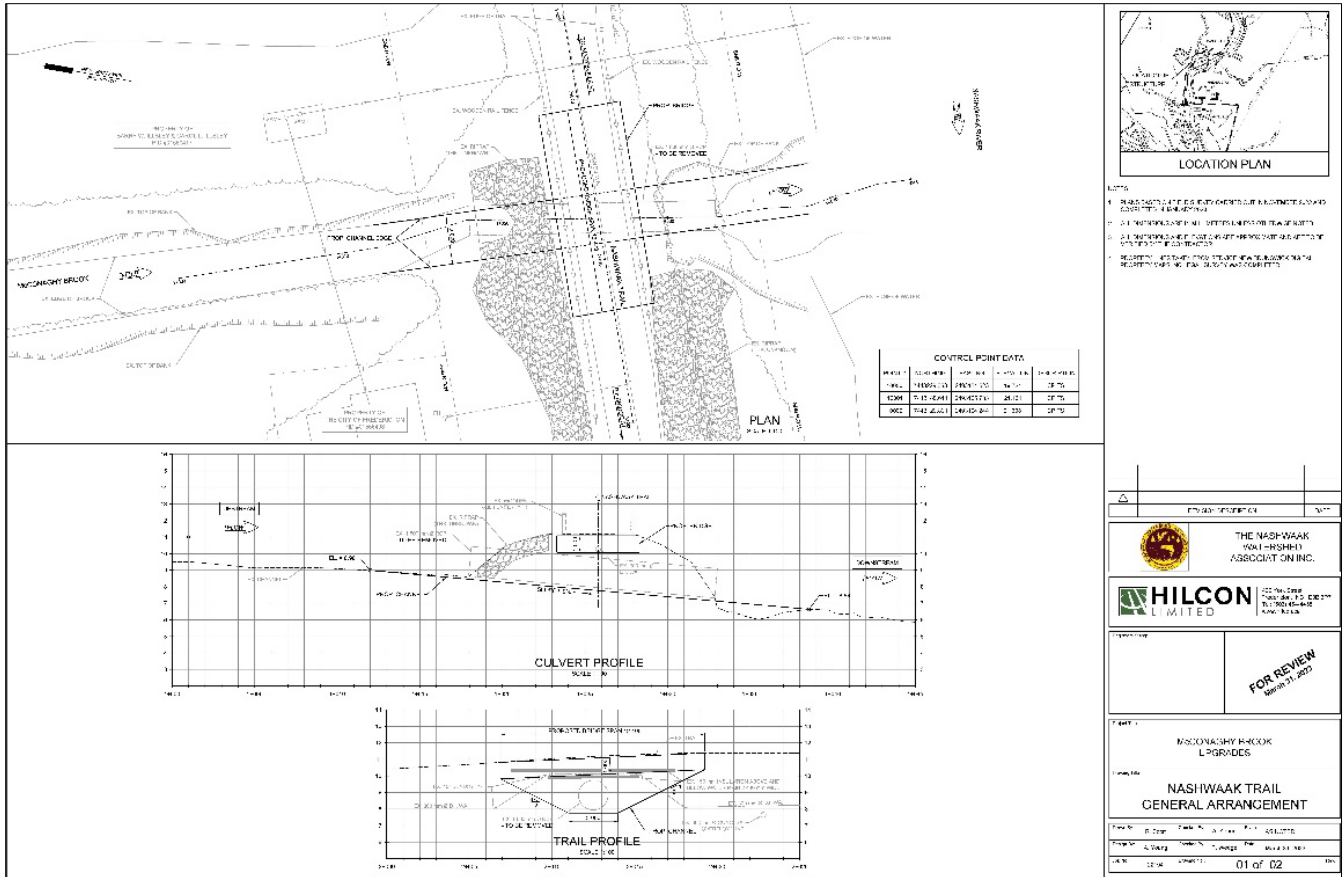
Figure 11. Preliminary engineering design showing the proposed bridge to replace the culvert MC02, crossing the NB trail on McConaghy Brook. Design completed by HILCON Ltd.

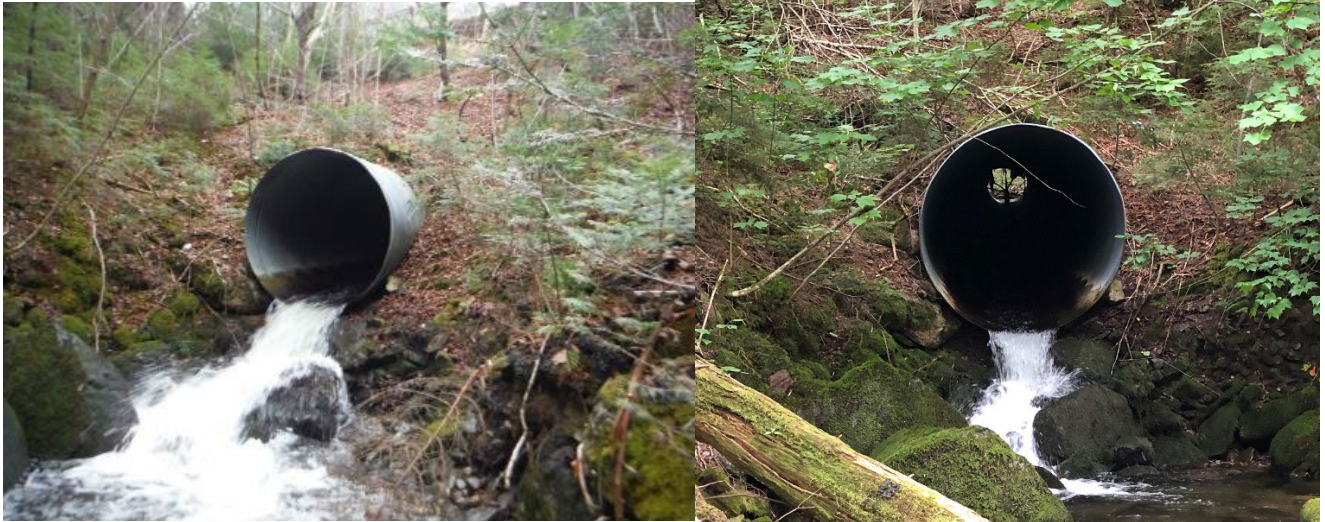
Porters Brook is a culvert located on Nashwaak West Road and is the property of NBDTI. It is understood that this culvert has been impeding fish passage in this cold-water tributary for many decades. The Porters Brook culvert is an 1,800 mm diameter corrugated steel pipe (Figure 11). The slope of the culvert is 14.96% with an outflow drop of approximately 1m. Collectively, the high slope and outlet drop confirm that this culvert is a full barrier to fish passage according to the DFO’s criteria. Currently the culvert is blocking access to over 4.9 km² of fish habitat.

Figure 12. The outlet of the Porters Brook culvert in high water conditions in 2017 (L) and in low water conditions in 2023 (R).

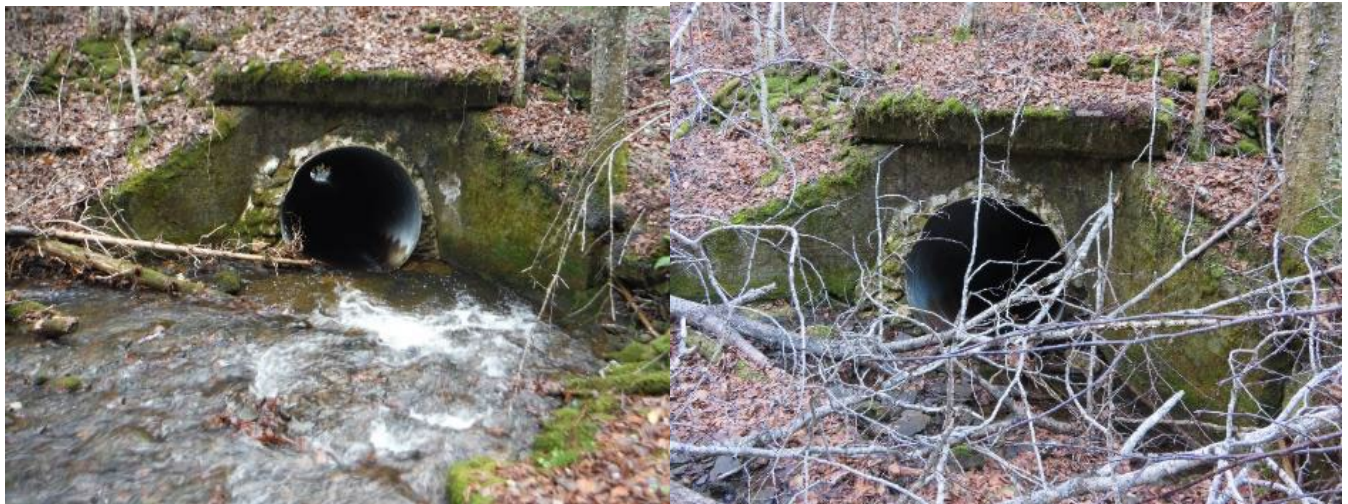
Figure 13. The inlet of the Porters Brook culvert in 2017 (L) and in 2020 (R). Many large trees have fallen in the stream and debris has started to clog the stream just above the inlet.

NBDTI closed this section of Nashwaak West Road more than 15 years ago, with no plans to reopen it. Despite the road being closed, ATVs, trucks and tractors are still driving through the blockade, which creates a safety liability for the province. As the road and culvert have not been maintained since the road was closed, the condition of both have deteriorated. Sediment fabric can be seen hanging inside the pipe, indicating that there are cracks in the top of the culvert (Figure 11). Significant erosion was noted both upstream (many large trees in the stream) and downstream in the plunge pool (Figures 11 and 12). The turbulent jet of water coming through the pipe is causing scour, which dislodges particles from the stream bed and banks. Deposition of that sediment is occurring in the pool at the mouth of the brook when water velocity slows. If the pipe and road were to collapse or washout, it would send road fill and sediment into the watercourse, which would irreversibly damage the brook as well as the important cold-water pool at the mouth. It is crucial to protect the integrity of this pool and prevent further damage due to ongoing sedimentation from the deteriorating culvert and

scour from the plunge pool. Furthermore, fine sediments have already infilled many pools and spawning areas in the Nashwaak, increasing the importance of protecting those that are remaining.

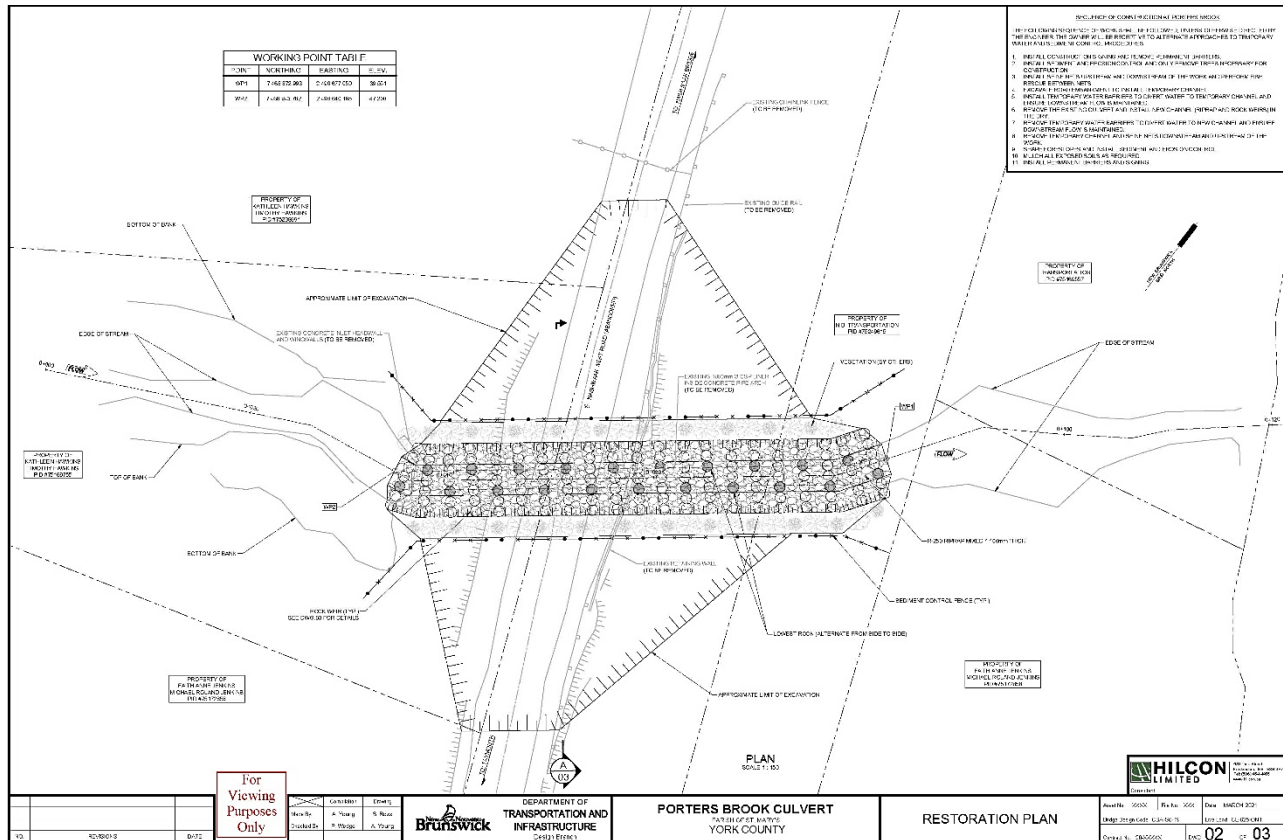
Figure 14. Preliminary engineering drawing for the removal of Porters Brook culvert. Designed in 2021 by HILCON Ltd.

An initial comprehensive survey for Porters Brook (Nashwaak West Road) was completed in 2021, which included flow monitoring, habitat assessment and site assessment. A brief electrofishing baseline survey was also performed with help from the DFO Community Indigenous partners in science program (Table 11). In March 2021, a tentative plan for the removal of Porters Brook culvert was designed by the engineering firm HILCON Ltd and presented to DTI (Figure 13).
