Introduction

MacPherson Brook, a cold-water stream in the community of Giants Glen, was identified during a 2016 geomorphic assessment and in our 2017-2020 Action Plan as an important source of cold water that should be protected and restored. The site is located between 269 and 273 Giant's Glen Road near the mouth of MacPherson Brook [46.2990, -66.7842] (Fig. 1). Approximately 14 years ago the landowner 269 Giant's Glen Road placed a number of large rocks on the edge of the brook to reduce flooding. This reduced the capacity of the floodplain and pushed the water into the opposing bank, which began to collapse. The substrate of this bank is fine and sandy, which allowed the water to cut into the bottom of the bank, leading it to slump down. The landowner of the collapsing bank estimated that he had lost ~3-5 m of land over the last 14 years, along with many trees.

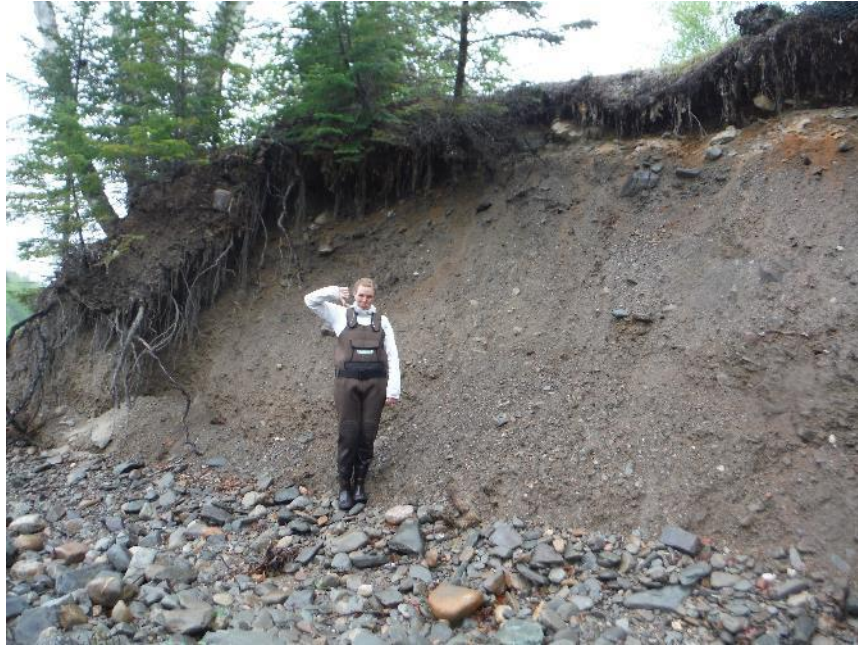
In 2017, the eroding section was ~30 m long by 4.5 m high (Figs. 2 & 3). Continuous erosion has been releasing sediment into the Nashwaak River, degrading water quality and aquatic habitat. In addition, sediment had built up a small island in the middle of the mouth of the brook, which was exacerbating the erosion as it was pushing water into both banks.

Figure 2. The downstream end of the eroding bank in May 2017.

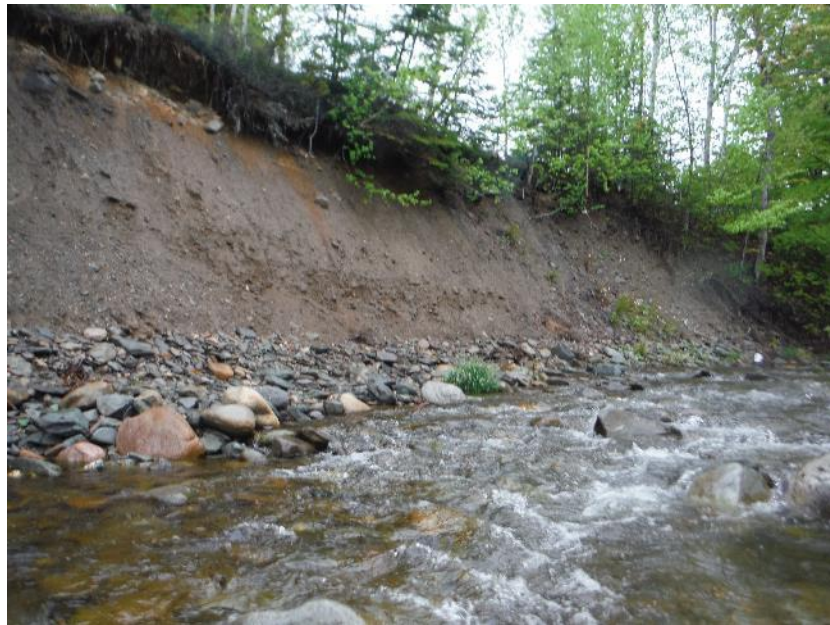
Figure 3. The upstream end of the eroding bank in May 2017.

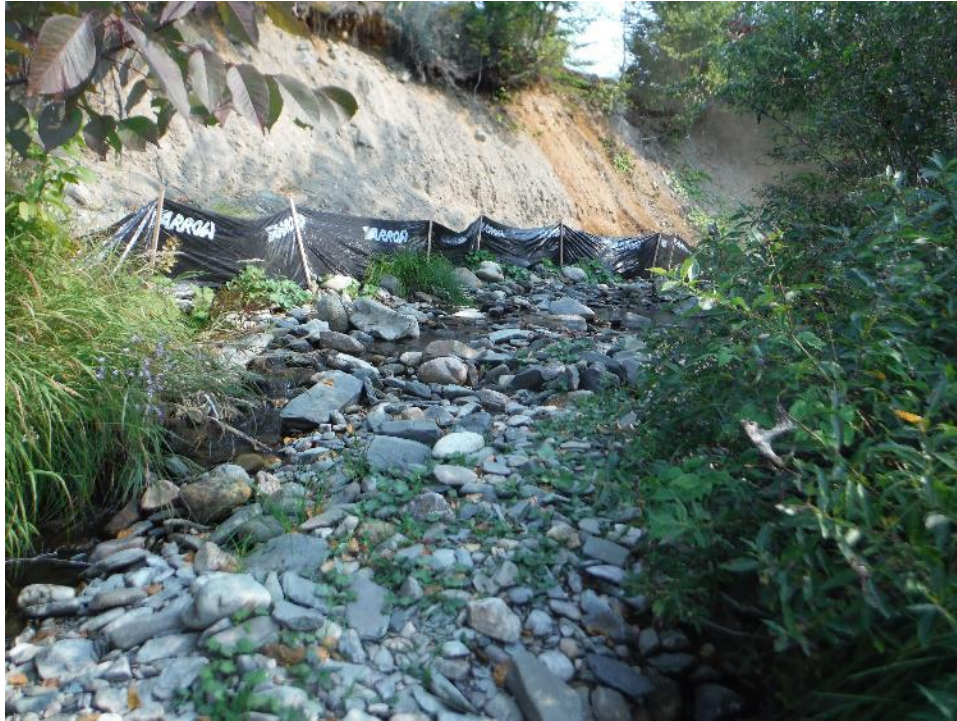
Figure 5. Step 1. A sediment fence was installed before work began.

A sediment fence was installed the day before work began to prevent sediment from coming down the bank and entering the stream. Water levels were extremely low while the work was happening.

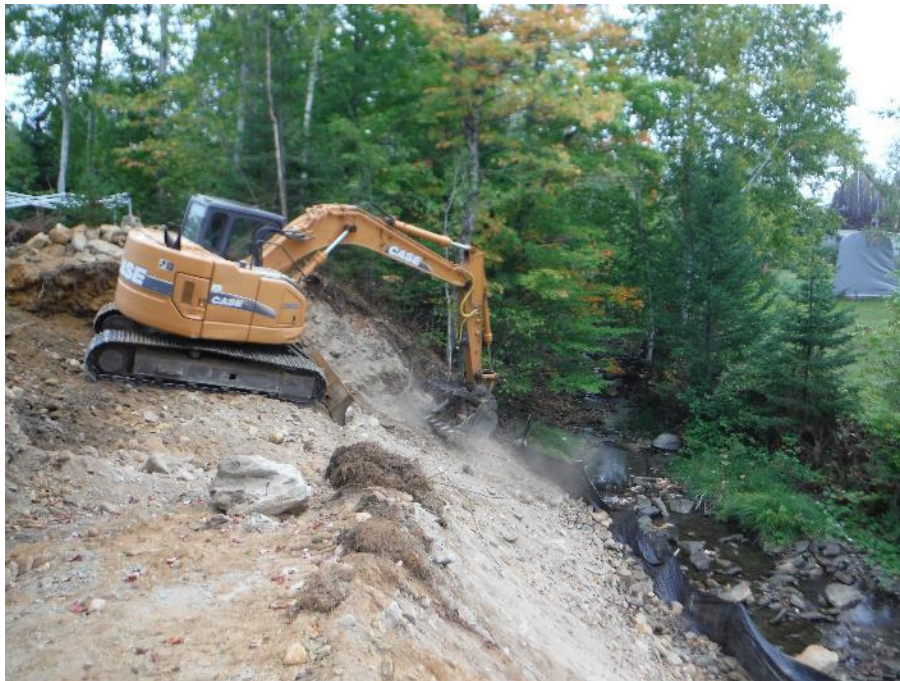
Figure 6. Step 2. We began reshaping the bank and digging the trench where the R50 would be placed.

Vegetation was removed along the top of the bank. Trees were only removed if absolutely necessary. Only one large tree had to be removed. The bank was reshaped to a 1.5:1 slope and a R50 (300 mm diameter rocks) rock toe was installed. The rock toe was buried ~0.5 m and extended ~1 m up the bank. Existing rocks were mixed in with the R50 to achieve a more natural look.

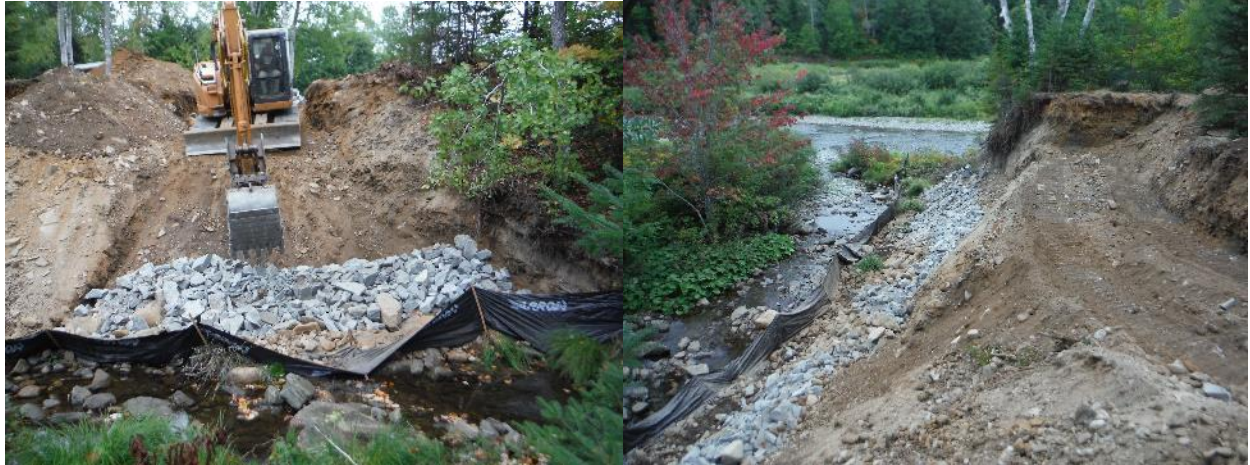
Figure 7. Step 3. R50 riprap was mixed with existing rocks and placed in a trench at the toe of the slope.

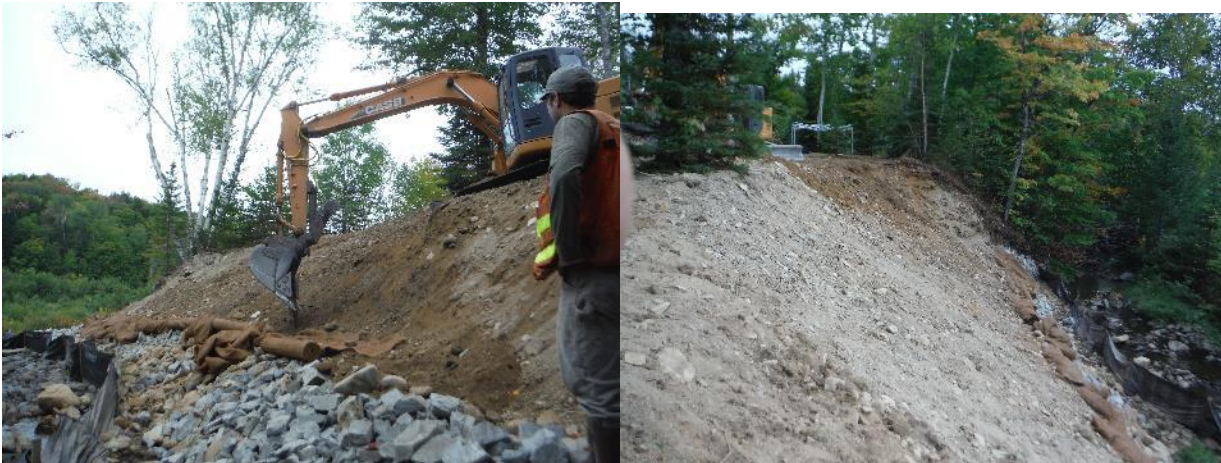
Figure 8. Step 4. The erosion control blankets were laid on top of the rock toe and dirt was place on the end on the blanket to hold it in place before the blankets were rolled up over the slope. Not shown is a layer of hay that was placed under the blankets.

Hay was scattered over the slope to prevent the fine sediment from blowing away due to the drought. Erosion control blankets were wrapped over the bank and secured with sod staples. Edges of the blankets were covered with a scoop of dirt and the blanket was wrapped over top. Sections of blankets were overlapped by ~10 cm. We ran the blankets over the top of the bank and secured them ~1 m beyond the top.

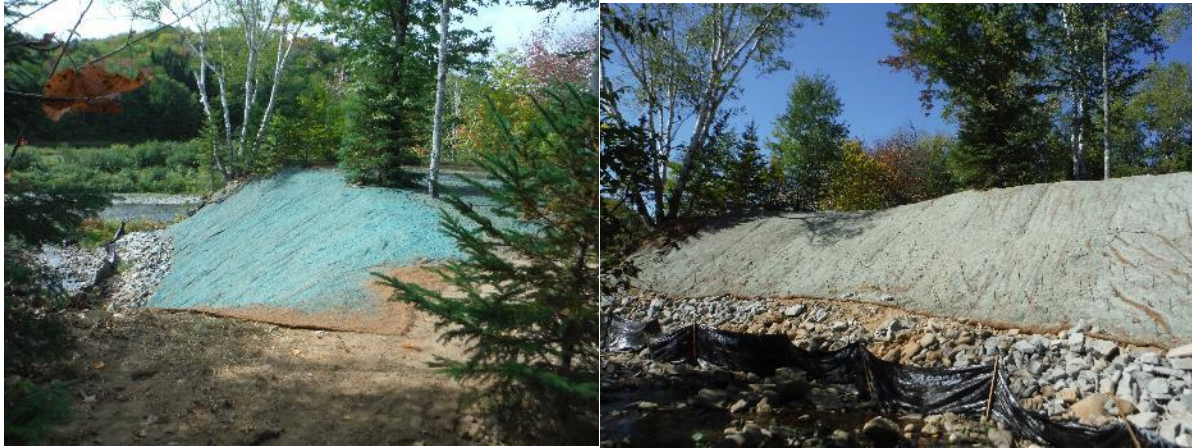
Figure 9. Step 5. The erosion control blankets were rolled up and hydroseeded. >200 willow stakes were planted in the lower half of the bank.

A professional hydroseeder sprayed grass seed on top to ensure that vegetation would become established this season. >200 live willow stakes were hammered into the lower half of the bank and on the opposing bank where the machinery had damaged some vegetation. About half of the stakes were taken from vegetation that had to be removed to allow access. All stakes were soaked in the river for at least 24 hours. The landowner agreed to water the bank daily. This work was completed by September 21st.

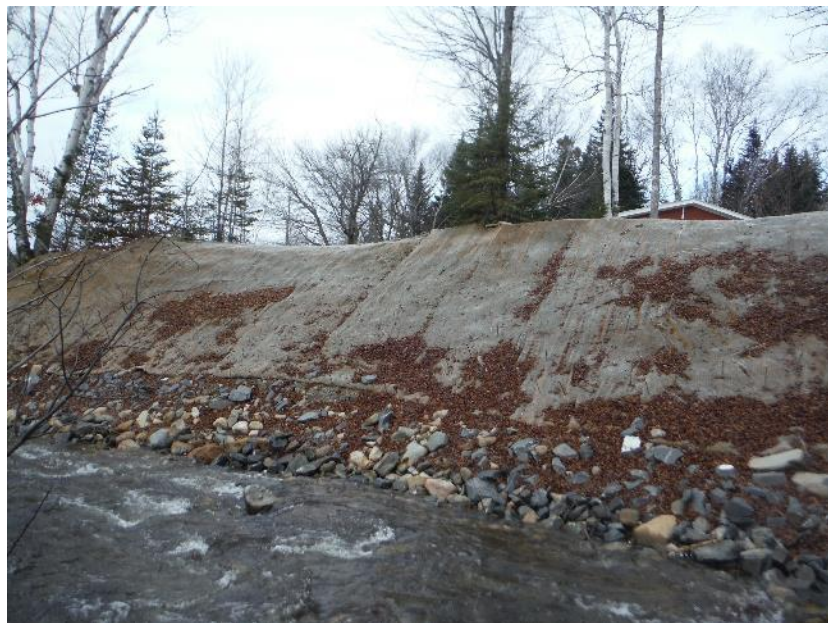
Figure 10. The bank in December 2017 at high water.

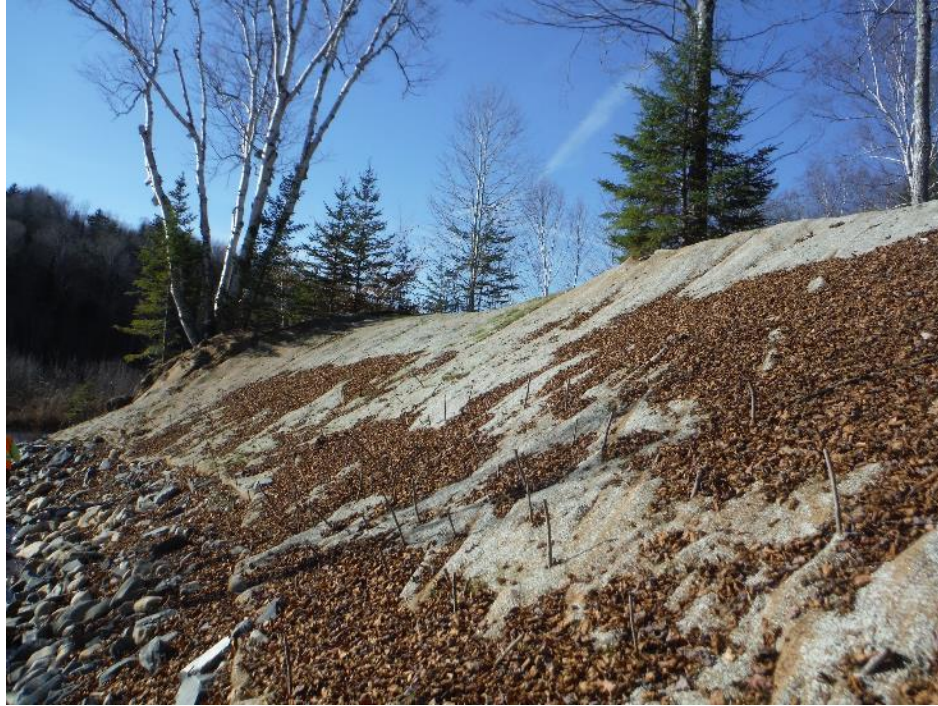
Figure 11. Tree seedlings were planted on top of the bank while willow stakes were planted in the lower half of the bank.

Silver maple, sugar maple, red oak, and white oak seedlings were planted on top of the bank in early October. We anticipate planting additional maple seedlings in the spring when conditions are better.

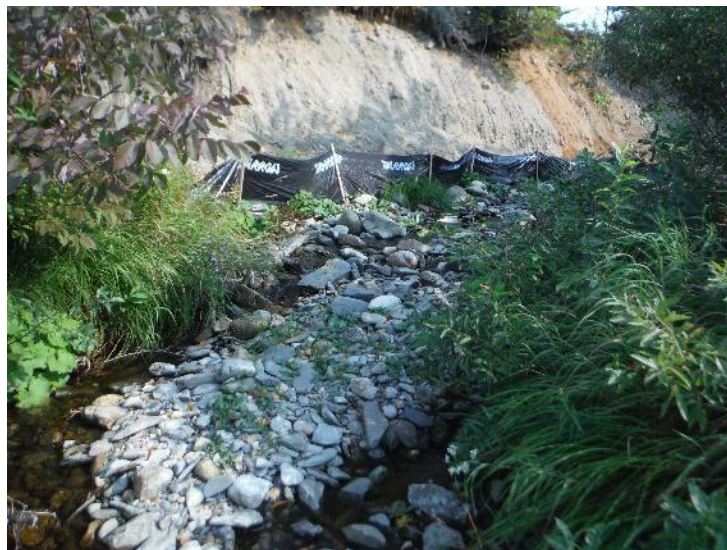
A rock weir consisting of 9 rocks that were 600 mm in diameter was placed at the downstream end of the repaired bank, close to the mouth of the brook. This is where there was a build up (island) of sediment that had some off of the bank. The island was pushing water into both banks and exacerbating the erosion. Machinery sat on the lower bank and reached into the stream. Staff watched for sedimentation of the stream and was prepared to stop work if large turbidity became too high. However, due to low flow conditions we did not have to stop and the sediment dropped out of the suspension very quickly.

Figure 12. The island that had formed at the mouth of the brook from sediment that had eroded off the bank.

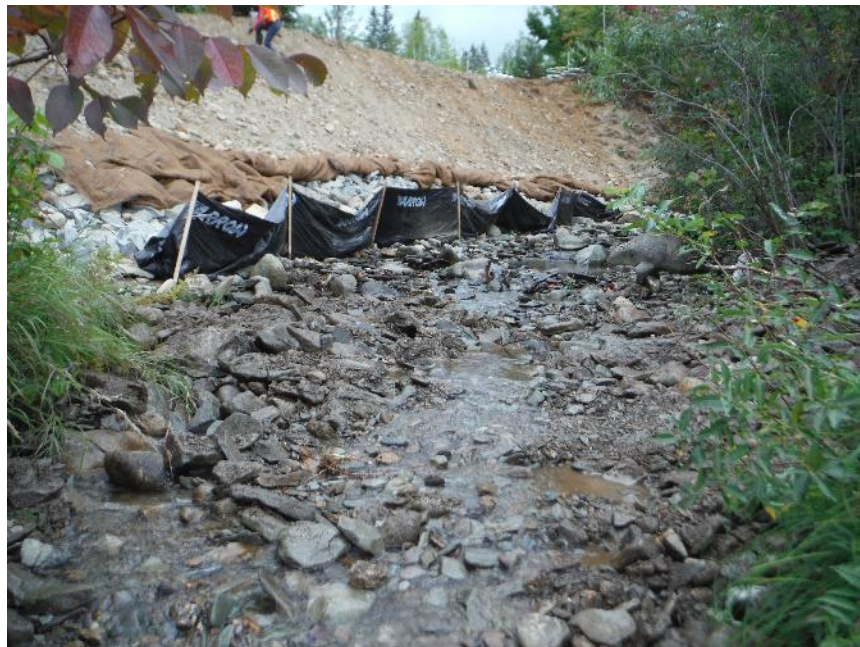
Figure 14. The rock weir (after) at low flow conditions.

This weir will act as a grade control and reduce scouring of the channel bed. In low flow conditions, it will also concentrate flow to allow for fish passage into the cold-water tributary. Fish (juvenile brook trout and black nosed dace) were noted swimming through the rock weir almost immediately upon completion of work.

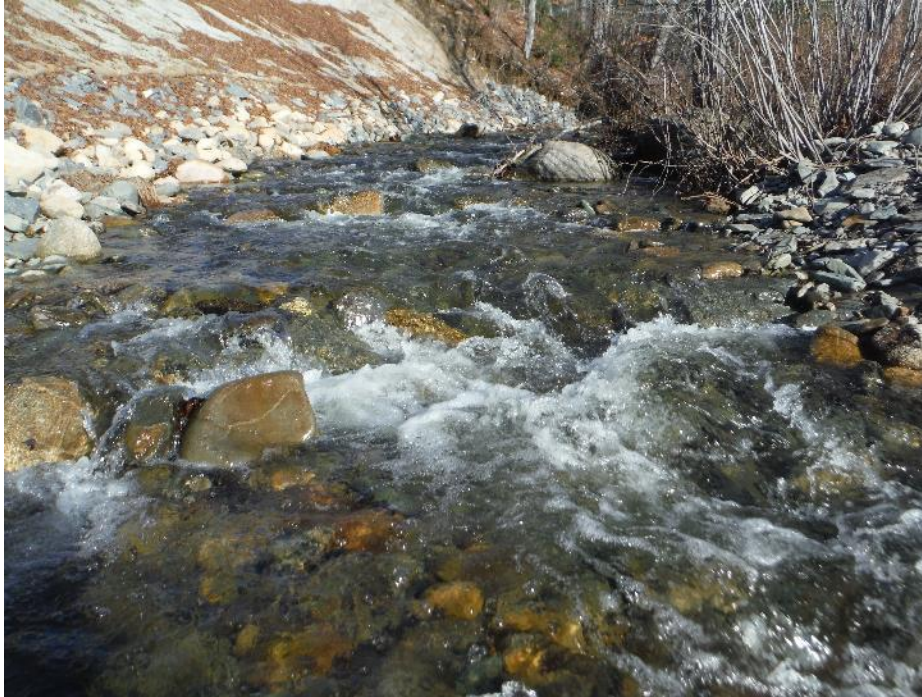
Visual inspection after a heavy rainfall revealed that there was much less fine suspended sediment and the rock weir was slowing the velocity of the water around the mouth. As of November, finer substrate had begun infilling gaps in the rock weir and rock toe, which will provide additional support.

Figure 15. The rock weir functioning well after heavy rains in November 2017.

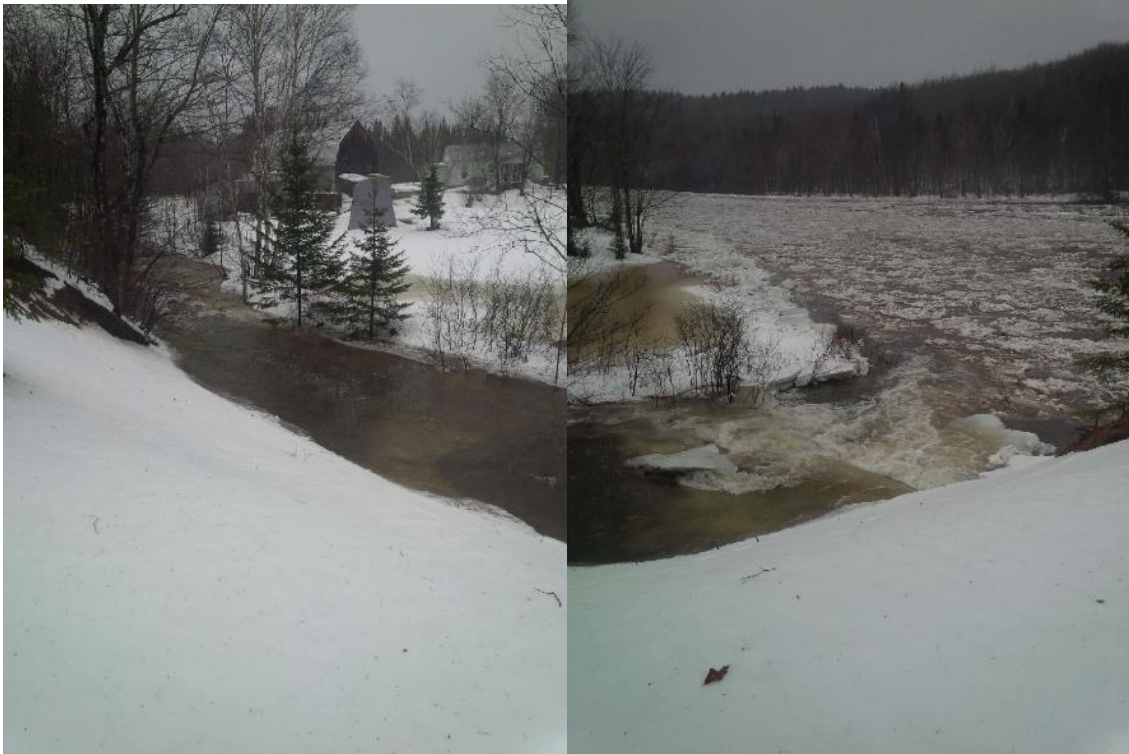
Figure 16. MacPherson Brook after a heavy rain in January 2018 (photos from landowner Jeff McIssac).

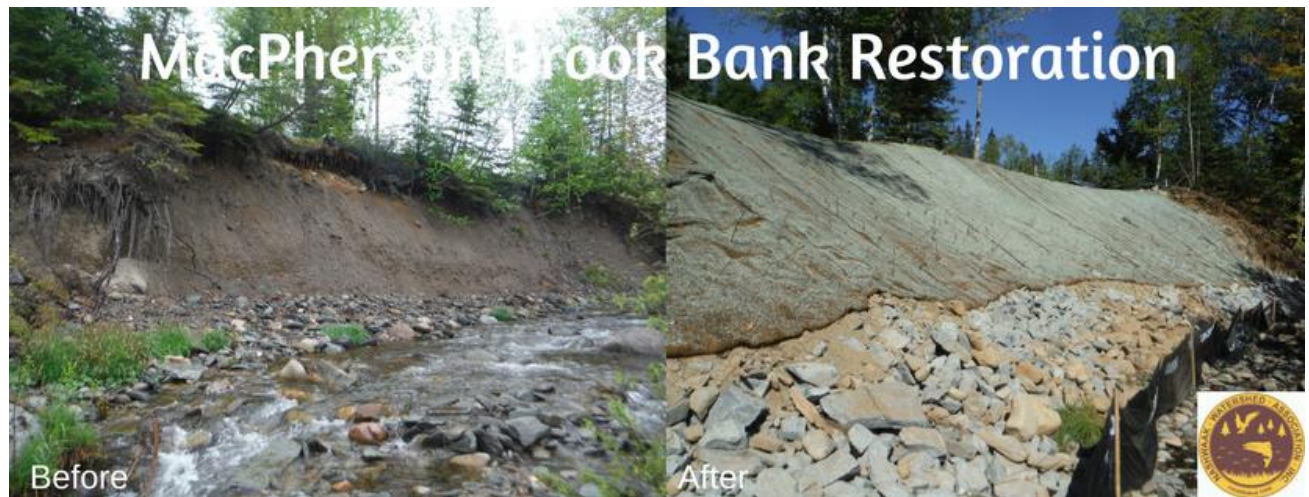
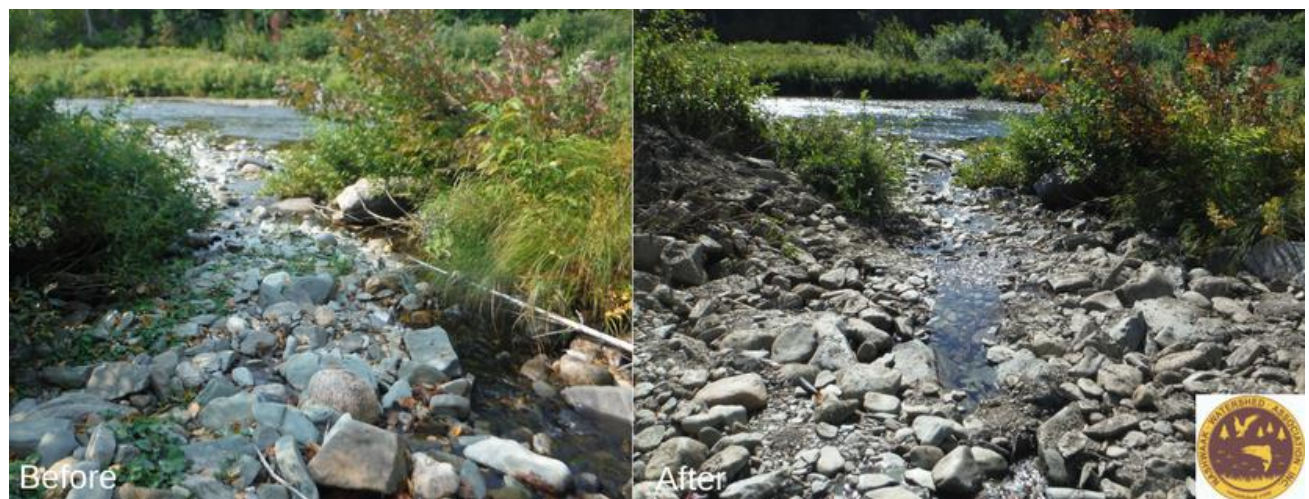
Figure 18. Looking downstream at the mouth of MacPherson Brook before (left) the rock weir was installed, a gravel island had built up and was channeling water to either side, which was causing more bank erosion. After (right) the installation of the sunken rock weir at low flow conditions.
