Soil Erosion Survey of the Nashwaak River and the Tay, Penniac and Cross Creek Streams

The New Brunswick Department of the Environment and Local Government
P.O. Box 6000
Fredericton, NB
E3B 5H1
March, 2005

The Nashwaak Watershed Association Inc.
P.O. Box 20037
Fredericton, NB
E6B 6Y8

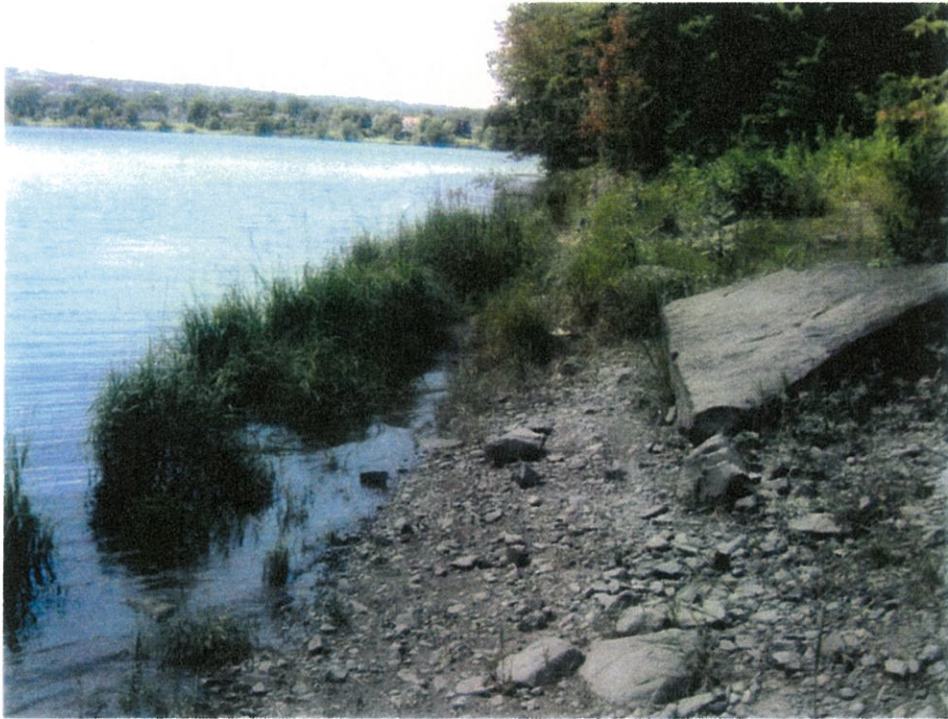
Photo # ER-1a

NWAJ Eroding Bank Survey, ETF Project 2004/2005			
Eroding Bank Number:	ER-1		
General Location:	Main Street Bridge - Fredericton		
GPS Coordinates:	Northerly	45	57.379
	Westerly	66	37.415
Erosion Severity:	Minor		
Recommended Remedial Action:	Grasses		
Eroding Bank Height (approx meters):	<1		
Eroding Bank Length (approx meters):	60		
Channel Location:	Right Hand Channel		
Bank Location:	Right Hand Bank

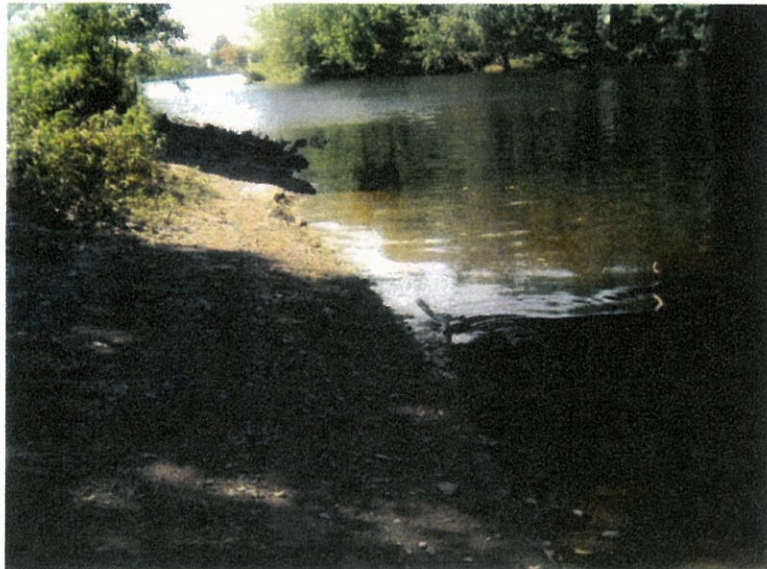
Photo # ER-2d

NWAJ Eroding Bank Survey, ETF Project 2004/2005			
Eroding Bank Number:	ER-2		
General Location:	Main Street Bridge - Fredericton		
GPS Coordinates:	Northerly	45	57.282
	Westerly	66	37.377
Erosion Severity:	Minor		
Recommended Remedial Action:	Grasses		
Eroding Bank Height (approx meters):	<1		
Eroding Bank Length (approx meters):	60		
Channel Location:	Left Hand Channel		
Bank Location:	Left Hand Bank

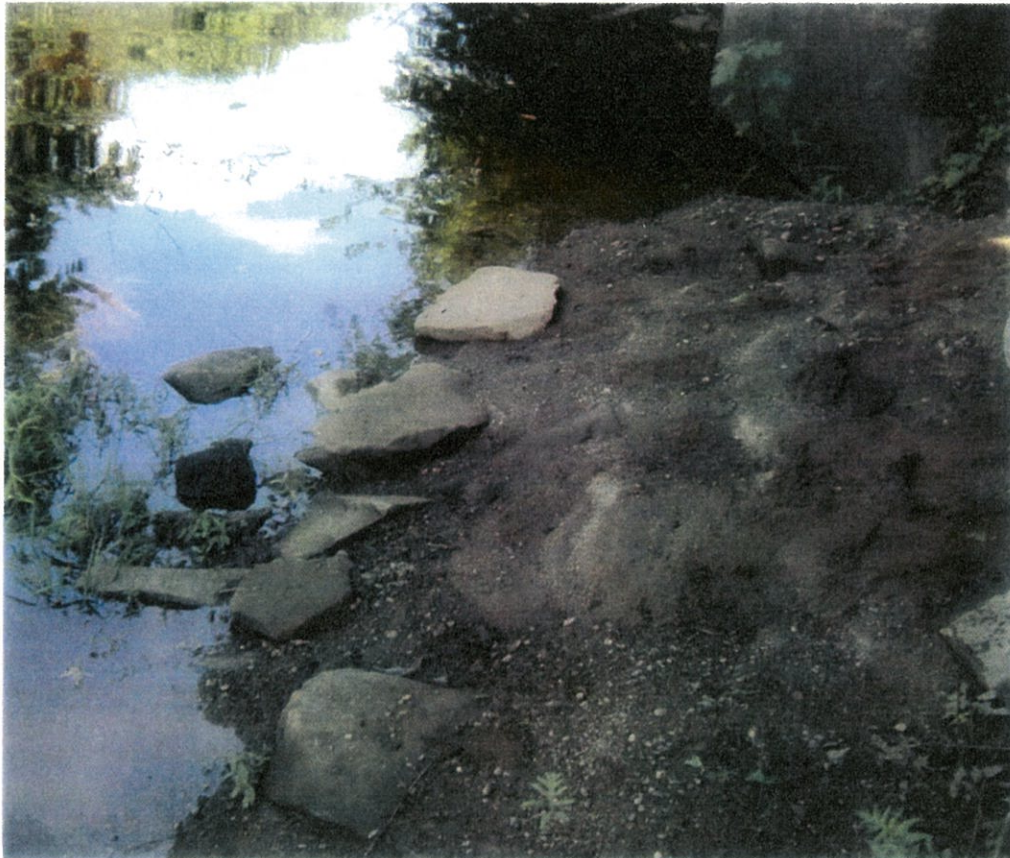
Photo # ER-3a

NWA I Eroding Bank Survey, ETF Project 2004/2005			
Eroding Bank Number:	ER-3		
General Location:	Old Bridge abutment - Charles Ave - Fredericton		
GPS Coordinates:	Northerly	45	57.401
	Westerly	66	37.052
Erosion Severity:	Minor		
Recommended Remedial Action:	Grasses		
Eroding Bank Height (approx meters):	<1		
Eroding Bank Length (approx meters):	30		
Channel Location:	Left Hand Channel		
Bank Location:	Left Hand Bank

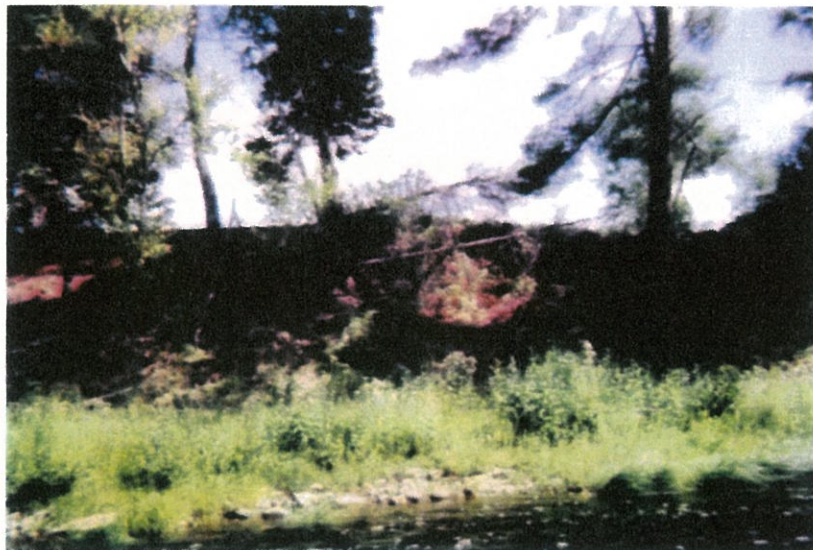
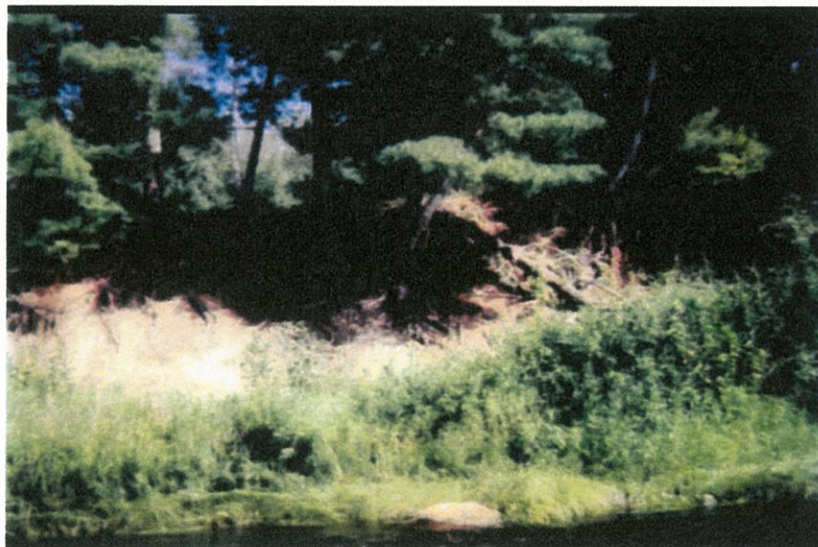
NWA I Eroding Bank Survey, ETF Project 2004/2005			
Eroding Bank Number:	ER-6		
General Location:	Below Nashwaak Bridge		
GPS Coordinates:	Northerly	46	13.818
	Westerly	66	36.782
Erosion Severity:	Moderate		
Recommended Remedial Action:	Trees/shrubs		
Eroding Bank Height (approx meters):	2 to 3		
Eroding Bank Length (approx meters):	180		
Channel Location:	Left Hand Channel		
Bank Location:	Left Hand Bank		
Special Location Instructions:	Marked in Pool below eroding bank

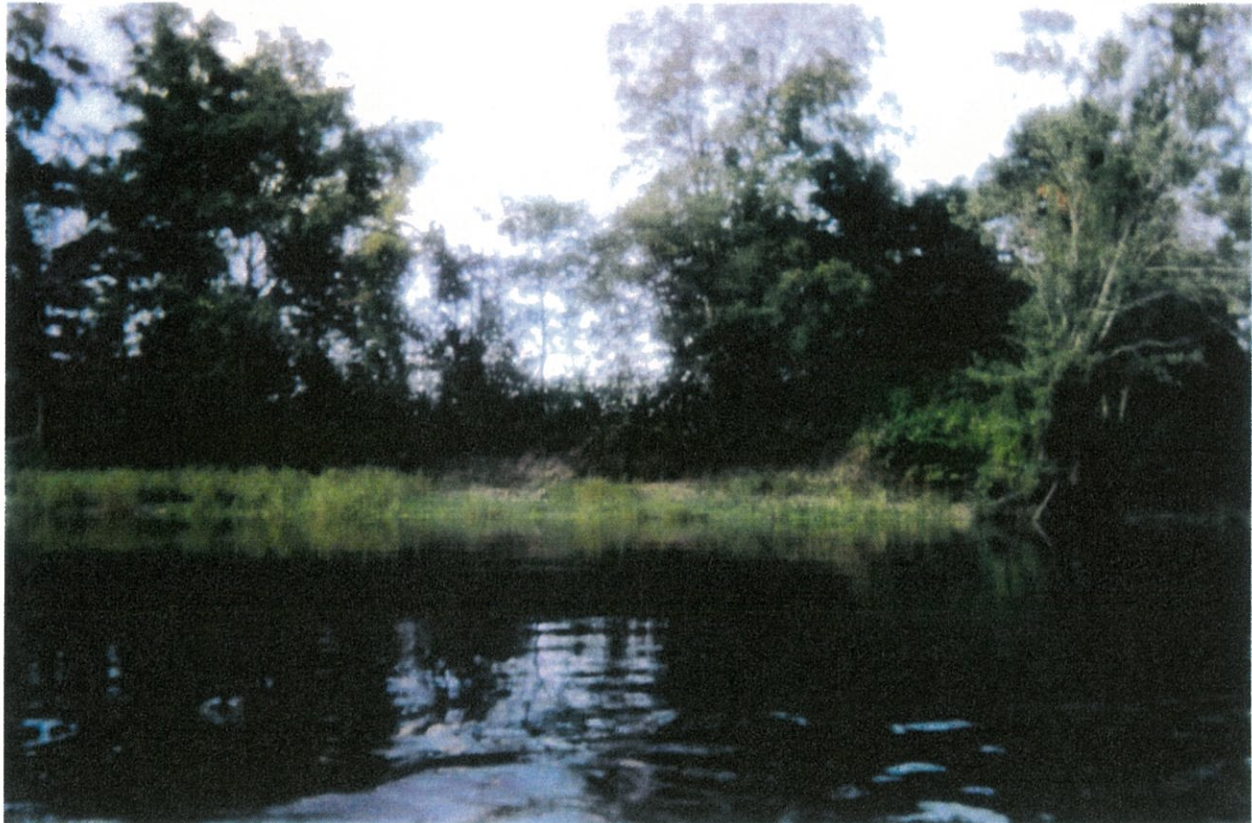
Photo # ER-7

NWA I Eroding Bank Survey, ETF Project 2004/2005			
Eroding Bank Number:	ER-7		
General Location:	Below Ross Pool		
GPS Coordinates:	Northerly	46	12.973
	Westerly	66	37.079
Erosion Severity:	Minor		
Recommended Remedial Action:	Trees/shrubs		
Eroding Bank Height (approx meters):	<1		
Eroding Bank Length (approx meters):	8		
Channel Location:	Main		
Bank Location:	Left Hand Bank		
Special Location Instructions:	Marked approx 200m below actual erosion

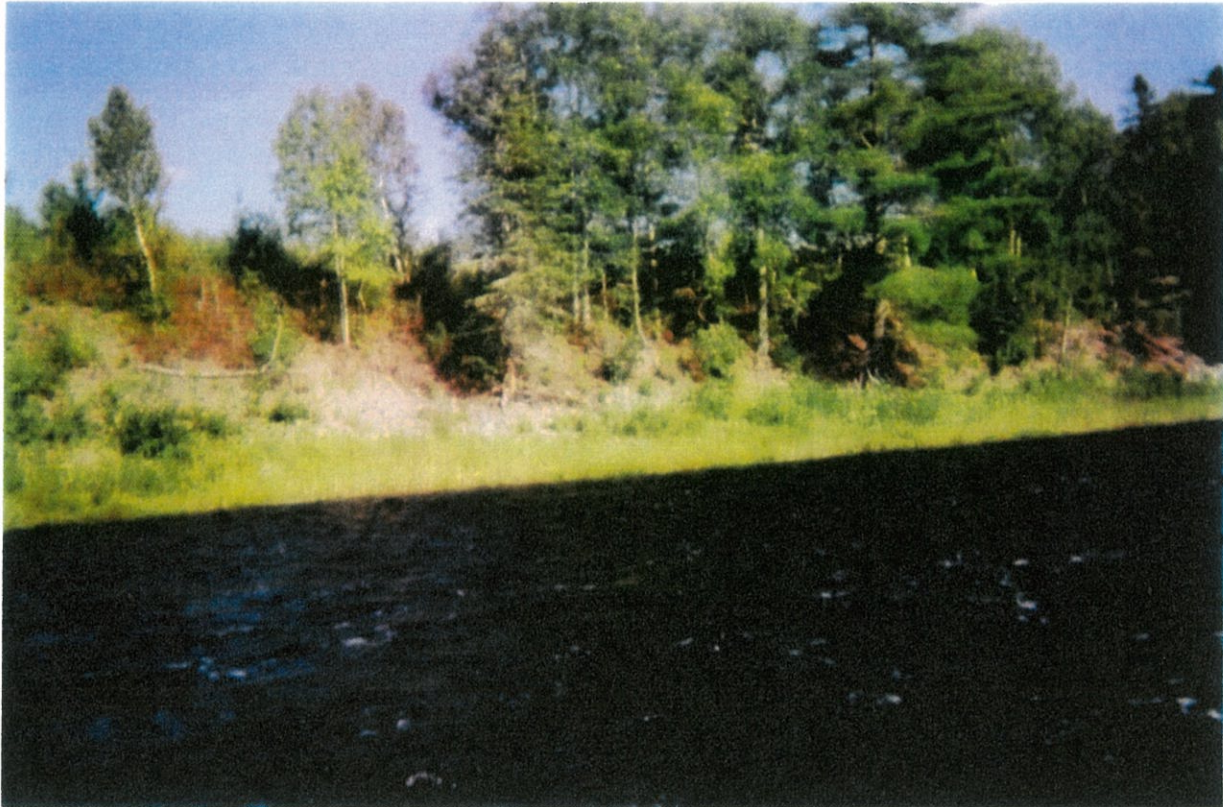
Photo # ER-8

NWA I Eroding Bank Survey, ETF Project 2004/2005			
Eroding Bank Number	ER-8		
General Location	Below Encroachment on Nashwaak West Rd.		
GPS Coordinates	Northerly	46	12.438
	Westerly	66	36.797
Erosion Severity	Minor		
Recommended Remedial Action	Trees/shrubs		
Eroding Bank Height (approx meters)	<1		
Eroding Bank Length (approx meters)	40		
Channel Location	Main		
Bank Location	Left Hand Bank

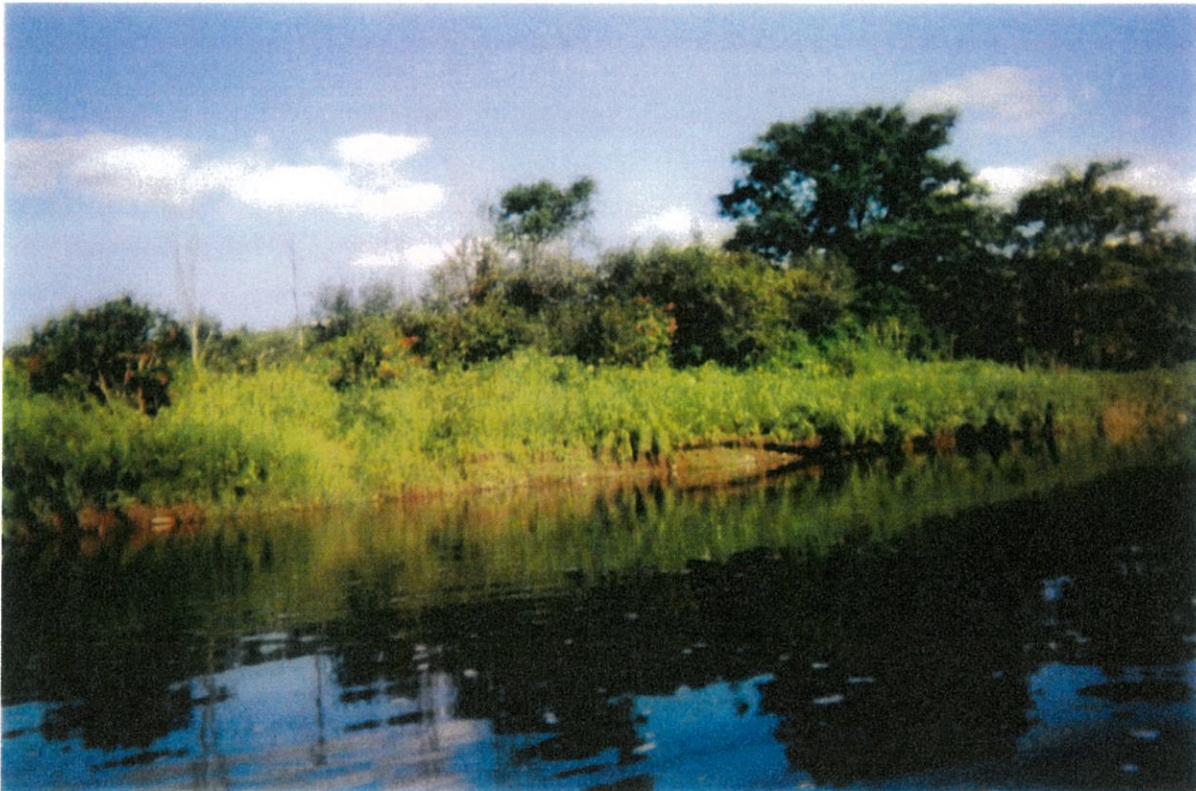
Photo # ER-10

NWA I Eroding Bank Survey, ETF Project 2004/2005			
Eroding Bank Number	ER-10		
General Location			
GPS Coordinates	Northerly	46	11.439
	Westerly	66	36.676
Erosion Severity	Moderate		
Recommended Remedial Action	Trees/shrubs		
Eroding Bank Height (approx meters)	3		
Eroding Bank Length (approx meters)	30		
Channel Location	Main		
Bank Location	Left Hand Bank

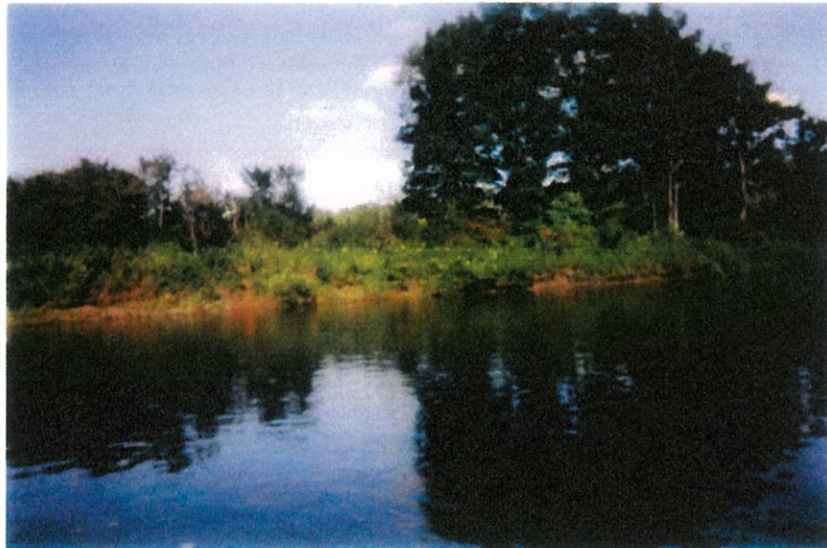
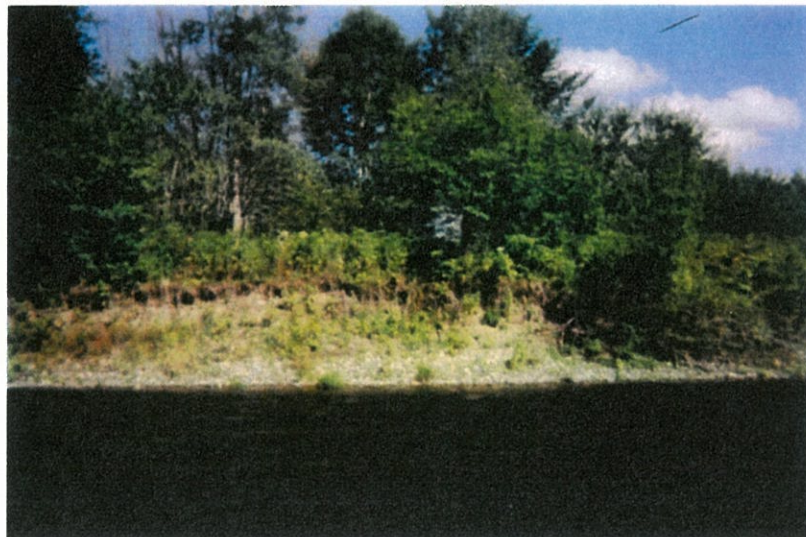
NWAJ Eroding Bank Survey, ETF Project 2004/2005			
Eroding Bank Number:	ER-11		
General Location:	Bottom of Cameron's Pool		
GPS Coordinates:	Northerly	46	10.979
	Westerly	66	36.710
Erosion Severity:	Minor		
Recommended Remedial Action:	Trees/shrubs		
Eroding Bank Height (approx meters):	1.5		
Eroding Bank Length (approx meters):	6		
Channel Location:	Main		
Bank Location:	Right Hand Bank

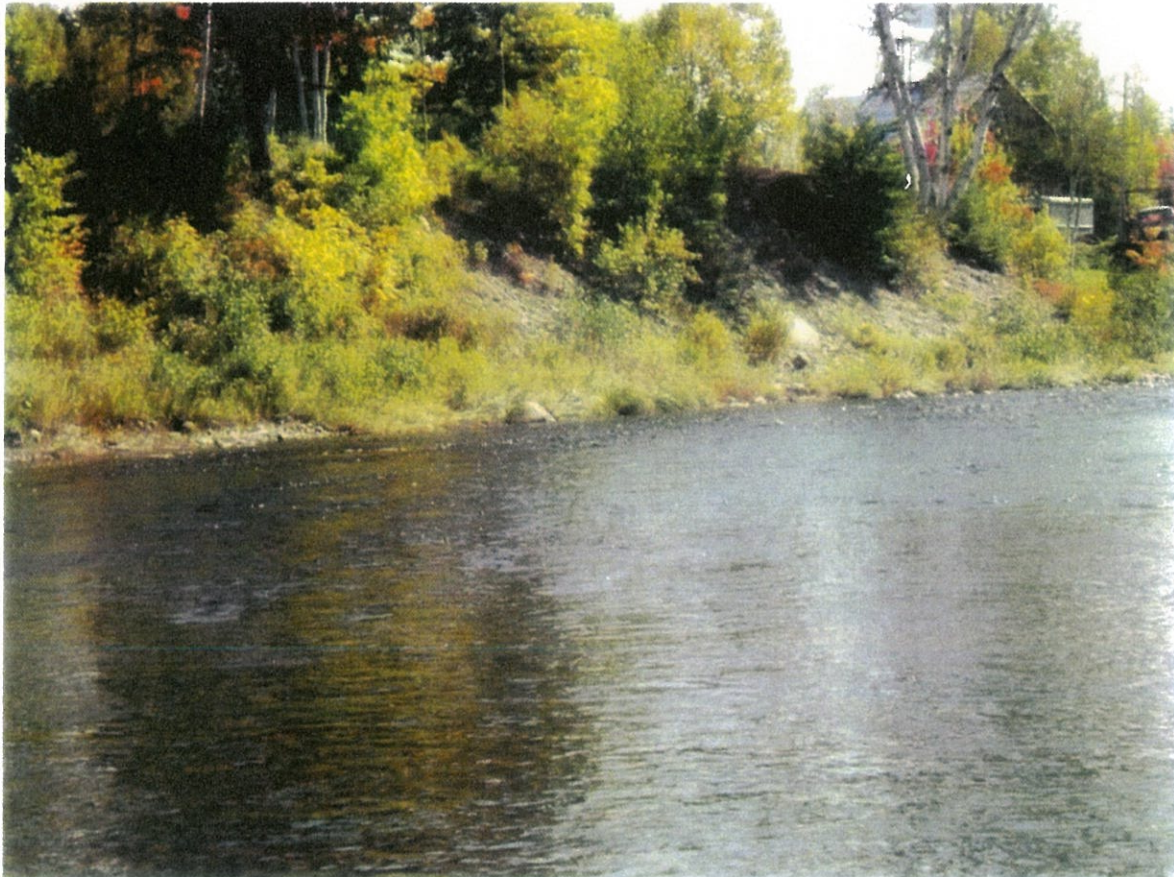
Photo #ER-15b

NWA I Eroding Bank Survey, ETF Project 2004/2005			
Eroding Bank Number:	ER-15		
General Location:	Above encroachment to Road		
GPS Coordinates:	Northerly	46	17.937
	Westerly	66	47.059
Erosion Severity:	Moderate-Major		
Recommended Remedial Action:	Trees/shrubs		
Eroding Bank Height (approx meters):	4.50		
Eroding Bank Length (approx meters):	60		
Channel Location:	Left Hand Channel		
Bank Location:	Left Hand Bank		
Special Location Instructions:	GPS Marked mid channel @ eroding bank

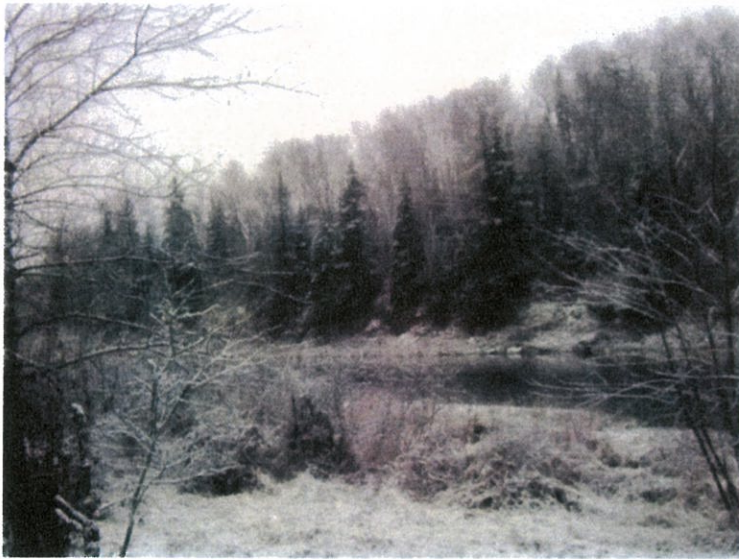
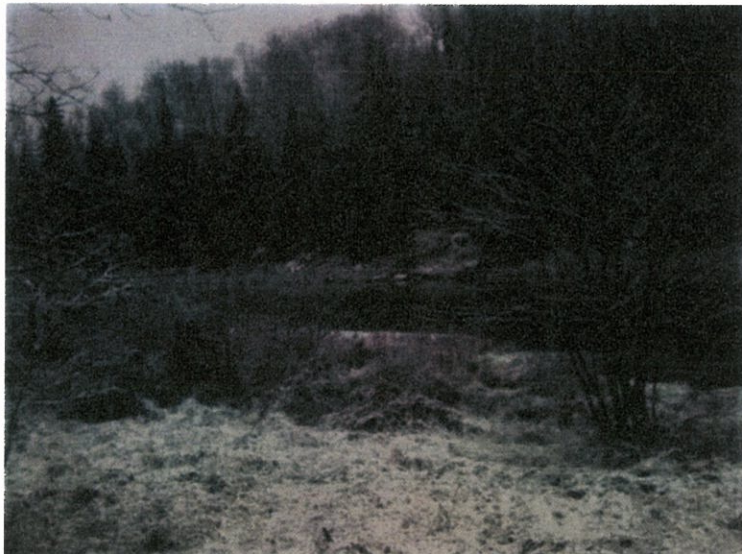
NWA I Eroding Bank Survey, ETF Project 2004/2005			
Eroding Bank Number:	ER-16		
General Location:	Church Pool		
GPS Coordinates:	Northerly	46	07.184
	Westerly	66	36.358
Erosion Severity:	Moderate - Major		
Recommended Remedial Action:	Trees/shrubs/geotextile?		
Eroding Bank Height (approx meters):	3		
Eroding Bank Length (approx meters):	80		
Channel Location:	Main		
Bank Location:	Left Hand Bank		
Special Location Instructions:	GPS Marked @ site

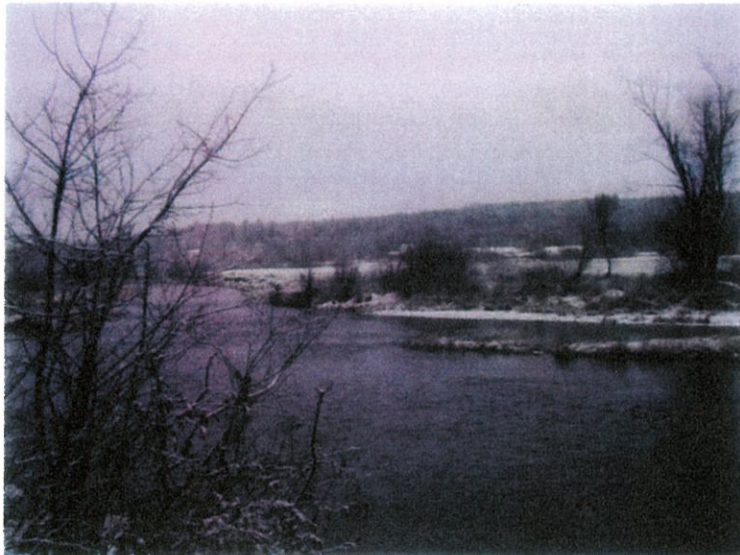
Photo #ER-17a

NWA I Eroding Bank Survey, ETF Project 2004/2005				
Eroding Bank Number:	ER-17			
General Location:	Golf Course		Start	End
GPS Coordinates:	Northerly	46	06.312	06.063
	Westerly	66	36.628	36.734
Erosion Severity:	Moderate			
Recommended Remedial Action:	Trees/shrubs			
Eroding Bank Height (approx meters):	2			
Eroding Bank Length (approx meters):	750			
Channel Location:	Main and Left Hand Channel			
Bank Location:	Left Hand Bank with some erosion on Right Hand Bank			
Special Location Instructions:	GPS Marked @ site

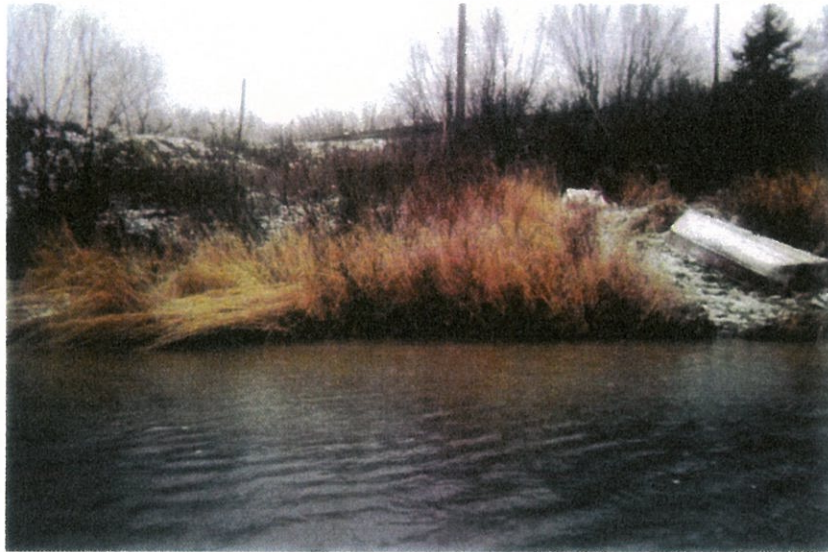
Photo # ER-18a

NWAJ Eroding Bank Survey, ETF Project 2004/2005			
Eroding Bank Number:	ER-18		
General Location:	Behind former Robert's Restaurant		
GPS Coordinates:	Northerly	46	05.907
	Westerly	66	36.672
Erosion Severity:	Moderate		
Recommended Remedial Action:	Trees/shrubs		
Eroding Bank Height (approx meters):	2.5		
Eroding Bank Length (approx meters):	15		
Channel Location:	Main		
Bank Location:	Right Hand Bank		
Special Location Instructions:	GPS Marked @ site

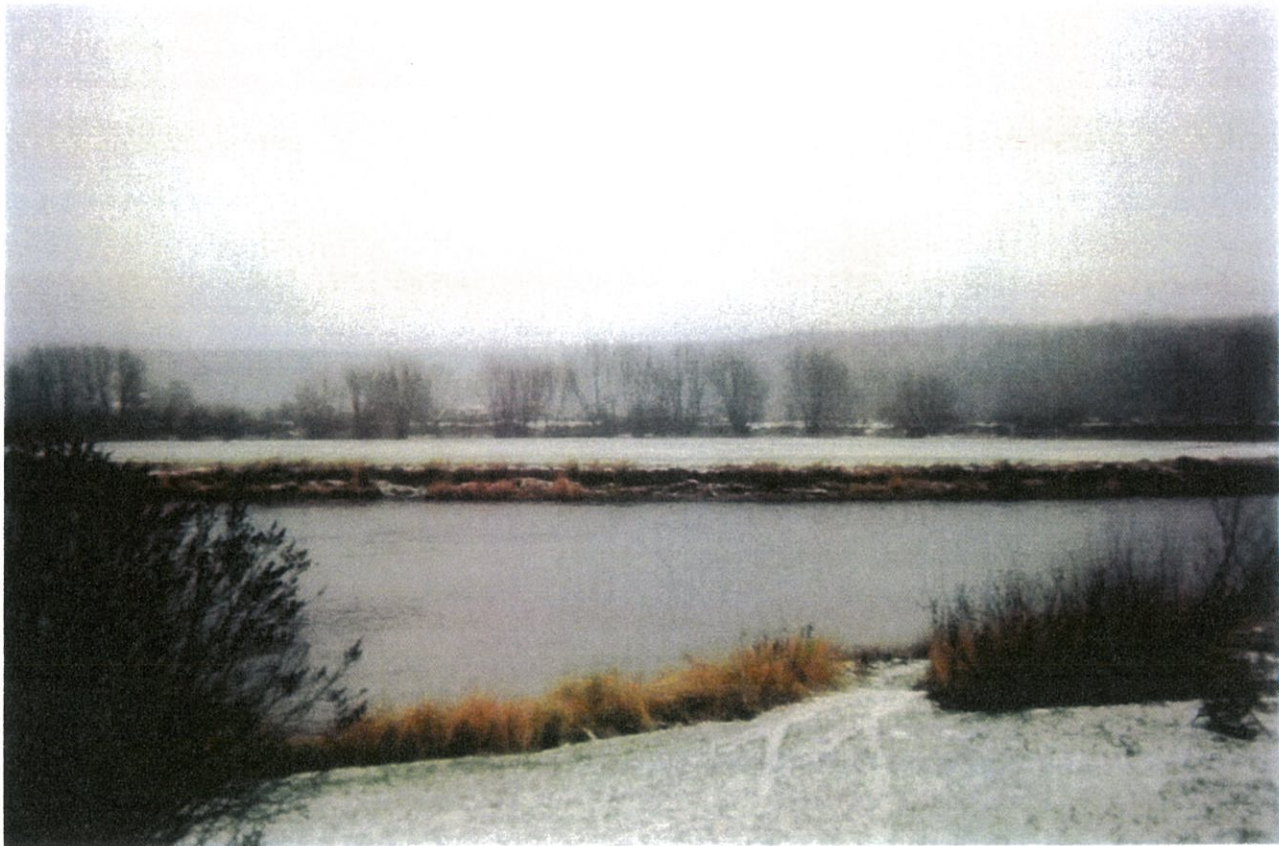
Photo # ER-19

Eroding Bank Number:	ER-19		
General Location:	Below former Robert's Restraunt		
GPS Coordinates:	Northerly	46	05.785
	Westerly	66	36.597
Erosion Severity:	Moderate		
Recommended Remedial Action:	Trees/shrubs		
Eroding Bank Height (approx meters):	2		
Eroding Bank Length (approx meters):	210		
Channel Location:	Main		
Bank Location:	Left Hand Bank		
Special Location Instructions:	GPS Marked @ site

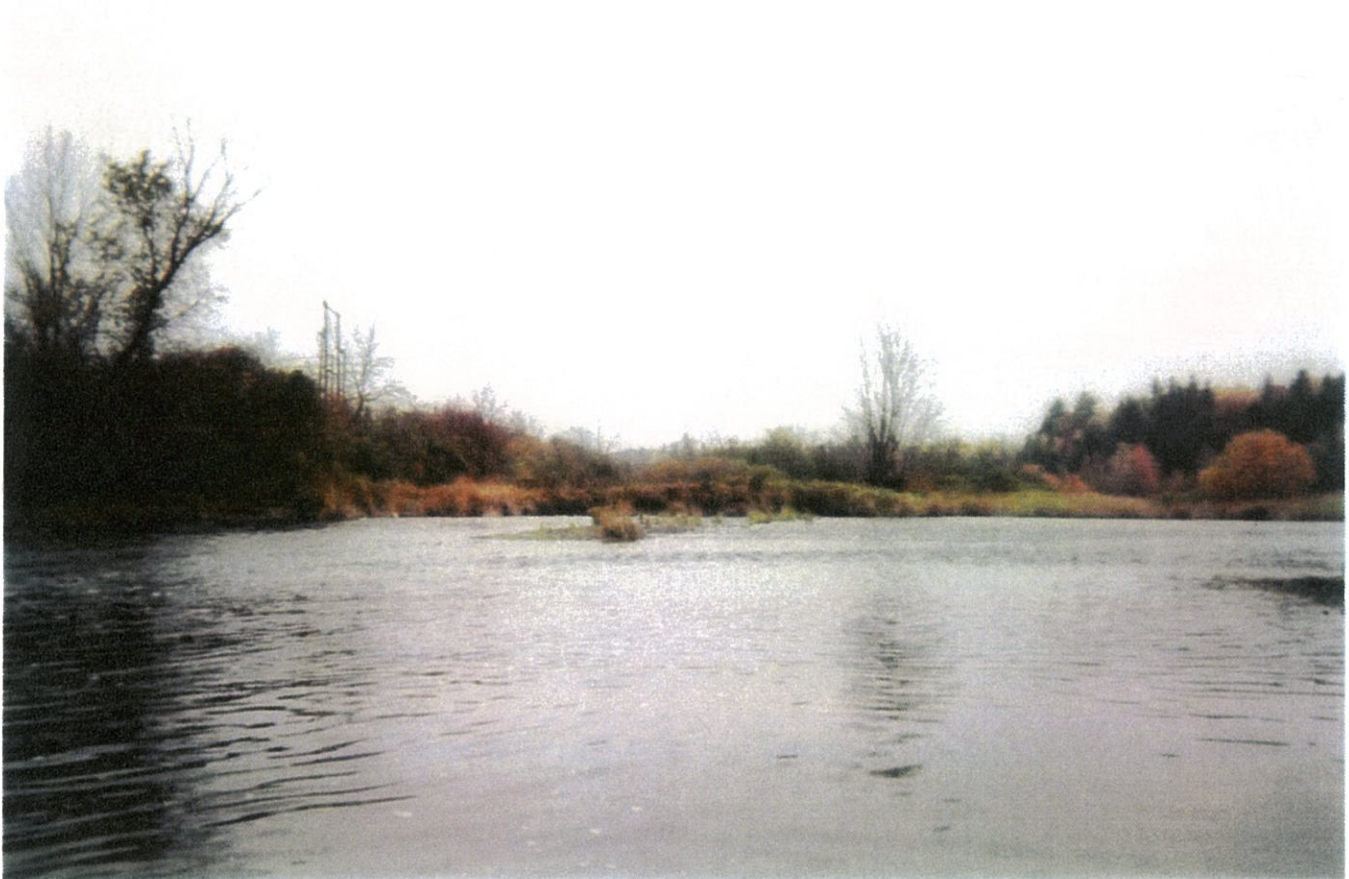
Photo # ER-20

Nwai Eroding Bank Survey, ETF Project 2004/2005			
Eroding Bank Number:	ER-20		
General Location:	Just below high voltage power lines		
GPS Coordinates:	Northerly	46	04.817
	Westerly	66	36.099
Erosion Severity:	Moderate		
Recommended Remedial Action:	Trees/shrubs		
Eroding Bank Height (approx meters):	1.4		
Eroding Bank Length (approx meters):	30		
Channel Location:	Right Hand Channel		
Bank Location:	Right Hand Bank		
Special Location Instructions:	GPS Marked @ site

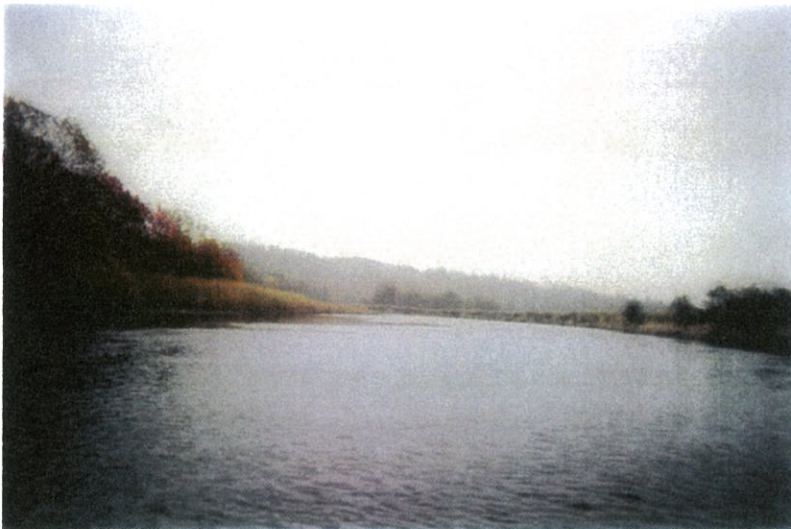
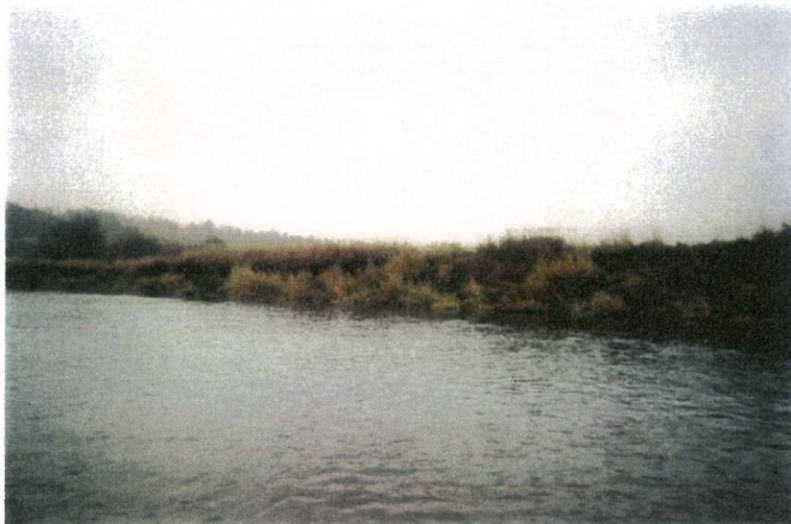
NWAJ Eroding Bank Survey, ETF Project 2004/2005			
Eroding Bank Number:	ER-23		
General Location:	Just above mouth of Manzer Bk.		
GPS Coordinates:	Northerly	46	03.797
	Westerly	66	35.861
Erosion Severity:	Moderate		
Recommended Remedial Action:	Trees/Shrubs		
Eroding Bank Height (approx meters):	1.10		
Eroding Bank Length (approx meters):	250		
Channel Location:	Main		
Bank Location:	Right Hand Bank		
Special Location Instructions:	GPS Marked @ site

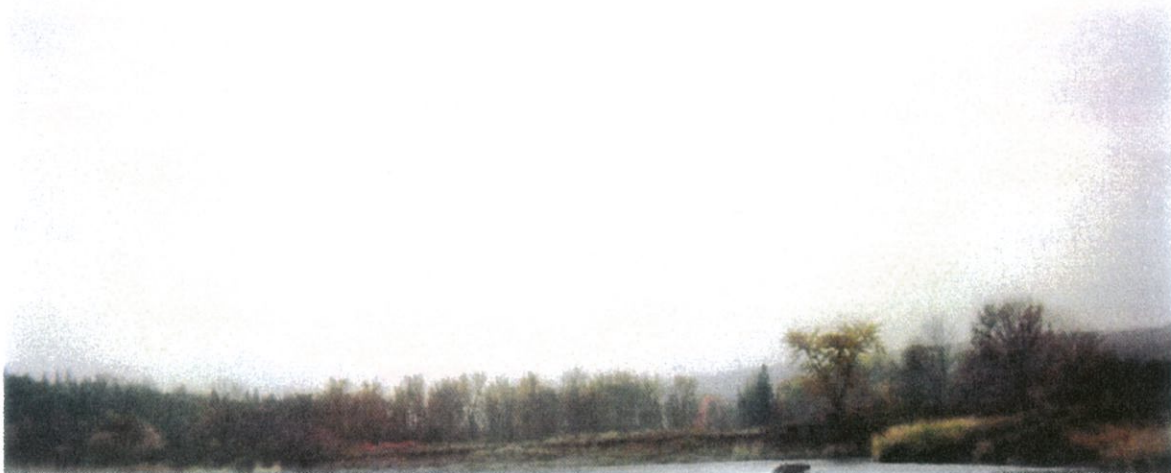
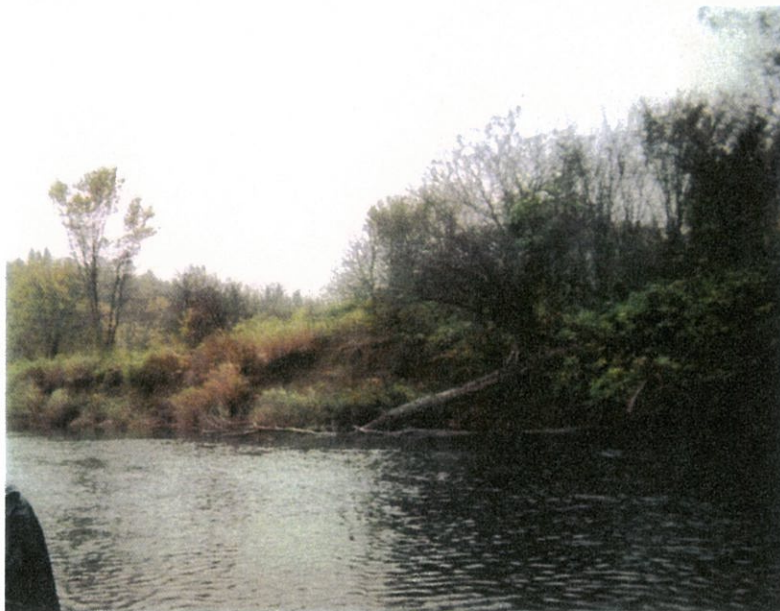
NWA I Eroding Bank Survey, ETF Project 2004/2005			
Eroding Bank Number:	ER-24		
General Location:	Cell tower visible		
GPS Coordinates:	Northerly	46	03.578
	Westerly	66	35.643
Erosion Severity:	Moderate		
Recommended Remedial Action:	Trees/Shrubs		
Eroding Bank Height (approx meters):	2.80		
Eroding Bank Length (approx meters):	90		
Channel Location:	Left Hand Channel		
Bank Location:	Right Hand Bank		
Special Location Instructions:	GPS Marked @ site

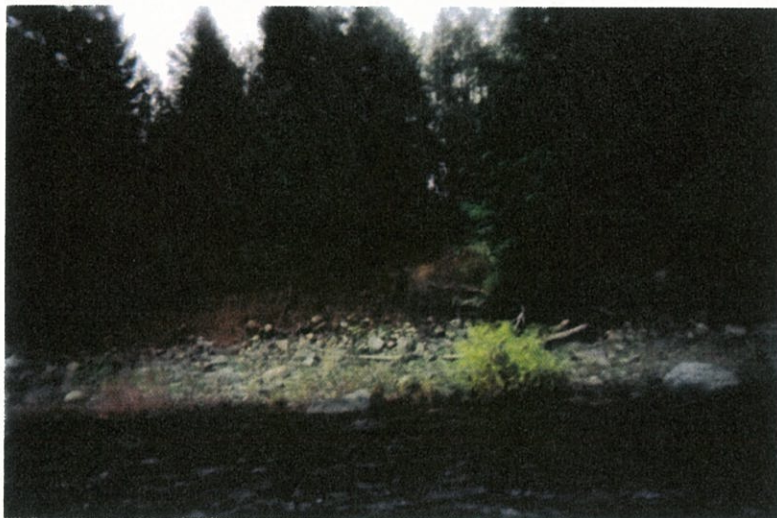
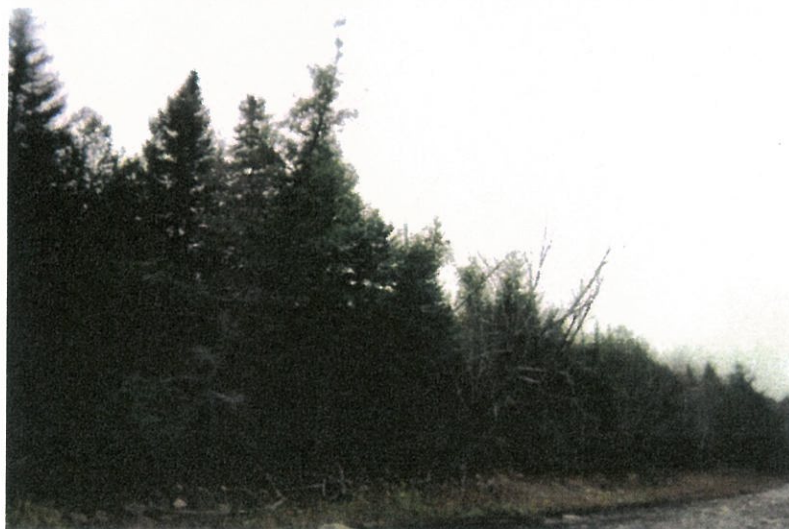
NWA I Eroding Bank Survey, ETF Project 2004/2005			
Eroding Bank Number:	ER-31		
General Location:	Across from NB Hwy 107		
GPS Coordinates:	Northerly	46	16.549
	Westerly	66	43.157
Erosion Severity:	Moderate - Major		
Recommended Remedial Action:	Trees/shrubs, perhaps engineered		
Eroding Bank Height (approx meters):	0.9		
Eroding Bank Length (approx meters):	45		
Channel Location:	Main		
Bank Location:	Right Hand Bank		
Special Location Instructions:	GPS Marked at site

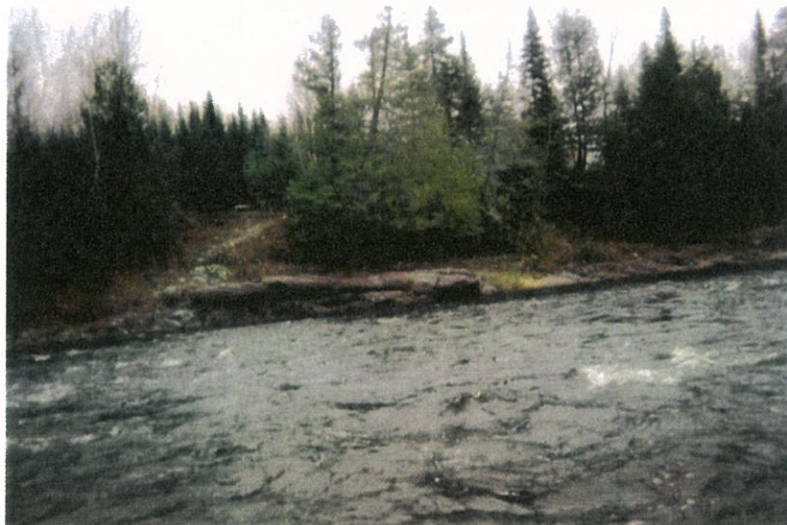
Photo # ER-32b

Nwai Eroding Bank Survey, ETF Project 2004/2005			
Eroding Bank Number:	ER-32		
General Location:	Near camps		
GPS Coordinates:	Northerly	46	16.346
	Westerly	66	42.519
Erosion Severity:	Moderate		
Recommended Remedial Action:	Trees/shrubs		
Eroding Bank Height (approx meters):	3.9		
Eroding Bank Length (approx meters):	3		
Channel Location:	Main		
Bank Location:	Left Hand Bank		
Special Location Instructions:	GPS Marked at site

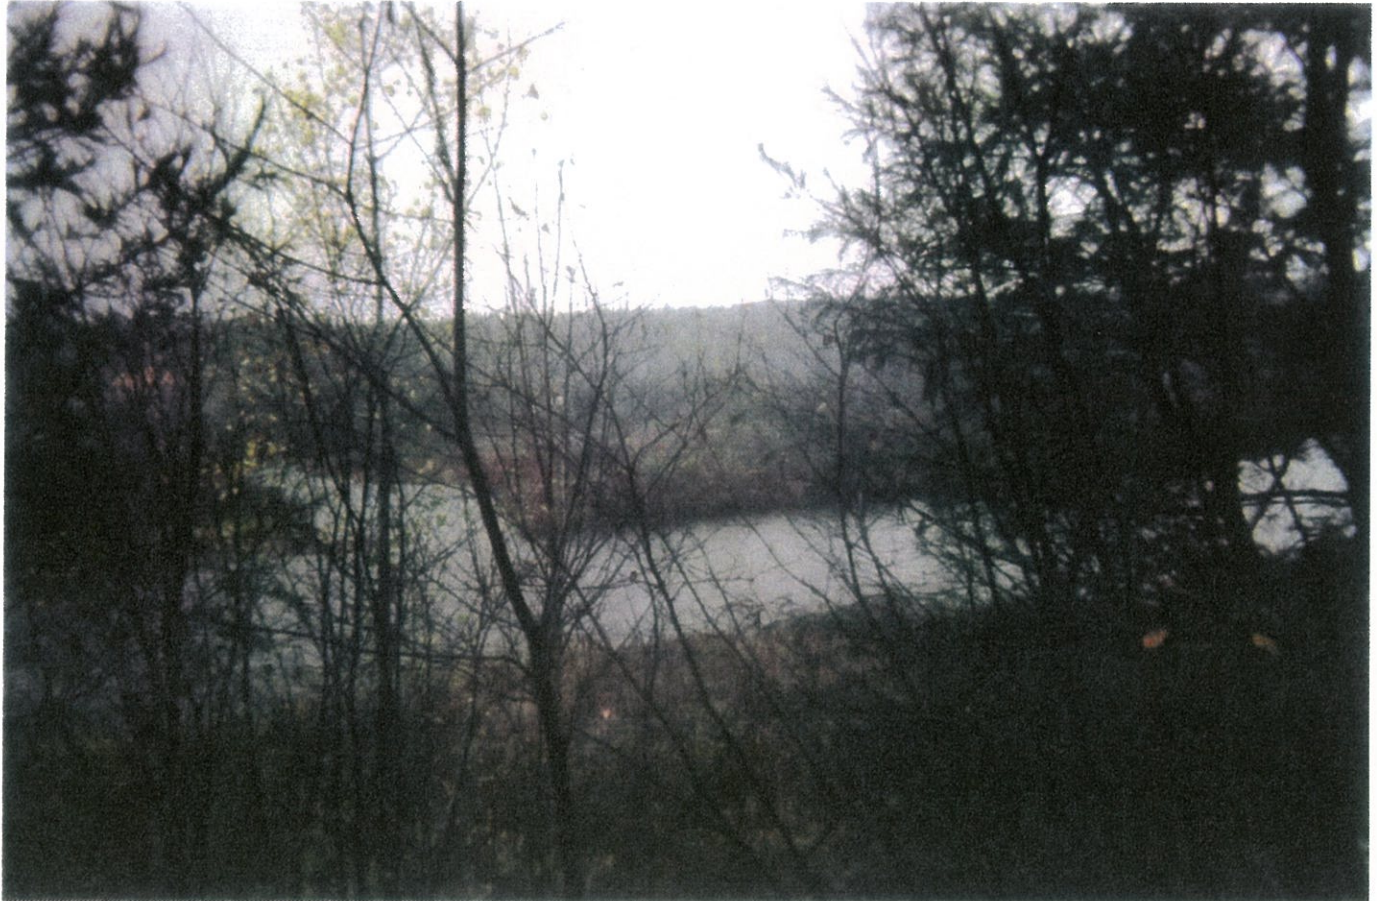
Photo # ER-37

NWA I Eroding Bank Survey, ETF Project 2004/2005		
Eroding Bank Number:	ER-37	
General Location:	Approx 500 m upstream from Nashwaak Bridge	
GPS Coordinates:	Northerly	46 14.783
	Westerly	66 37.365
Erosion Severity:	Minor	
Recommended Remedial Action:	Trees, maybe engineered	
Eroding Bank Height (approx meters):	0.5 – 1	
Eroding Bank Length (approx meters):	45	
Channel Location:	Main	
Bank Location:	Both intermittently	
Special Location Instructions:	GPS Marked at site

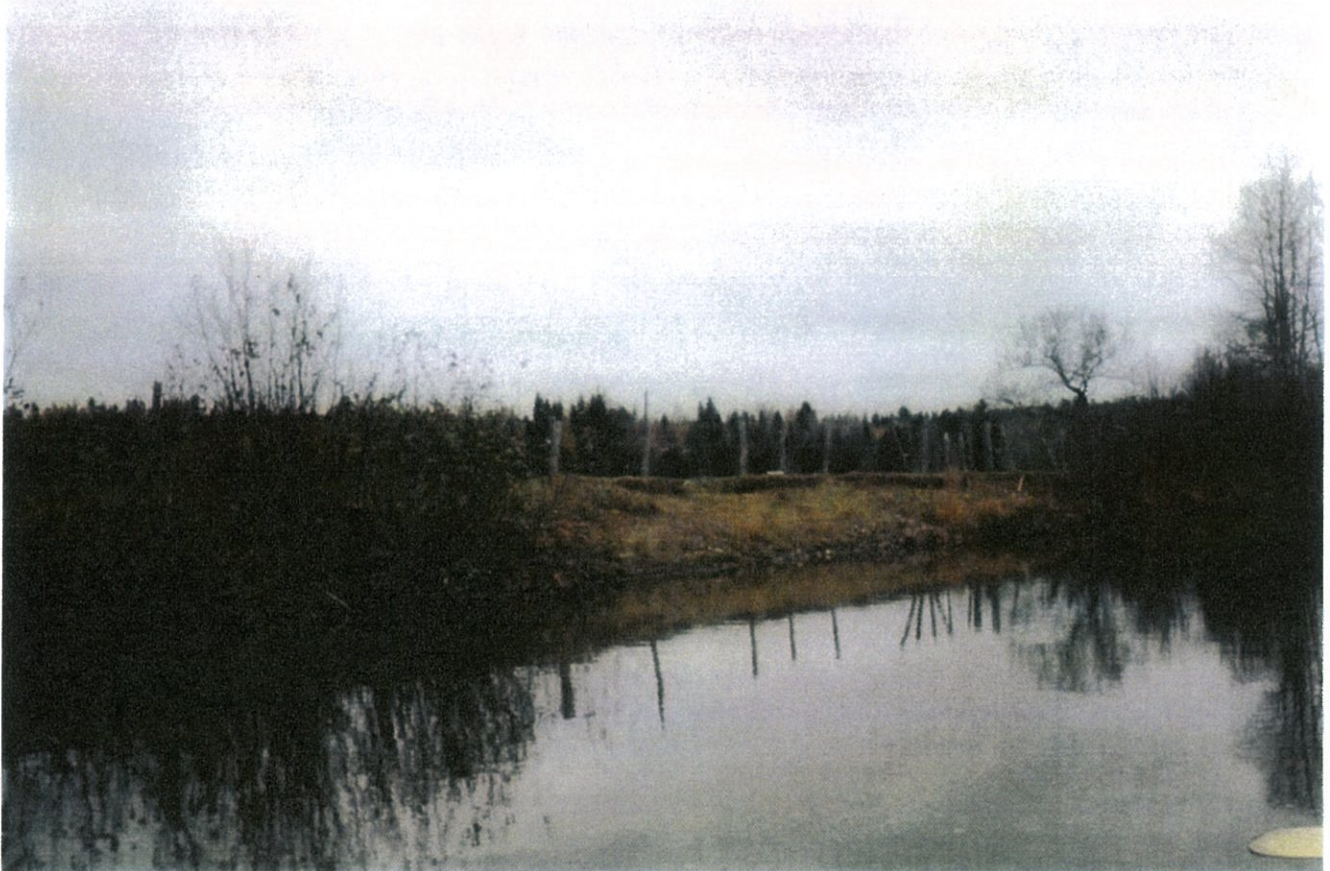
Photo # ER-40

NWA I Eroding Bank Survey, ETF Project 2004/2005			
Eroding Bank Number:	40		
General Location:	Farm Land		
GPS Coordinates:	Northerly	46	10.889
	Westerly	66	37.627
Erosion Severity:	Moderate		
Recommended Remedial Action:	Shrubs		
Eroding Bank Height (approx meters):	1.5		
Eroding Bank Length (approx meters):	15.2		
Channel Location:	Main Tay River		
Bank Location:	Left Hand Bank		
Special Location Instructions:

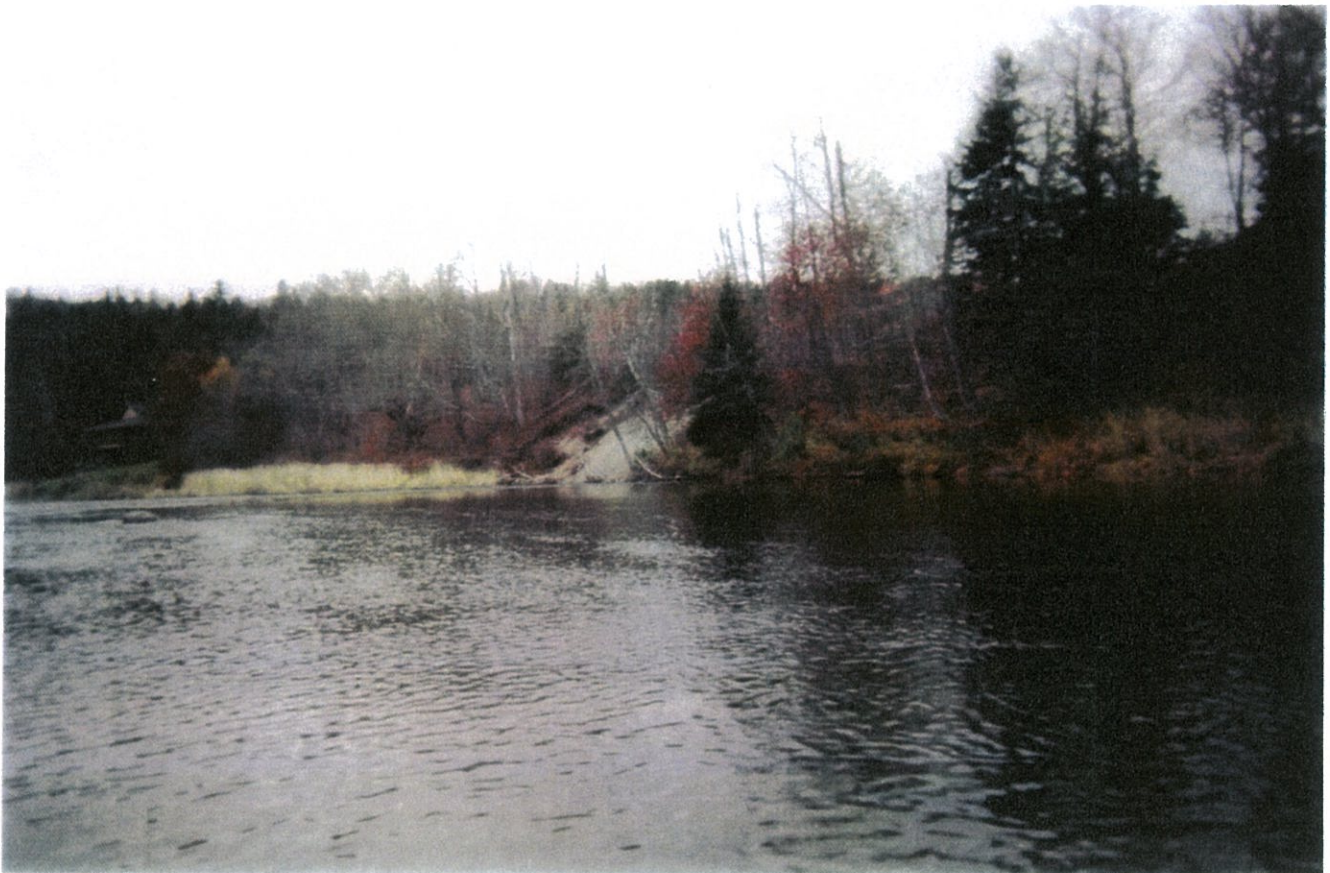
Photo # Er-44

NWAJ Eroding Bank Survey, ETF Project 2004/2005			
Eroding Bank Number:	44		
General Location:	Top of 1st island below Tay		
GPS Coordinates:	Northerly	46	10.309
	Westerly	66	36.881
Erosion Severity:	Major to Moderate		
Recommended Remedial Action:	Engineered		
Eroding Bank Height (approx meters):	4.5		
Eroding Bank Length (approx meters):	30		
Channel Location:	Right Hand Channel		
Bank Location:	Right Hand Bank		
Special Location Instructions:

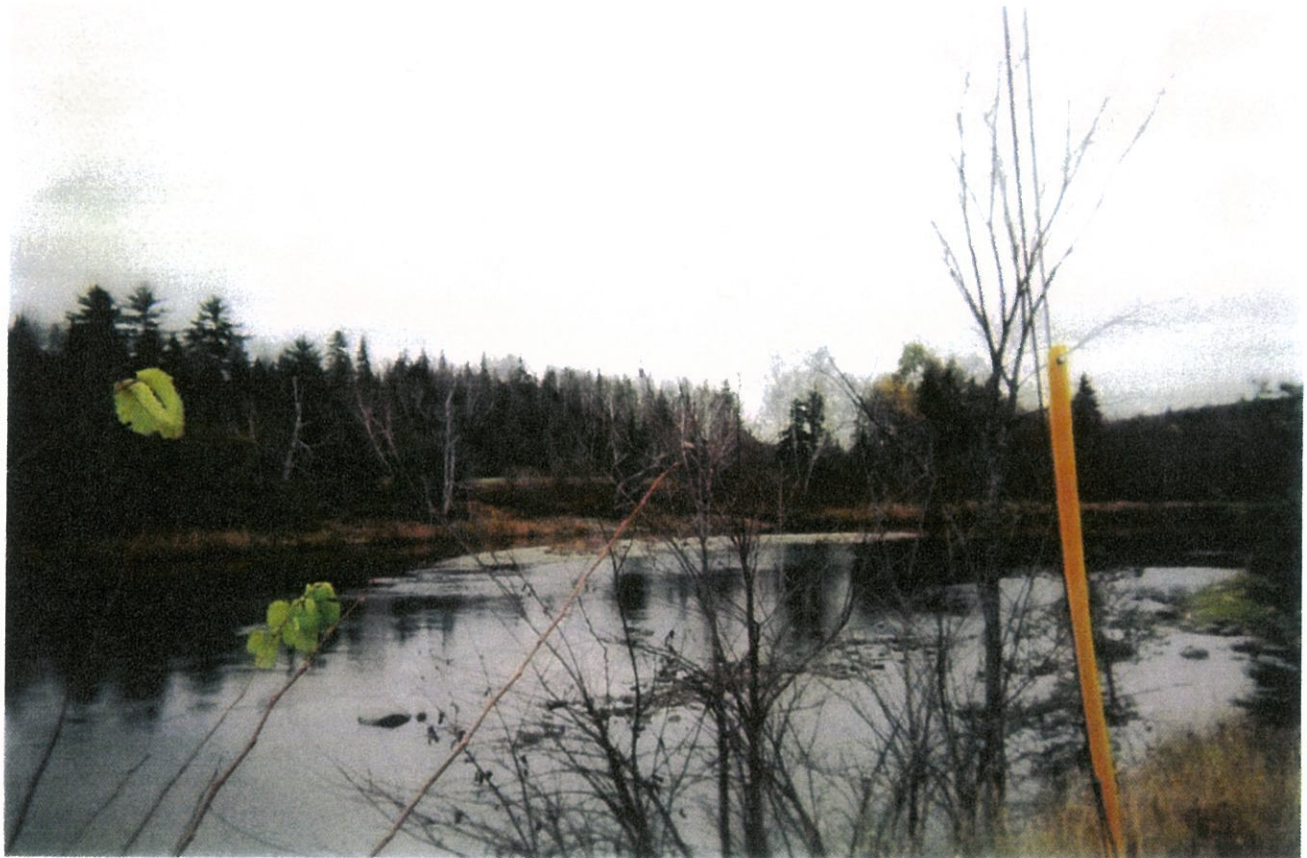
Photo # ER-49

NWA I Eroding Bank Survey, ETF Project 2004/2005			
Eroding Bank Number:	49		
General Location:	Bridge @ Taymouth		
GPS Coordinates:	Northerly	46	10.952
	Westerly	66	37.046
Erosion Severity:	Moderate-minor		
Recommended Remedial Action:	Trees/shrubs		
Eroding Bank Height (approx meters):	2.3		
Eroding Bank Length (approx meters):	9		
Channel Location:	Main		
Bank Location:	Left Hand Bank		
Special Location Instructions:

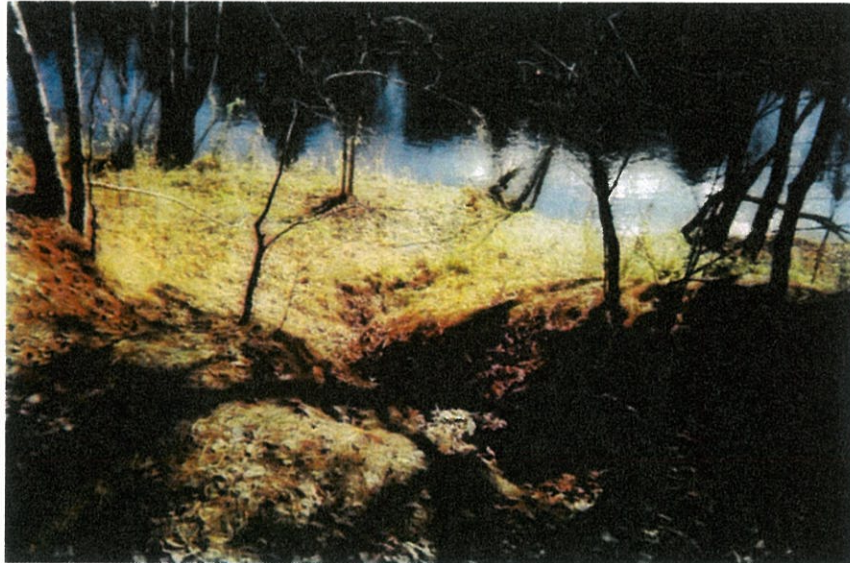
Photo # ER-50a

NWAJ Eroding Bank Survey, ETF Project 2004/2005			
Eroding Bank Number:	50		
General Location:	Near closed gas station approx 1 km above Marysville Bridge		
GPS Coordinates:	Northerly	45	59.502
	Westerly	66	34.654
Erosion Severity:	Moderate		
Recommended Remedial Action:	Rocks for channel running down eroding bank		
Eroding Bank Height (approx meters):	0.8		
Eroding Bank Length (approx meters):	2		
Channel Location:	Main		
Bank Location:	Right Hand Bank		
Special Location Instructions:
