Soil Erosion Survey of the Nashwaak River and the Tay, Penniac and Cross Creek Streams

The New Brunswick Department of the Environment and Local Government
P.O. Box 6000
Fredericton, NB
E3B 5H1
March, 2005

The Nashwaak Watershed Association Inc.
P.O. Box 20037
Fredericton, NB
E6B 6Y8

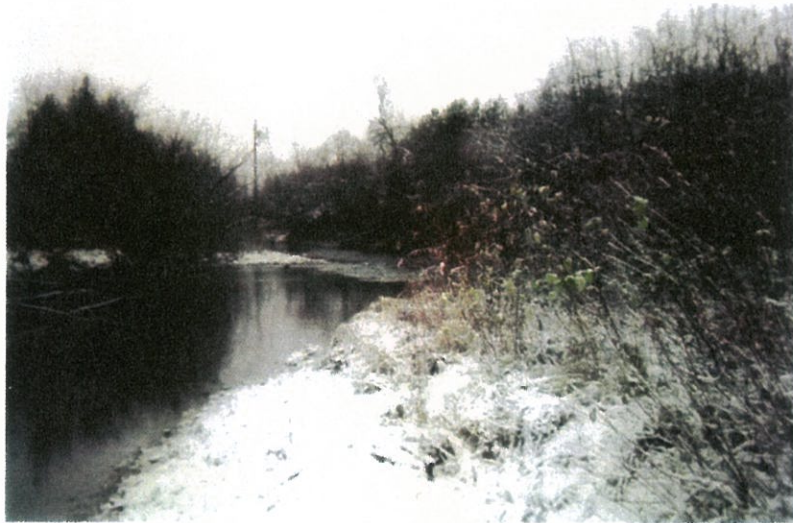
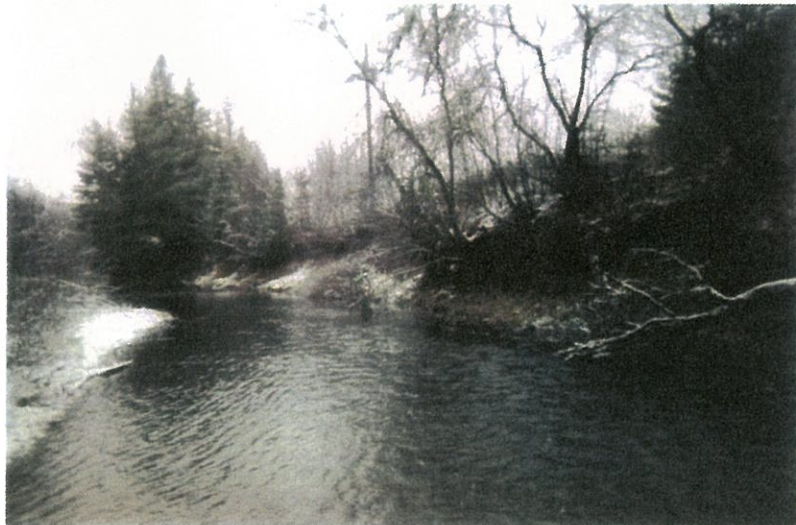
NWAJ Eroding Bank Survey, ETF Project 2004/2005			
Eroding Bank Number:	61		
General Location:			
GPS Coordinates:	Northerly	46	02.675
	Westerly	66	32.629
Erosion Severity:	Minor-Moderate		
Recommended Remedial Action:	Trees/riprap		
Eroding Bank Height (approx meters):	LHB = 0.6, RHB = 2		
Eroding Bank Length (approx meters):	LHB = 50, RHB = 150		
Channel Location:	Main Penniac		
Bank Location:	Left Hand Bank and Right Hand Bank		
Special Location Instructions:

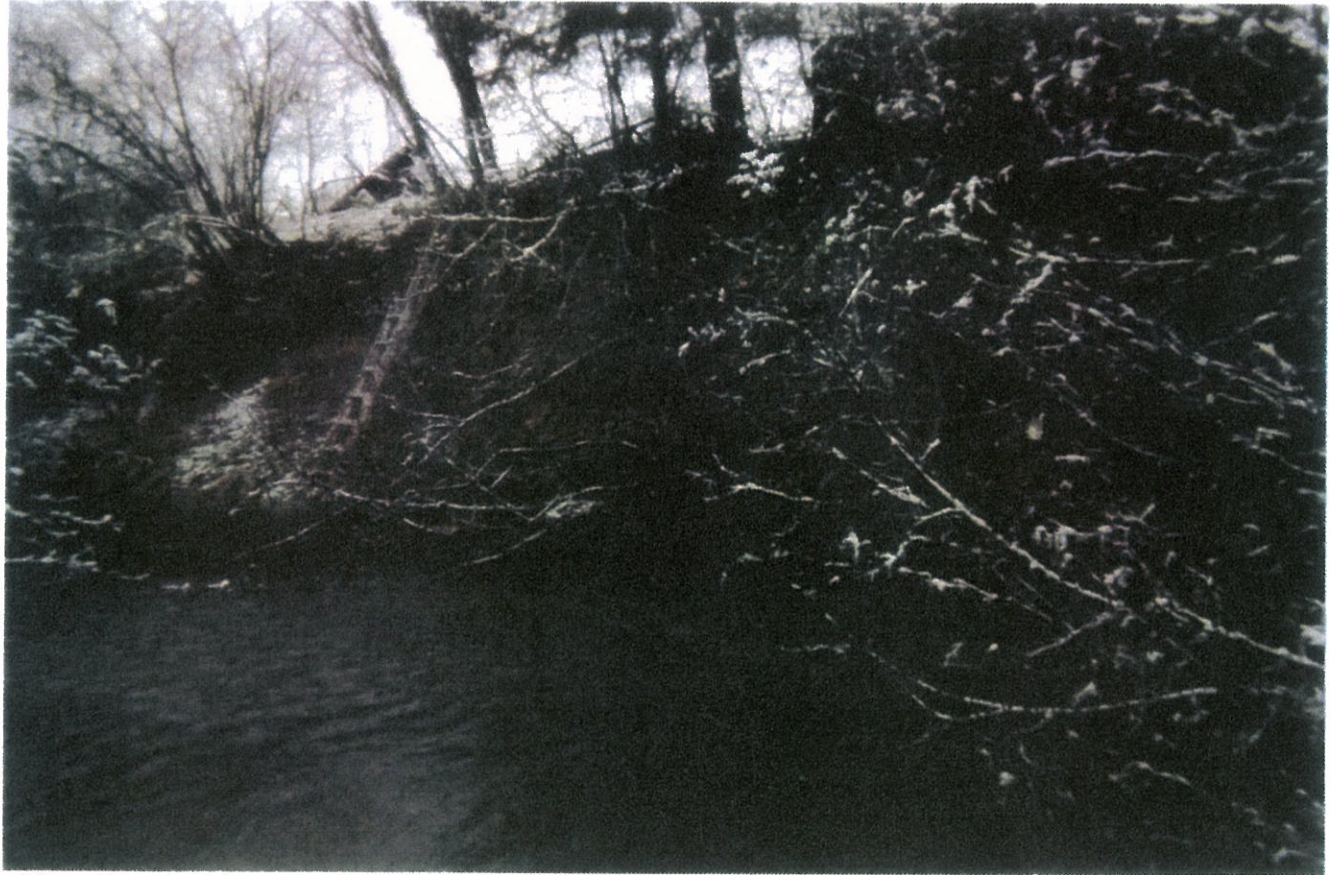
Photo # ER-62

NWA I Eroding Bank Survey, ETF Project 2004/2005			
Eroding Bank Number:	62		
General Location:	Below ER-61 on RHC of island		
GPS Coordinates:	Northerly	46	02.555
	Westerly	66	32.807
Erosion Severity:	Major		
Recommended Remedial Action:	Riprap		
Eroding Bank Height (approx meters):	2.5		
Eroding Bank Length (approx meters):	10		
Channel Location:	Right Hand Channel		
Bank Location:	Right Hand Bank		
Special Location Instructions:
