2020 NASHWAAK WATERSHED AQUATIC CONNECTIVITY REPORT

Written by: Jillian Hudgins Nashwaak Watershed Association Inc.

2020 Aquatic Connectivity Report

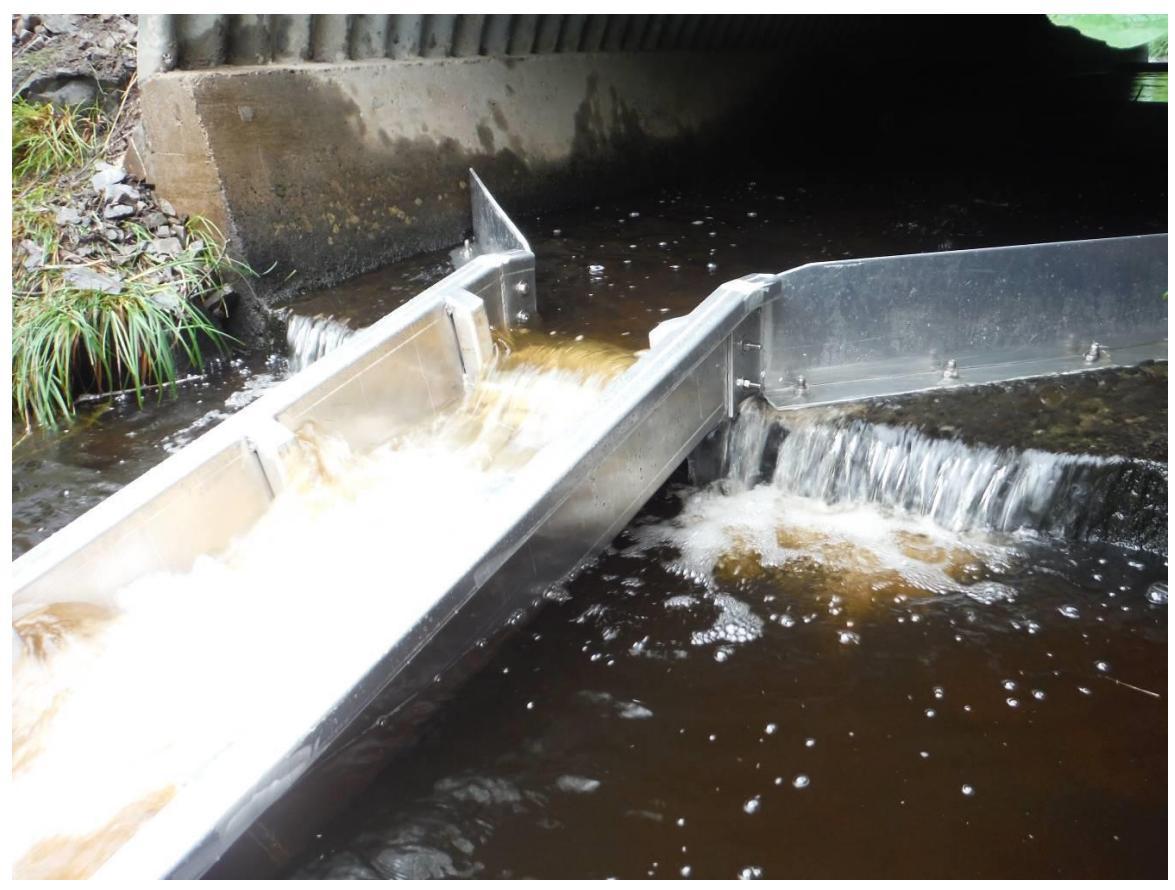
We have been regularly checking on the Manzer Brook fish ladder, installed in 2018. It survived the last two winters well and has not been catching debris. Electrofishing in August 2018 prior to the install of the remediation found seven species downstream and five species upstream (a total of 54 fish downstream and 55 fish upstream). Electrofishing in September 2020 found six species downstream and five species upstream (a total of 154 fish downstream and 104 fish upstream). Unfortunately, no new species were found upstream that were not present there before; however, higher numbers of fish were found upstream after the remediation.

FIGURE 2. THE MANZER BROOK FISH LADDER, INSTALLED IN AUGUST 2018

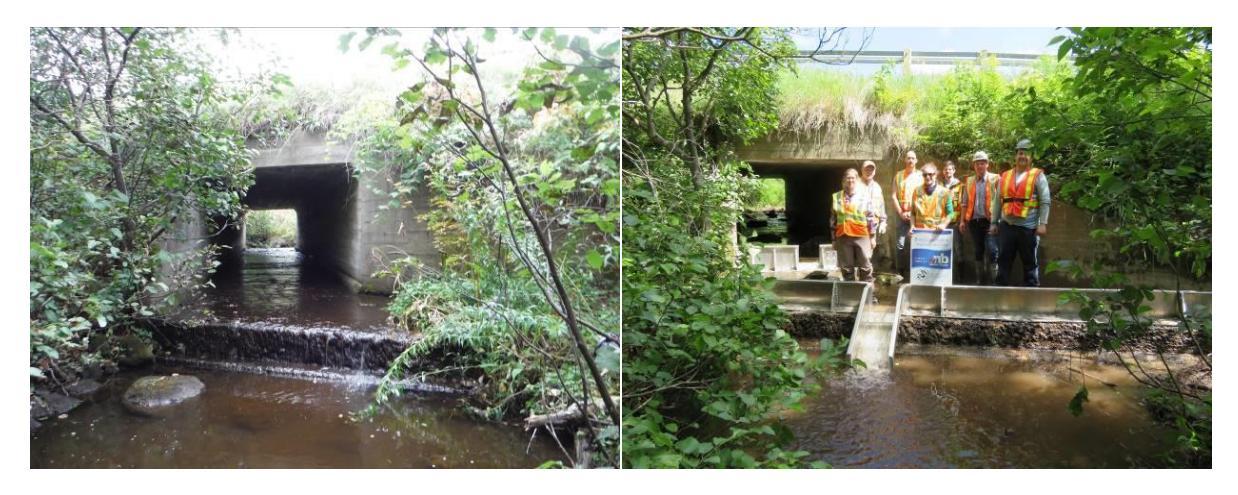
At East Ryan Brook, a cast in place 2,750 x 1,800 mm concrete box installed in the 1950s on Rte 107 was too steep (2.3% over 20 m) and had a 30 cm step at the outlet, preventing fish passage through the pipe. Water in the pipe was very shallow due to its wide, flat bottom. Electrofishing in 2019 showed that there were many brook trout using this cold-water stream along with a single American eel.

FIGURE 3. BEFORE (LEFT) AND AFTER (RIGHT) OF THE EAST RYAN BROOK FISH PASSAGE PROJECT.

The remediation took place in two phases: First, a baffle was placed at the end of the enclosed pipe and another just before the drop (Fig 3). Baffle height was 350 mm and notch width and depth were 200 mm and 150 mm, respectively for both. These allowed the water in the pipe to back-flood and velocity to decrease. A short chute was installed over the drop at the end of the structure. The chute contained roughness bars to prevent sheet flow. The second baffle was fitted with a small slide to allow fish to swim up and over. The second phase, installed a few weeks later, involved three shorter baffles that extended 4/5ths of the way across the pipe (Fig 4). We alternated what side of the baffle was opened to create a sinuous channel through the pipe. These helped back-flood the remainder of the pipe. Large rocks were placed throughout the pipe to create microhabitat. Water will eddy behind the rocks and they will provide protection for small fish.

This project opened 1.8 km² of habitat and 800 m of stream length above it. Electrofishing results preand post-remediation showed similar numbers of the same species (mainly brook trout and a few American eel). We hope that electrofishing in 2021 during higher water conditions will yield higher numbers upstream and perhaps the presence of other species. A temperature logger installed over the summer of 2020 gave an average temperature between 21 June and 21 September of only 13.33°C and a peak temperature of 18.7°C, indicating that this brook is an excellent thermal refuge for salmonids in the summer.

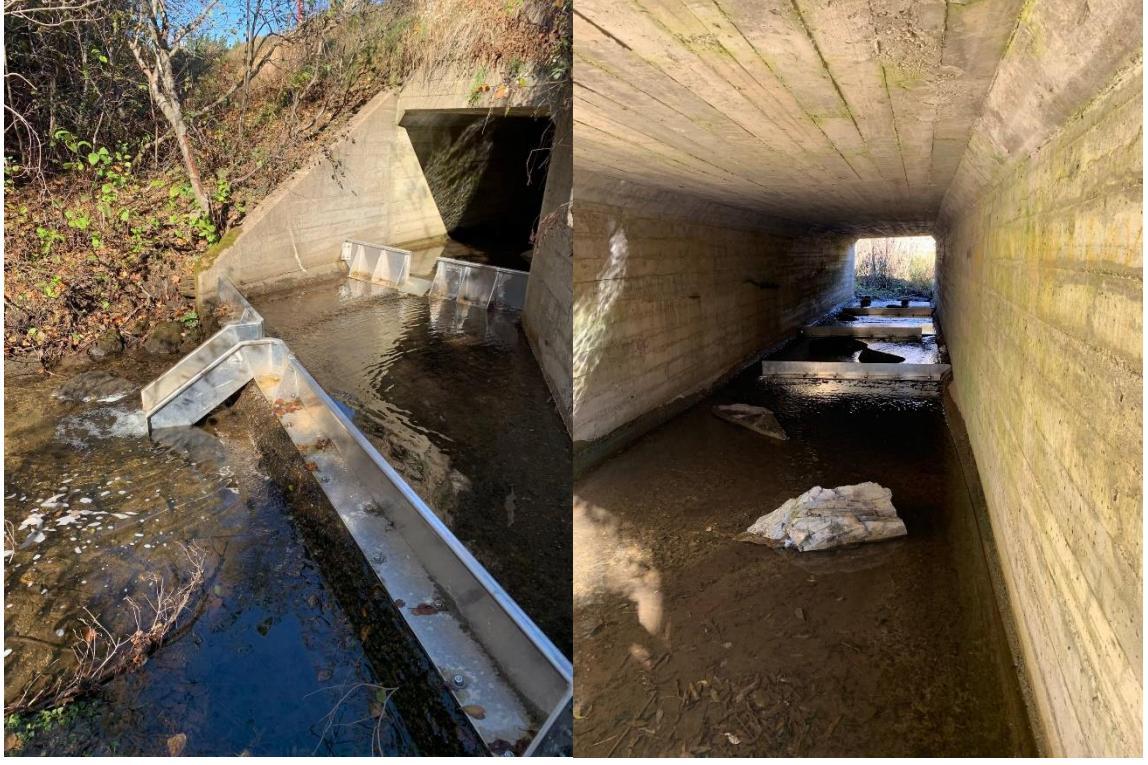
FIGURE 4. DETAILS OF THE EAST RYAN BROOK FISH PASSAGE PROJECT SHOWING THE CHUTE AND FIRST TWO BAFFLES (LEFT) AND THE UPPER THREE PARTIAL BAFFLES (RIGHT) AS WELL AS THE LARGE ROCKS PLACED TO PROVIDE MICROHABITAT IN THE PIPE.

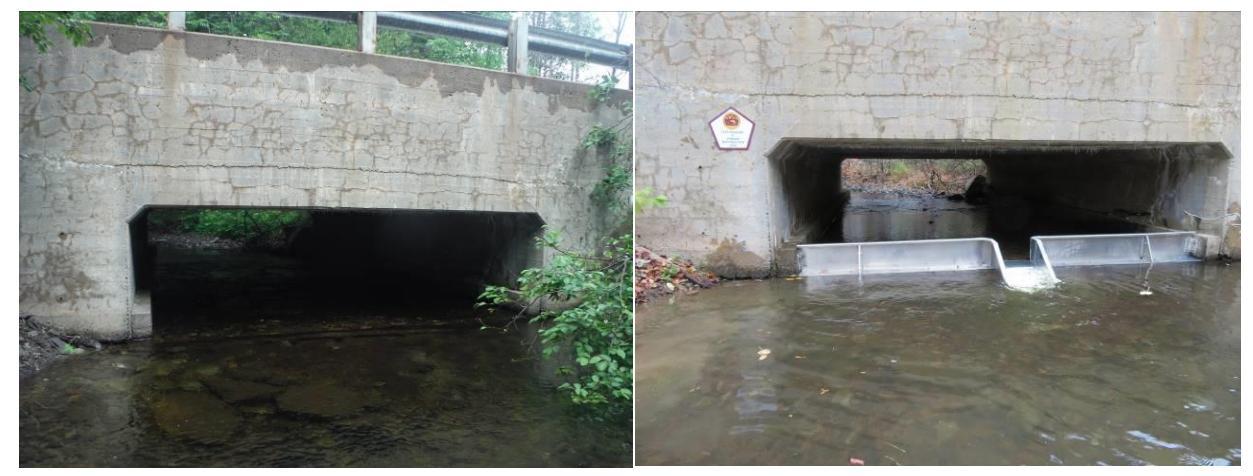
The McGivney Brook pipe is a cast in place concrete box (4,580 x 1,260 mm) on route 625. The remediation work at this site was completed in October 2020. This culvert was slightly too steep (0.9% over 9.8 m) to allow for fish passage. Its wide, flat bottom meant that there were only a few millimetres of water depth during low flow. Pre-remediation electrofishing found three species downstream and four species upstream (American eel was found upstream but not downstream). Similar numbers of brook trout were found up and downstream but higher numbers of black nose dace and slimy sculpin were found downstream compared to upstream. A total of 43 fish were found downstream versus 25 upstream. Post-remediation electrofishing will be completed in 2021. A temperature logger installed over the summer of 2020 gave an average temperature between 21 June and 21 September of only 15.04°C and a peak temperature of 20.6°C, indicating that this brook is an excellent thermal refuge for salmonids in the summer.

FIGURE 5. BEFORE AND AFTER OF THE MCGIVNEY BROOK FISH PASSAGE PROJECT

Remediation work involved the installation of one aluminum baffle and chute at the outlet of the pipe. The baffle was 300 mm high with a notch width and depth of 400 mm and 300 mm, respectively. The chute was 400 mm wide and 615 mm long. The baffle allows water to back-flood in the culvert, becoming deeper and slower (and easier for fish to swim in). The chute allows fish to swim into the culvert during low flow and it was fitted with roughness bars to prevent sheet flow. This project opened 10.2 km² of habitat and 8,913 m of stream length above it.

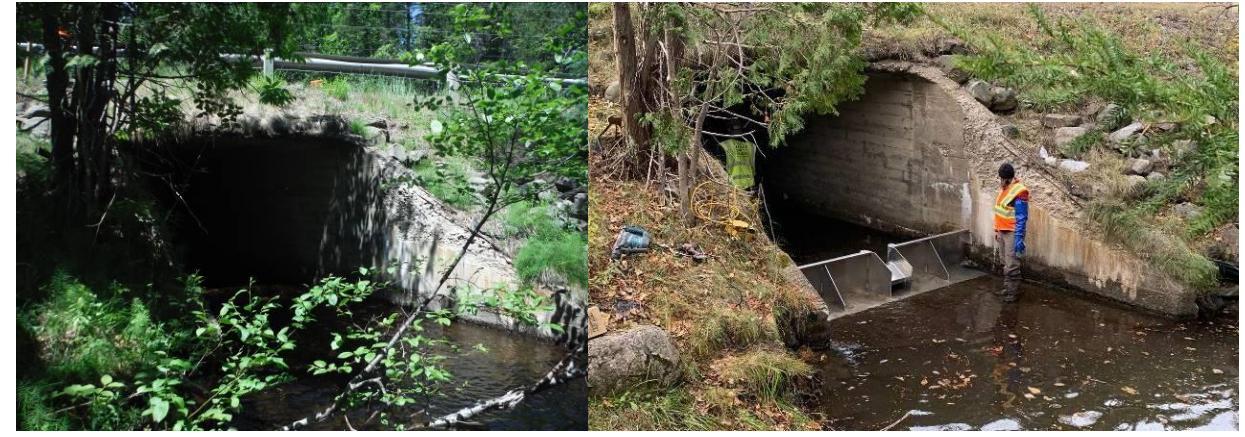
The Limekiln Brook pipe is a cast in place concrete box (3,000 x 2,400 mm) on route 620. The remediation work at this site was completed in October 2020. This culvert was too steep (2.11% over 28 m) to allow for fish passage. Its wide, flat bottom meant that there were only a few millimetres of water depth during low flow. Pre-remediation electrofishing found 4 species downstream and 2 species upstream. American eel and black nose dace were not found above the pipe. A total of 14 fish were found downstream versus 6 fish upstream. Post-remediation electrofishing will be completed in 2021. A temperature logger installed over the summer of 2020 gave an average temperature between 21 June and 21 September of 18.41°C and a peak temperature of 24.73°C, indicating that this brook would be an excellent thermal refuge for salmonids in early/late summer. However, in peak summer, it may be too warm (temperature exceeded 23°C on 20 days this summer).

FIGURE 6. BEFORE (LEFT) AND AFTER (RIGHT, BELOW) OF THE LIMEKILN BROOK FISH PASSAGE PROJECT.

The remediation involved the installation of 4 fish weirs spaced 7 m apart throughout the pipe. The baffles were 500 mm high with a notch width and depth of 300 mm and 200 mm, respectively. This project opened 7.25 km² of habitat and 10,732 m of stream length above it.

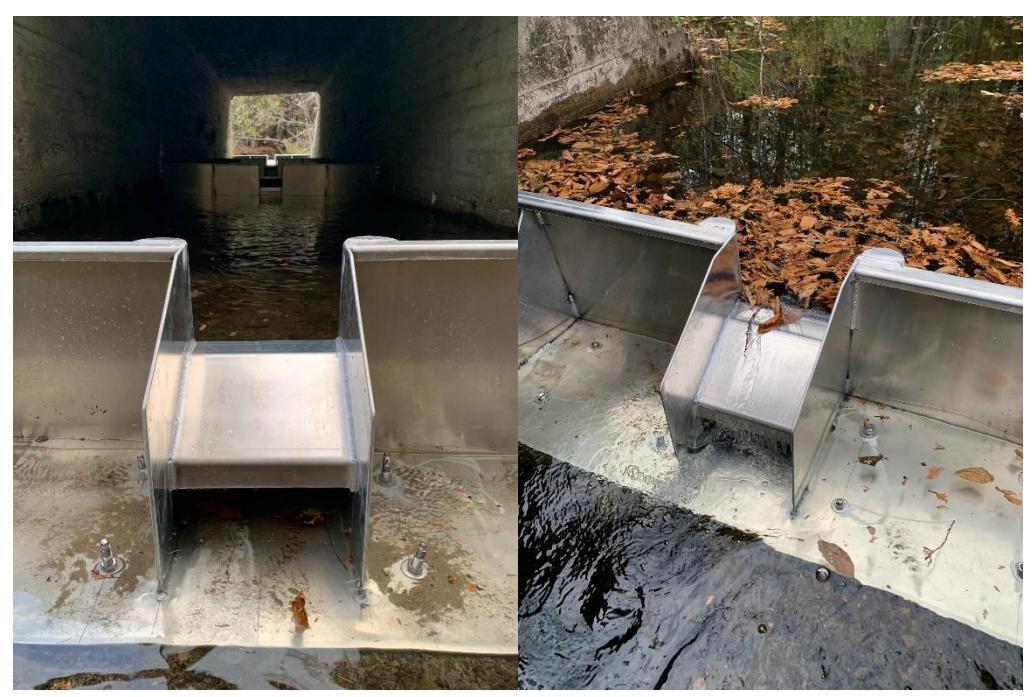
FIGURE 7. A CLOSE-UP SHOT SHOWING THE WEIRS INSTALLED FOR THE LIMEKILN BROOK FISH PASSAGE PROJECT. THE WEIRS WERE NOT FULLY INSTALLED AT THIS POINT, SO WATER WAS JUST STARTING TO FLOW OVER THE CHUTE.

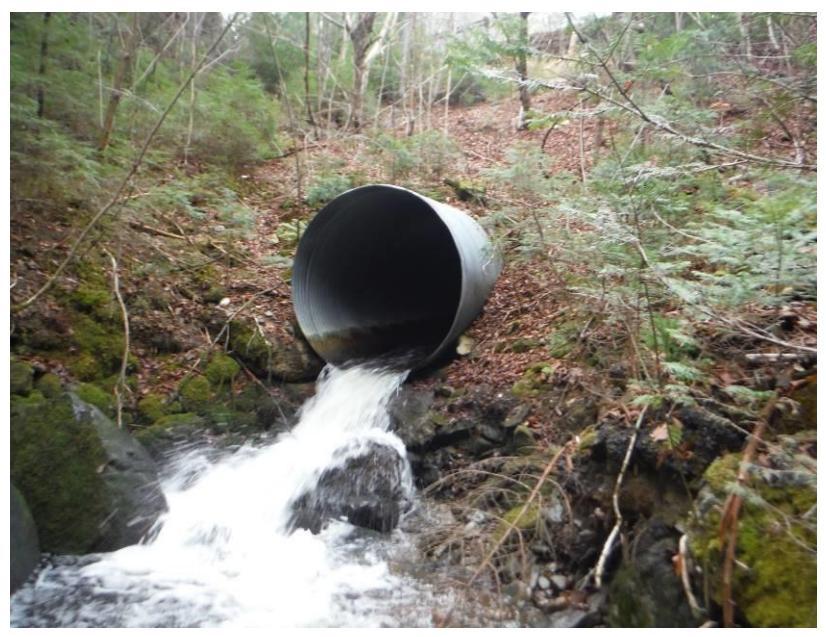
FIGURE 8. THE PORTER'S BROOK CULVERT ON NASHWAAK WEST ROAD IS A SEVERE BARRIER TO FISH. THE POOL AT THE MOUTH OF THIS BROOK IS AN IMPORTANT SALMON HOLDING POOL THAT DFO CLOSES ANNUALLY ON JUNE 15. NASHWAAK WEST ROAD HAS BEEN CLOSED FOR MANY YEARS AND WILL NOT REOPEN. IF THIS CULVERT BLOWS OUT IN A STORM, THE BROOK, THE POOL AT THE MOUTH OF THE BROOK, AND DOWNSTREAM HABITAT IN THE NASHWAAK RIVER WILL BE IRREVERSIBLY DAMAGED.

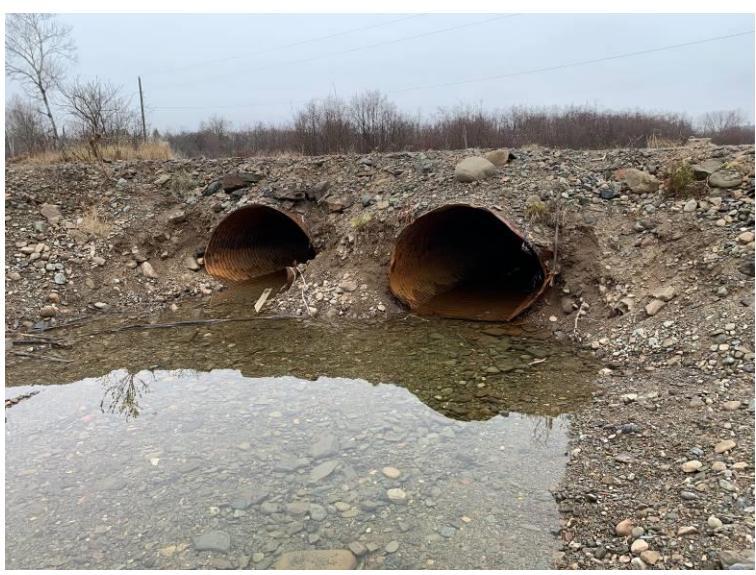
FIGURE 9. THIS PIPE ON MCLEAN FLATS ROADS IS IN VERY POOR SHAPE AND FILLS WITH GRAVELS ANNUALLY DURING THE FRESHET. THESE PIPES NEED TO BE REPLACED. LOCAL RESIDENTS DESCRIBED MANY FISH INCLUDING ATLANTIC SALMON USING THIS STREAM IN PREVIOUS YEARS.

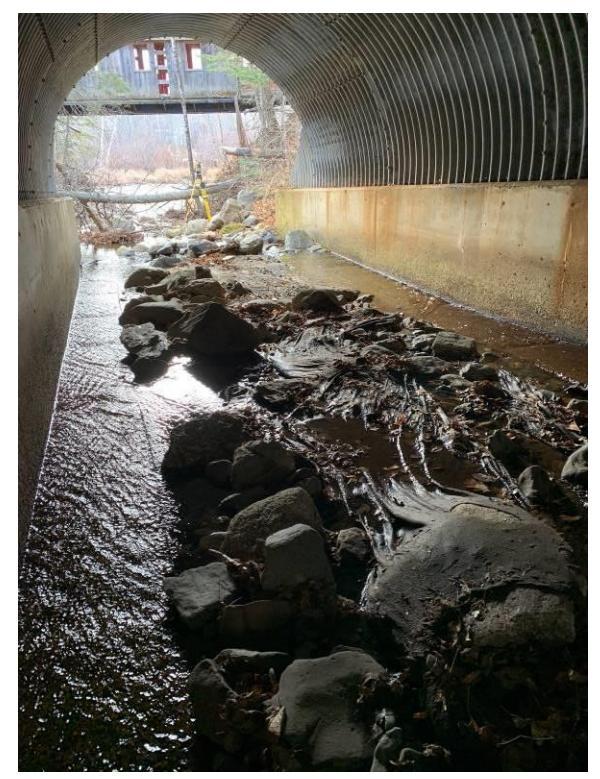
FIGURE **10.** THIS PIPE ON SANDS BROOK ON GIANT'S GLEN ROAD HAS EXPERIENCED MAJOR DETERIORATION OF THE SUBSTRATE IN THE LAST FEW YEARS. THOUGH IT HAS OPEN BOTTOM IT APPEARS AS THOUGH THIS CULVERT IS NO LONGER PASSABLE TO FISH. BLACK SEDIMENT CONTROL FABRIC IS SHOWN EXPOSED IN THE PHOTO ABOVE.
