2021 NASHWAAK WATERSHED AQUATIC CONNECTIVITY REPORT

Written by: Natalie Deseta & Lauren Murdock Nashwaak Watershed Association Inc.

2021 Aquatic Connectivity Report

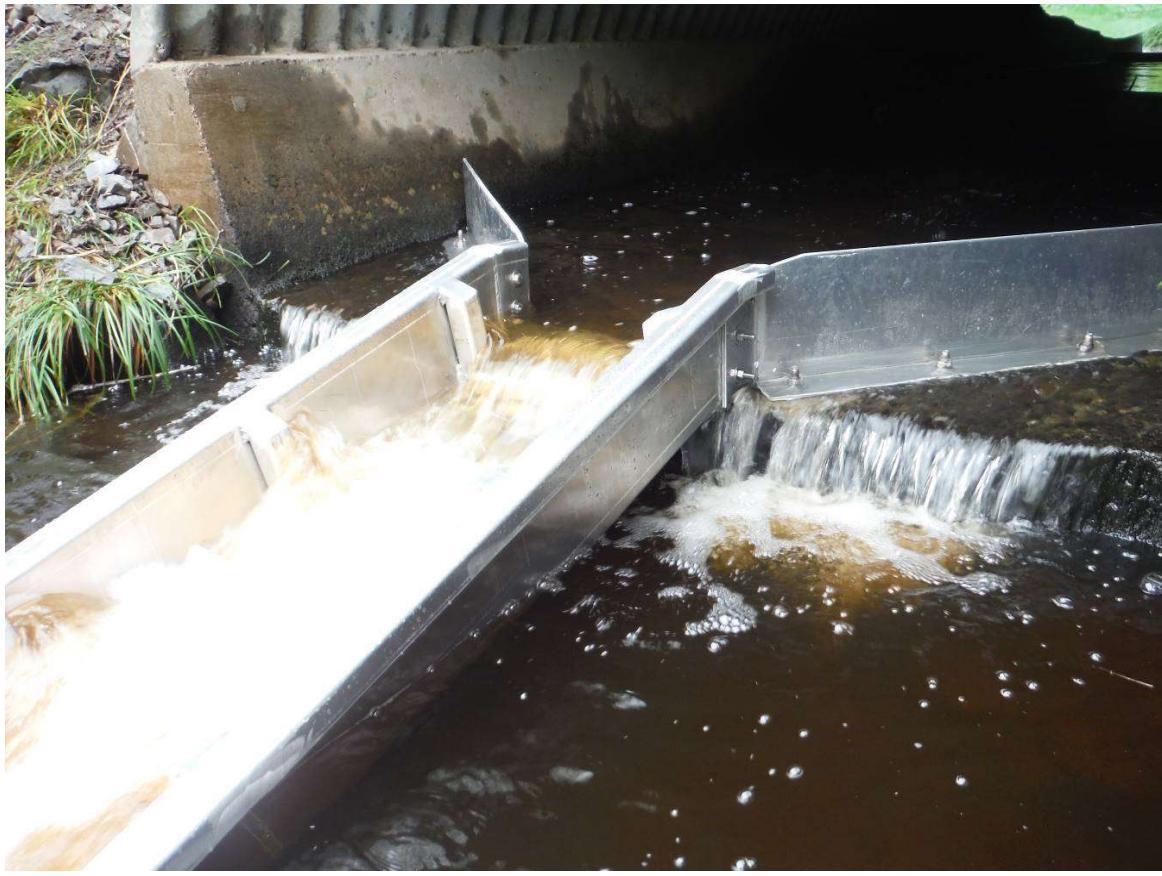
We have been regularly checking on the Manzer Brook fish ladder (Figure 7), installed in 2018. It survived the last three winters well and has not been catching debris. Electrofishing in August 2018 prior to the install of the remediation found seven species downstream and five species upstream (a total of 54 fish downstream and 55 fish upstream). Electrofishing in September 2020 found six species downstream and five species upstream (a total of 154 fish downstream and 104 fish upstream). In 2021, using a sweep and shock method, we determined there were 7 species downstream and 5 species upstream, with a grand total of 59 fish (Table 3).

FIGURE 3. THE MANZER BROOK FISH LADDER, INSTALLED IN AUGUST 2018

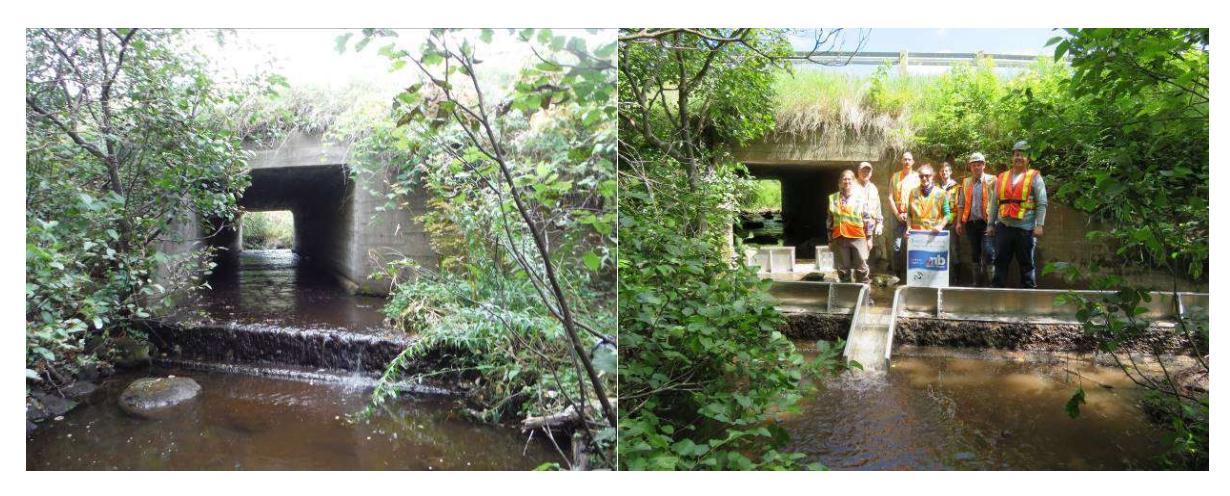
At East Ryan Brook, a cast in place $2,750 \times 1,800$ mm concrete box installed in the 1950s on Rte 107 was too steep (2.3% over 20 m) and had a 30 cm step at the outlet, preventing fish passage through the pipe. Water in the pipe was very shallow due to its wide, flat bottom. Electrofishing in 2019 showed that there were many brook trout using this cold-water stream along with a single American eel.

FIGURE 4. BEFORE (LEFT) AND AFTER (RIGHT) OF THE EAST RYAN BROOK FISH PASSAGE PROJECT.

The remediation took place in two phases: First, a baffle was placed at the end of the enclosed pipe and another just before the drop (Fig 3). Baffle height was 350 mm and notch width and depth were 200 mm and 150 mm, respectively for both. These allowed the water in the pipe to back-flood and velocity to decrease. A short chute was installed over the drop at the end of the structure. The chute contained roughness bars to prevent sheet flow. The second baffle was fitted with a small slide to allow fish to swim up and over. The second phase, installed a few weeks later, involved three shorter baffles that extended 4/5ths of the way across the pipe (Fig 4). We alternated what side of the baffle was opened to create a sinuous channel through the pipe. These helped back-flood the remainder of the pipe. Large rocks were placed throughout the pipe to create microhabitat. Water will eddy behind the rocks and they will provide protection for small fish.

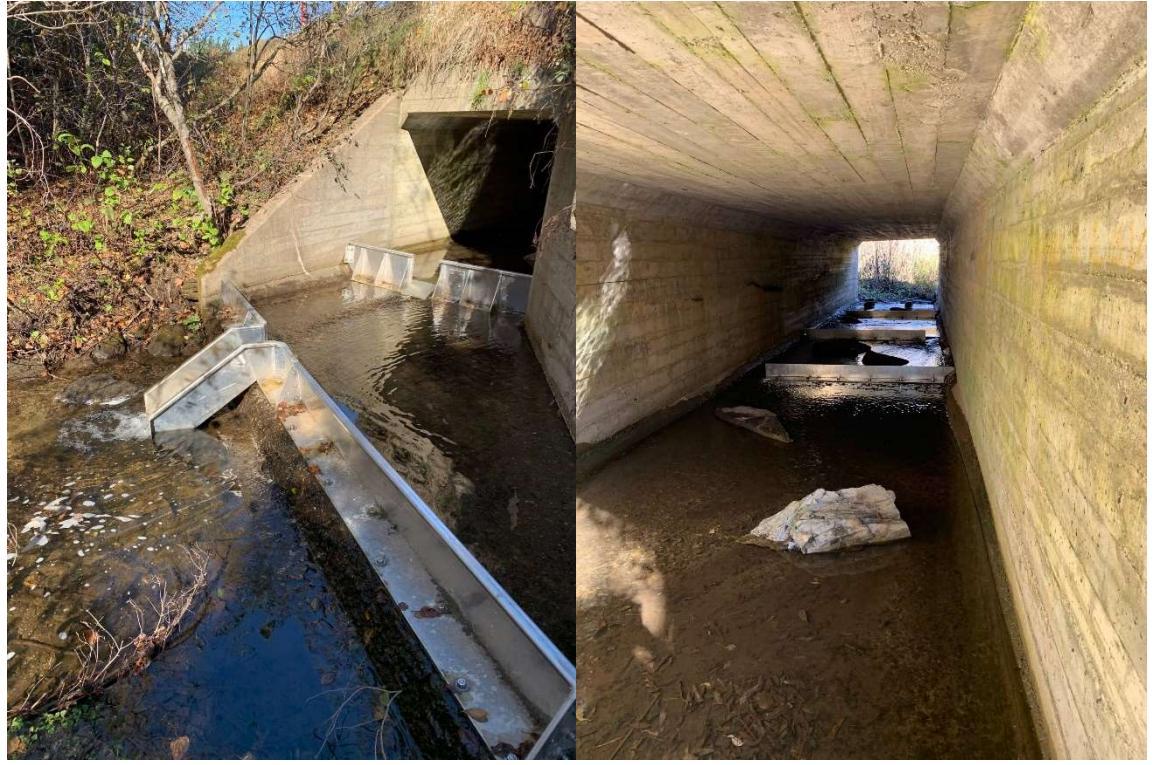
FIGURE 5. DETAILS OF THE EAST RYAN BROOK FISH PASSAGE PROJECT SHOWING THE CHUTE AND FIRST TWO BAFFLES (LEFT) AND THE UPPER THREE PARTIAL BAFFLES (RIGHT) AS WELL AS THE LARGE ROCKS PLACED TO PROVIDE MICROHABITAT IN THE PIPE.

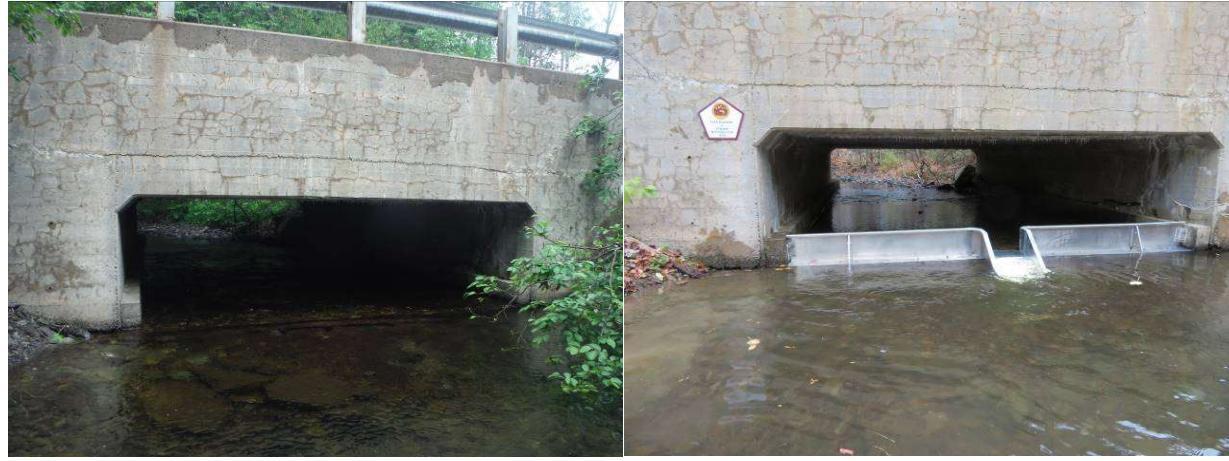
The McGivney Brook pipe is a cast in place concrete box (4,580 x 1,260 mm) on route 625. The remediation work at this site was completed in October 2020. This culvert was slightly too steep (0.9% over 9.8 m) to allow for fish passage. Its wide, flat bottom meant that there were only a few millimetres of water depth during low flow. Pre-remediation electrofishing found three species downstream and four species upstream (American eel was found upstream but not downstream). Similar numbers of brook trout were found up and downstream but higher numbers of black nose dace and slimy sculpin were found downstream compared to upstream. A total of 43 fish were found downstream versus 25 upstream. A temperature logger installed over the summer of 2020 gave an average temperature between 21 June and 21 September of only 15.04°C and a peak temperature of 20.6°C, indicating that this brook is an excellent thermal refuge for salmonids in the summer.

FIGURE 6. BEFORE AND AFTER OF THE MCGIVNEY BROOK FISH PASSAGE PROJECT

Remediation work involved the installation of one aluminum baffle and chute at the outlet of the pipe. The baffle was 300 mm high with a notch width and depth of 400 mm and 300 mm, respectively. The chute was 400 mm wide and 615 mm long. The baffle allows water to back-flood in the culvert, becoming deeper and slower (and easier for fish to swim in). The chute allows fish to swim into the culvert during low flow and it was fitted with roughness bars to prevent sheet flow. This project opened 10.2 km² of habitat and 8,913 m of stream length above it.

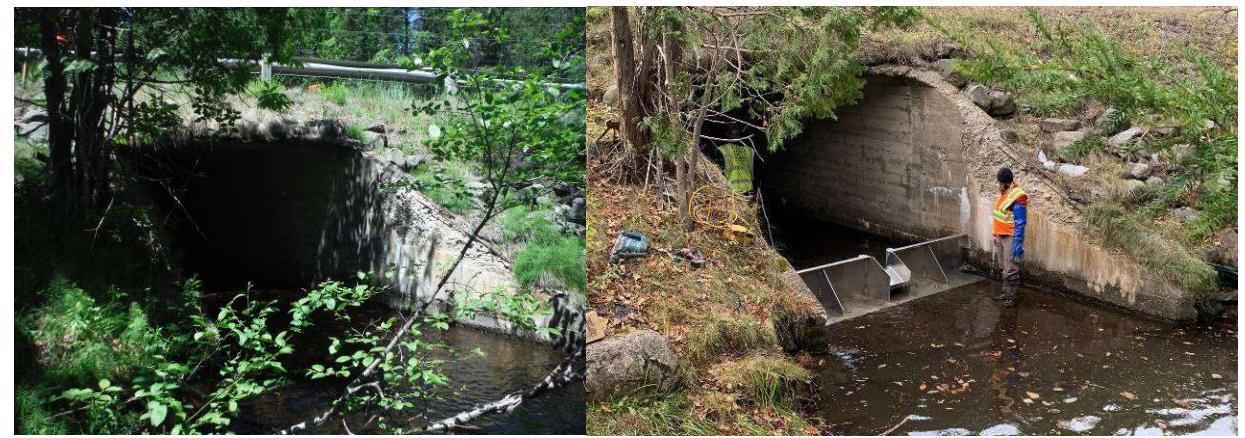
The Limekiln Brook pipe is a cast in place concrete box (3,000 x 2,400 mm) on route 620. The remediation work at this site was completed in October 2020. This culvert was too steep (2.11% over 28 m) to allow for fish passage. Its wide, flat bottom meant that there were only a few millimetres of water depth during low flow. Pre-remediation electrofishing found 4 species downstream and 2 species upstream. American eel and black nose dace were not found above the pipe. A total of 14 fish were found downstream versus 6 fish upstream. Post-remediation electrofishing will be completed in 2021. A temperature logger installed over the summer of 2020 gave an average temperature between 21 June and 21 September of 18.41°C and a peak temperature of 24.73°C, indicating that this brook would be an excellent thermal refuge for salmonids in early/late summer. However, in peak summer, it may be too warm (temperature exceeded 23°C on 20 days this summer).

FIGURE 7. BEFORE (LEFT) AND AFTER (RIGHT, BELOW) OF THE LIMEKILN BROOK FISH PASSAGE PROJECT.

The remediation involved the installation of 4 fish weirs spaced 7 m apart throughout the pipe. The baffles were 500 mm high with a notch width and depth of 300 mm and 200 mm, respectively. This project opened 7.25 km² of habitat and 10,732 m of stream length above it.

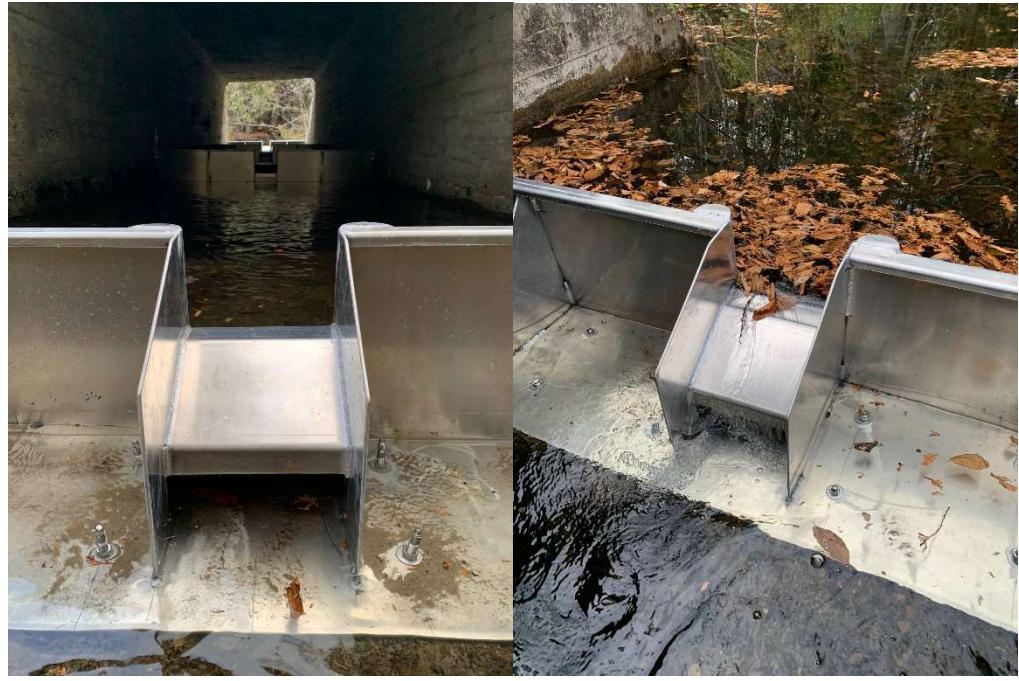
FIGURE 8. A CLOSE-UP SHOT SHOWING THE WEIRS INSTALLED FOR THE LIMEKILN BROOK FISH PASSAGE PROJECT. THE WEIRS WERE NOT FULLY INSTALLED AT THIS POINT, SO WATER WAS JUST STARTING TO FLOW OVER THE CHUTE.

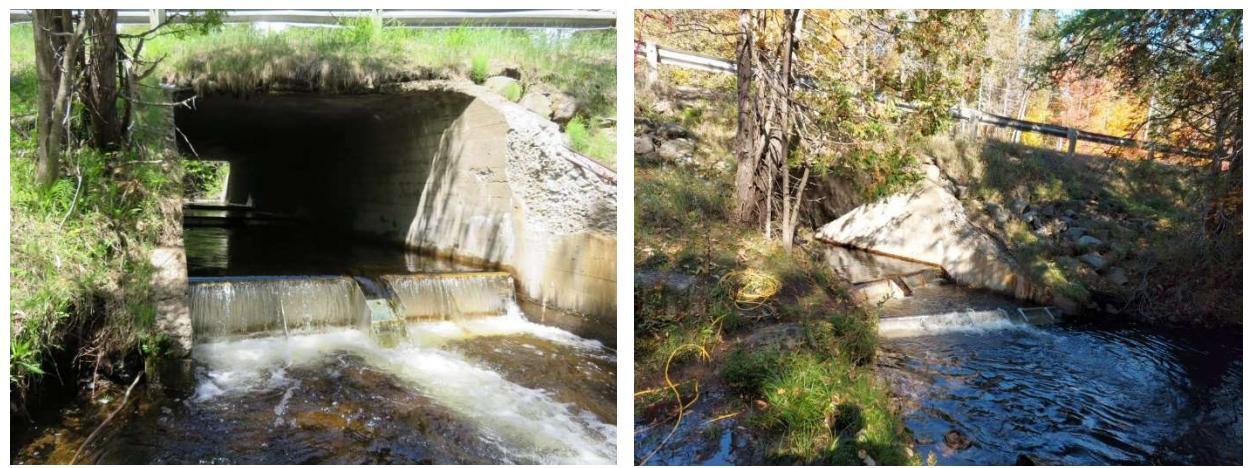
In 2021 we noted that the outflow drop in the fish ladder was higher than ideal and installed an additional weir to further facilitate fish passage (Fig. 9). Table 10 shows the post-remediation electro-

FIGURE 9. LIMEKILN FISH LADDER BAFFLE INSTALLATION FROM EARLY 2021 (LEFT) AND AFTER AN ADDITION BAFFLE WAS INSTALLED IN FALL 2021 (RIGHT)

In the fall of 2021, Limekiln Brook we installed an additional aluminium weir at the downstream side of the fish ladder to decrease the outflow drop and provide improved opportunity for fish passage (Fig 8). The new weir was installed at an angle and had the following dimensions: 300 mm high, with a notch depth of 200 mm and width of 300 mm.

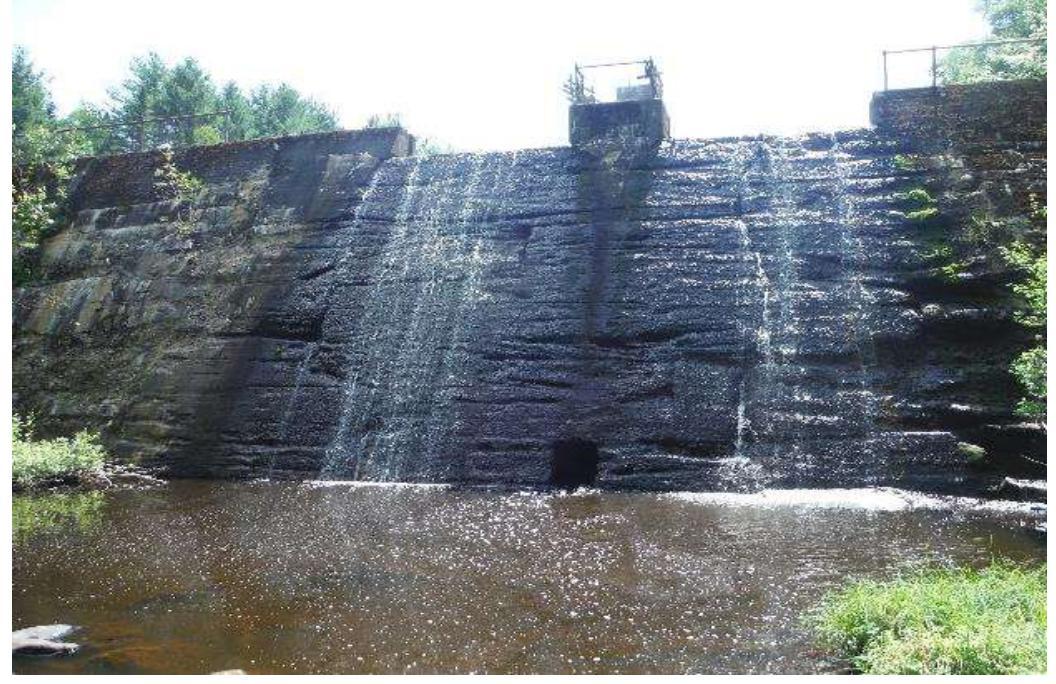
FIGURE 10 CAMPBELL CREEK DAM, LOOKING UPSTREAM IN THE SUMMER OF 2018

Complete removal of the dam was recommended by engineers as it was a safety liability. The dam did not meet the Canadian Dam Association guidelines with respect to the hydraulic capacity of the spillways, stability, seepage and erosion, or public safety and fish passage was non-existent, negatively affecting fish habitat and aquatic connectivity for over a century. With our rapidly warming climate affecting so many rivers, opening as much high quality, cold, clean water habitat as possible is a priority for creating a well-connected and resilient landscape. Wild brook trout, Atlantic salmon, American eel, and sea lamprey are among native aquatic species that stand to benefit from this work.

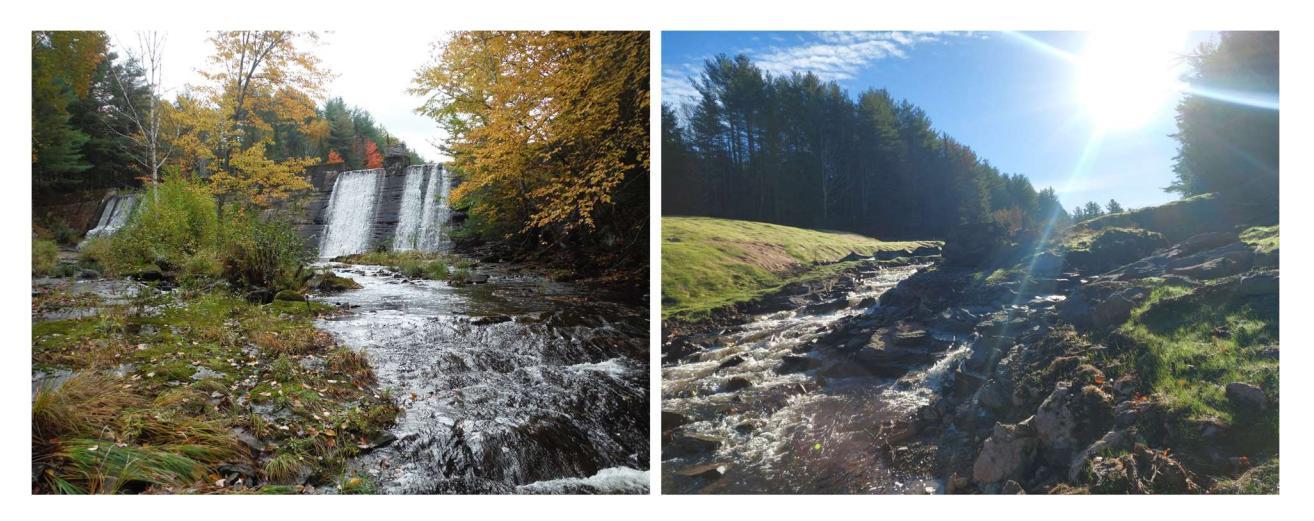
FIGURE 11. PICTURE OF CAMPBELL CREEK LOOKING UPSTREAM IN 2019 (LEFT) AND 2021 (RIGHT)

In September 2021 the Campbell Creek Dam was fully removed, and free flow to the stream restored for the first time in 100 years. Multiple fish rescues were conducted throughout the removal process to mitigate fish mortality in the construction zone, and we were pleased to find numerous Atlantic salmon parr and American eel just downstream of the dam (Fig. 16).

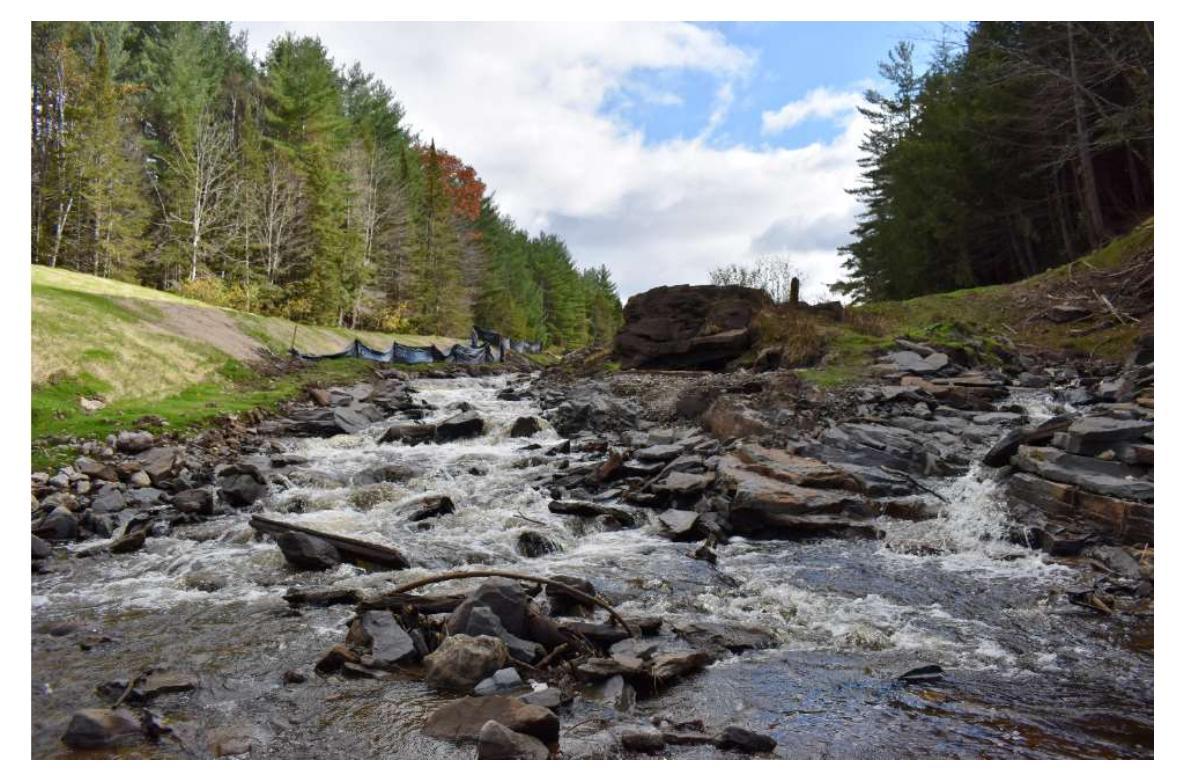
FIGURE 12. A PICTURE OF THE NEWLY RESTORED CHANNEL IN CAMPBELL CREEK LOOKING UPSTREAM IN 2021

After being tested thoroughly for potential toxins and contaminants the concrete of the dam was laid to rest on-site, buried and covered in topsoil to be revegetated. The newly-established stream channel was reconstructed to facilitate fish passage by roughening the stream bottom and creating a series of riffles and pools (Fig. 14).

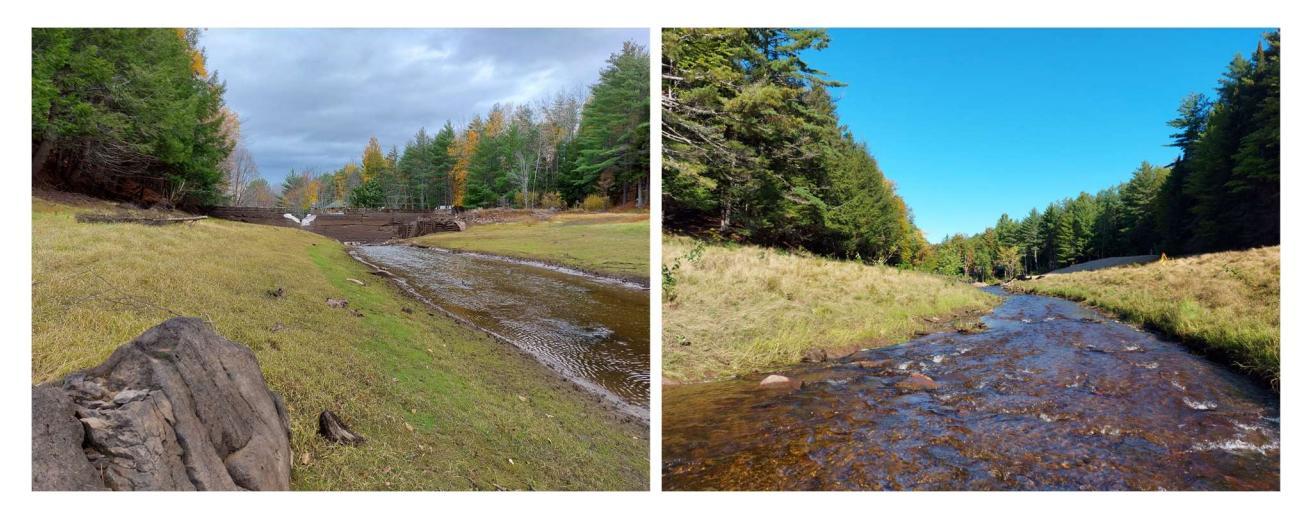
FIGURE 13. PICTURE OF CAMPBELL CREEK LOOKING DOWNSTREAM IN 2019 (LEFT) AND 2021 (RIGHT)

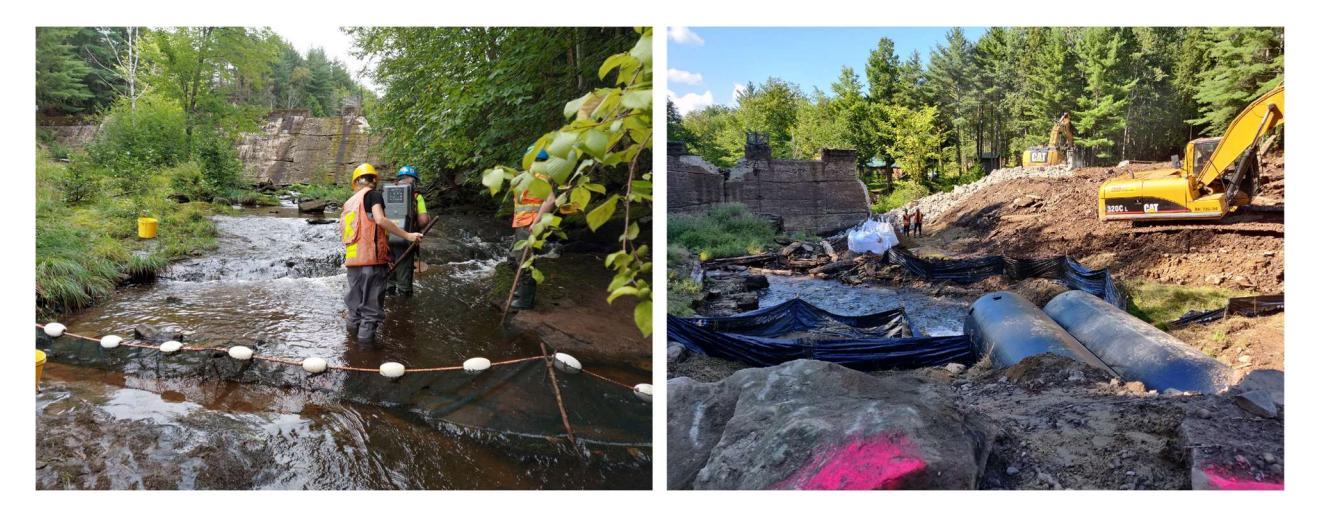
FIGURE 14 LEFT: PHOTO OF ONE OF SEVERAL FISH RESCUES CONDUCTED THROUGHOUT THE DAM REMOVAL PROCESS. RIGHT: DAM REMOVAL, MID-CONSTRUCTION. THE CREEK CHANNEL WAS DIVERTED SEVERAL TIMES DURING THIS PROCESS.

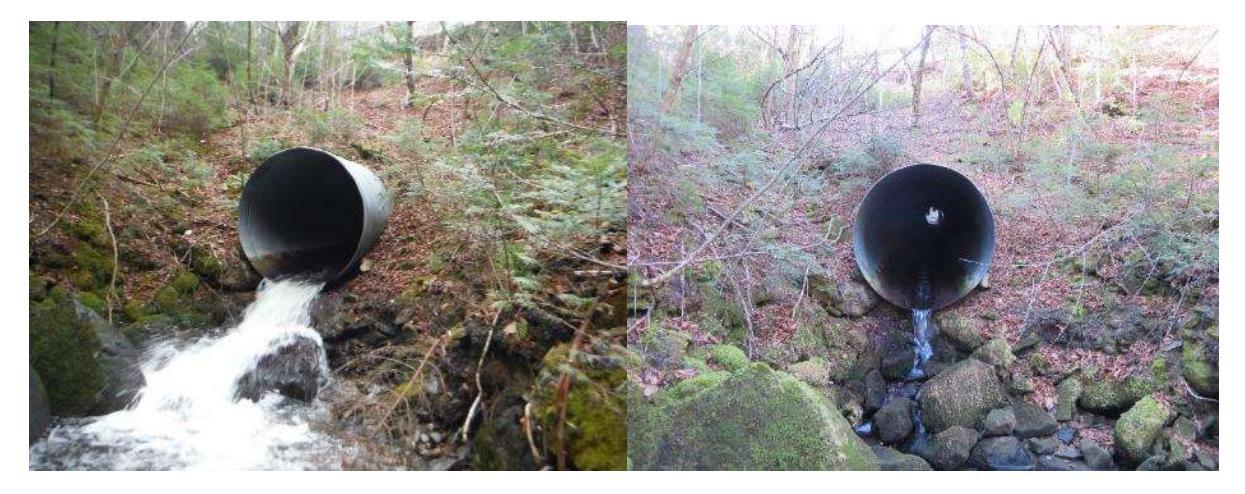
Porters Brook is a culvert located on Nashwaak West Road and is the property of NBDTI. It is understood that this culvert has been impeding fish passage in this cold-water tributary for many decades. The Porters Brook culvert is an 1,800 mm diameter corrugated steel pipe (Figure 15). The culvert does not meet DFO's stream crossing standard (slope is >0.5%, no baffles, perched outlet). A concrete headwall is visible on the upstream site, which appears to be older cast in place arch that was not removed when the culvert was replaced. Cobbles were mortared between the metal pipe and the concrete arch. Some of these mortared cobbles were seen in the stream below the culvert. It is unclear how far the concrete arch extends but it is not visible on the downstream side. There is a large crack in the left side of the headwall.

FIGURE 15. THE OUTLET OF THE PORTERS BROOK CULVERT IN HIGH WATER CONDITIONS IN 2017 (L) AND IN LOW WATER CONDITIONS IN 2020 (R)

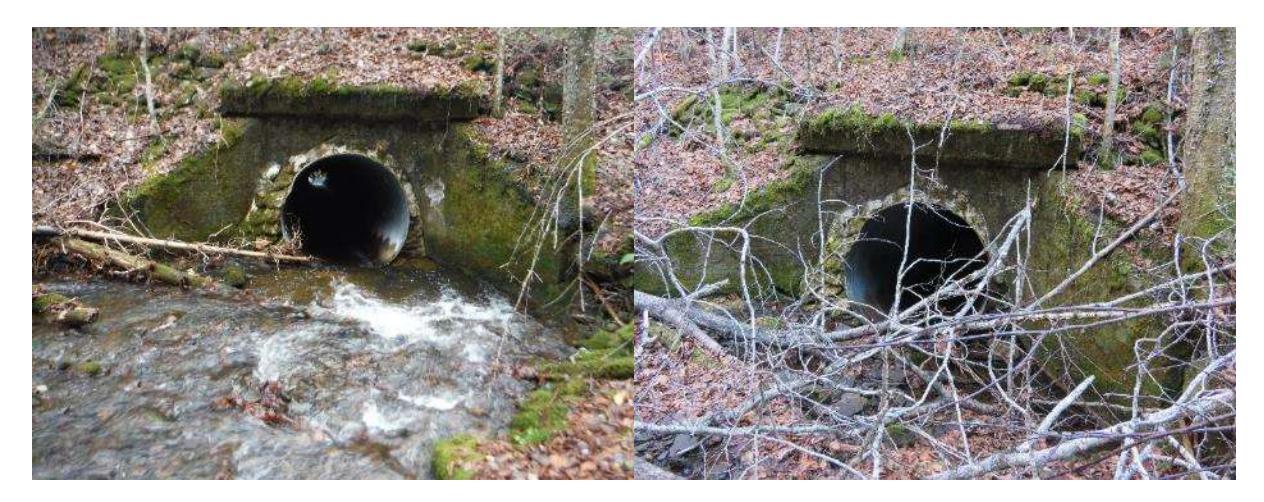
FIGURE 16.THE INLET OF THE PORTERS BROOK CULVERT IN 2017 (L) AND IN 2020 (R). MANY LARGE TREES HAVE FALLEN IN THE STREAM AND DEBRIS HAS STARTED TO CLOG THE STREAM JUST ABOVE THE INLET.

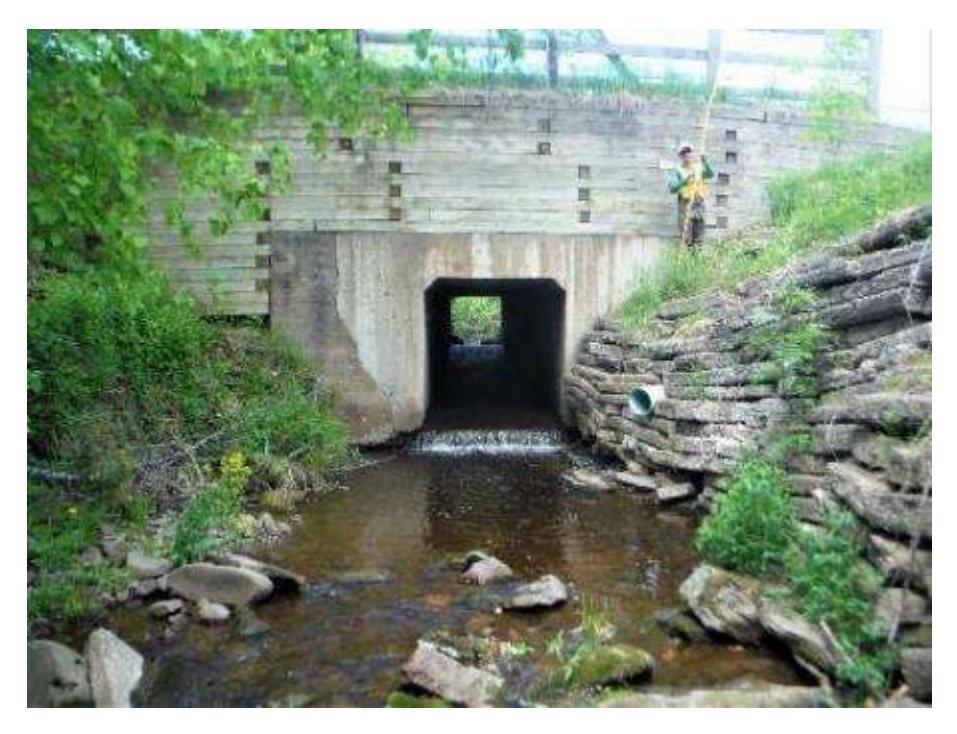
Two barriers of primary concern are in McConaughy Brook (Fig 18 and 19). These full barriers are blocking over 4.2 km² of functional upstream habitat. We plan to conduct a hydroengineering assessment of these barriers in 2022.

FIGURE 17. PICTURE LOOKING UPSTREAM IN MCCONAGHY BROOK (MCO1). THIS SITE IS A FULL BARRIER TO FISH PASSAGE, BLOCKING 4.2 KM² OF VIABLE UPSTREAM HABITAT.

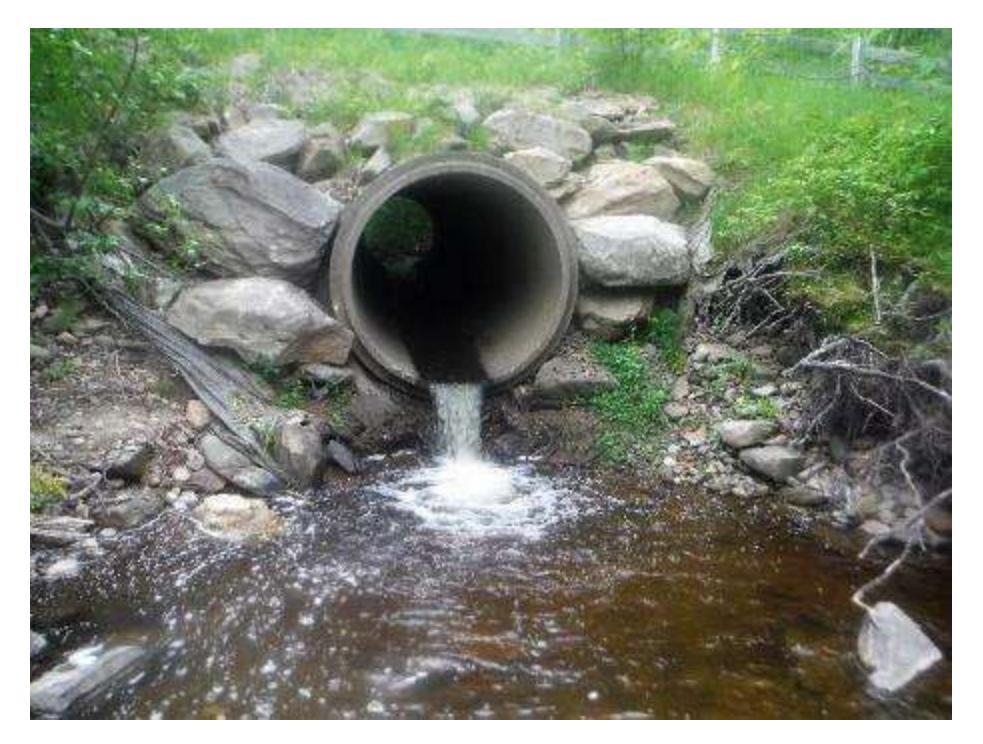
FIGURE 18. MCCONAGHY BROOK ON THE NB TRAIL LOOKING UPSTREAM (MCO2).
