2017-2018 FINAL REPORT

NEW BRUNSWICK WILDLIFE TRUST FUND

NASHWAAK WATERSHED ASSOCIATION INC.

The Nashwaak Watershed Wetland Habitat

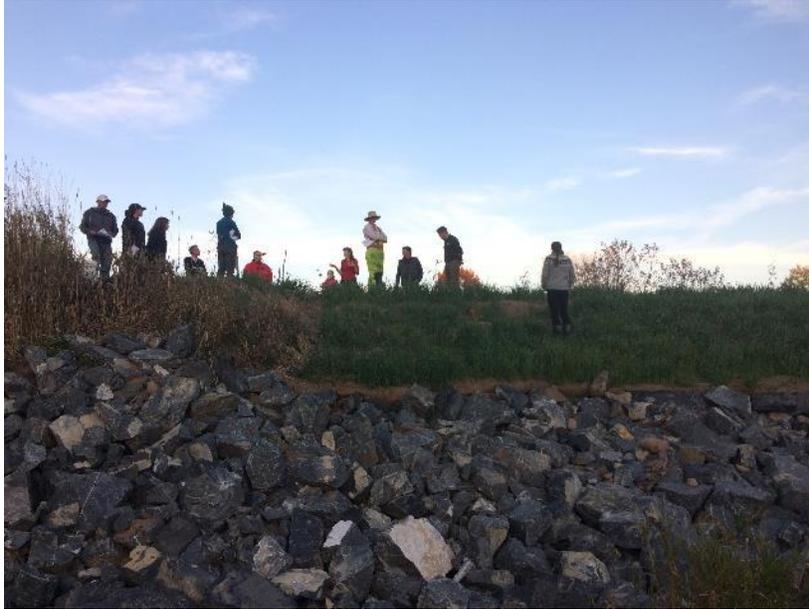
FIGURE 1. TOUR OF OUR BIOENGINEERED RIVERBANK RESTORATION PROJECT

Over the course of the project, we held two meetings for landowners to attend. The first was a tour of our completed bio-engineered riverbank restoration site (see Phase 2), where we demonstrated how to stake willows for erosion control and where landowners could ask questions about restoration techniques (Figure 1). Nine landowners attended this event. The second meeting was our Annual General Meeting and 42 people were in attendance (Figure 2). Bio-engineered riverbank restoration was highlighted by NWA staff during a presentation at the AGM.

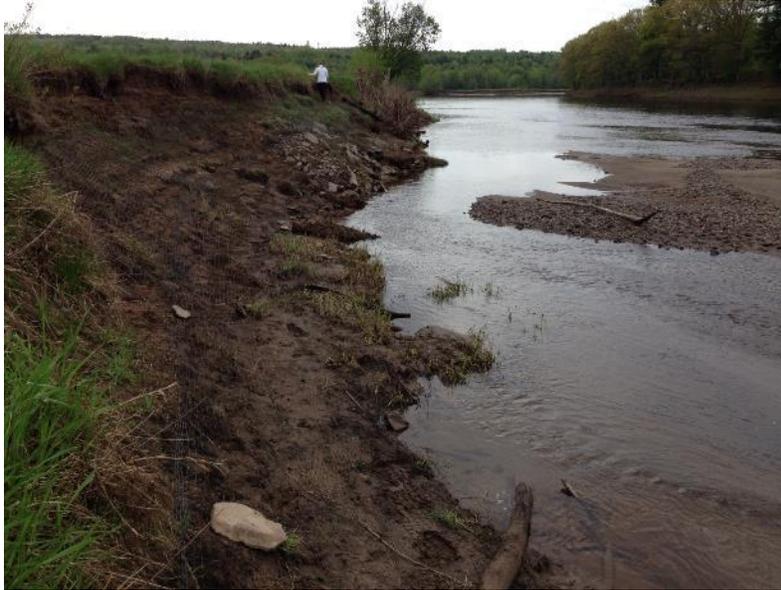
FIGURE 5. THE BANK IN MAY 2017 AFTER THE PROTECTING NETTING HAD BEEN INSTALLED.

A local hydraulic engineering company, HILCON Ltd., surveyed the bank along with NWA staff on 9 June 2017. A stamped engineering drawing was produced (see attached) and circulated to six local contractors for bidding. The winning bid was Malcolm Foster Ltd. and a contract was signed between the two parties.

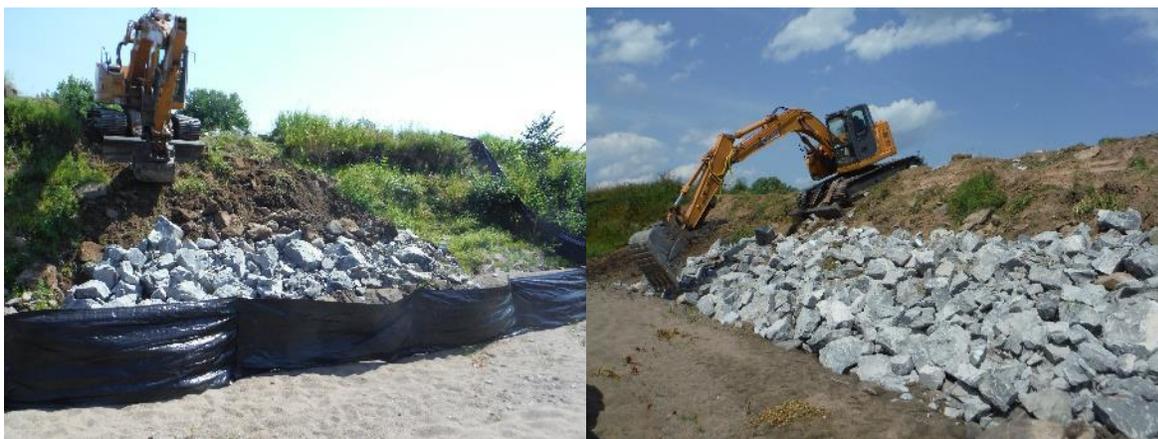
FIGURE 6. LEFT: THE EXCAVATOR PLACING THE FIRST SECTION OF R250 MIXED RIP-RAP IN THE TRENCH AT THE TOE OF THE SLOPE. THE SEDIMENT FENCE IS PROTECTING THE WATERCOURSE FROM SEDIMENTATION. RIGHT: THE EXCAVATOR PLACING THE FINAL SECTION OF R250 RIP-RAP AT THE TOE OF THE SLOPE.

The restoration happened over two days in August 2017. A sediment control fence was installed the day prior to the work and the area was carefully inspected for the presence of Wood Turtle. Day 1 involved the heavy machinery work, which consisted of digging a trench ~0.5 – 1.0 m deep at the toe of the slope and placing R250 mixed rip-rap along the toe (Figure 6). These large rocks will prevent undercutting of the bank and they were keyed into existing rocks on either side of the restoration area. The rock toe extended ~ 1 to 1.5 m up the bank. The hydraulic engineer from HILCON Ltd. inspected the work on both days.

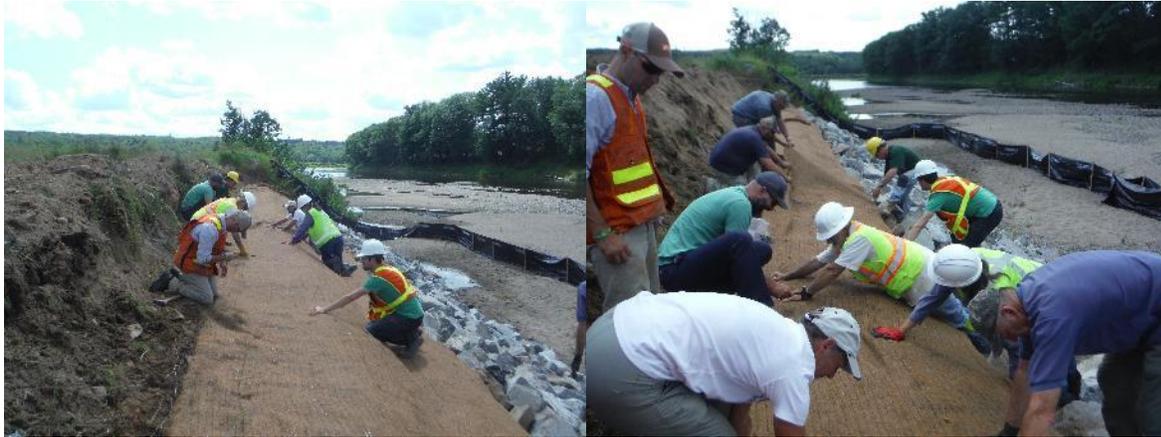
FIGURE 7. VOLUNTEERS ASSIST WITH THE INSTALLATION OF THE C200 EROSION CONTROL BLANKETS.

On Day 2, NWAJ arranged for ~10 volunteers to assist with placing the geotextile blankets (Figure 7). Volunteers were provided with hardhats, safety vests, gloves, and asked to wear steel toes boots. The geotextile material (Terrafix C200 Erosion Control Blanket) is made of coconut jute fibres and will biodegrade in approximately three years. The upper 2/3 of the bank was re-sloped at a 2:1 slope over four steps or terraces that were 0.5 m high and 1 m wide (see General Arrangement for detailed drawing). The first section of blanket was placed on the rock toe, soil was added by the excavator and packed down. Native grass seed was sprinkled on top of the soil, the blanket was wrapped over the soil and stapled in place (using sod staples) by the volunteers. Soil was then added on to the first terrace and the process was repeated four times. Straw was spread over any exposed soil as per our WAWA permit (Figure 8).

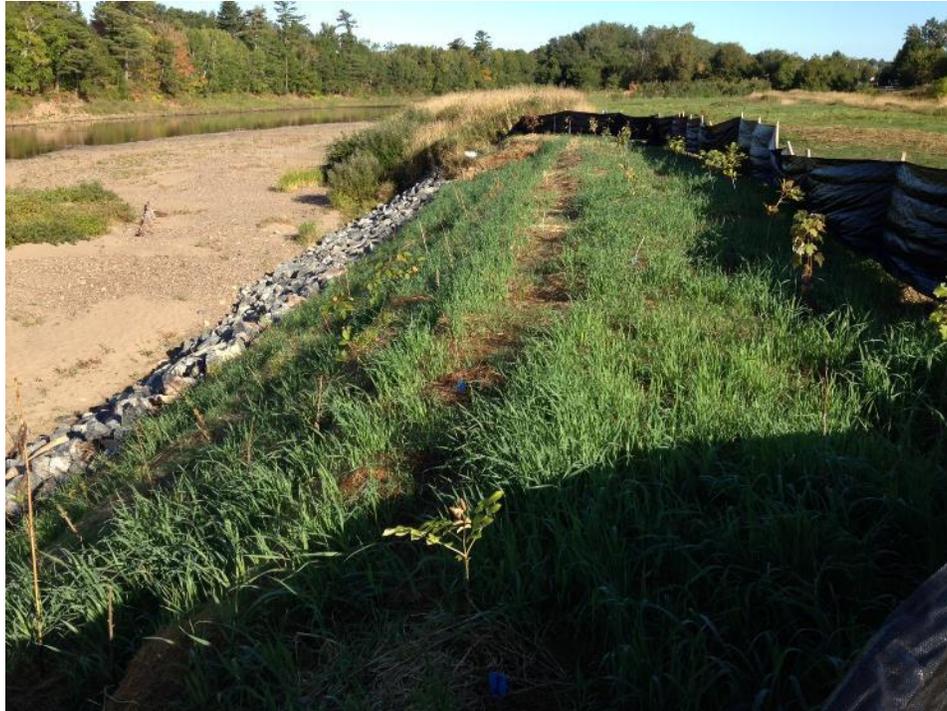
FIGURE 9. THE RESTORED SECTION AFTER ~1 MONTH OF GROWTH. THE SEDIMENT FENCE WAS REMOVED IN NOVEMBER 2017.

Over the course of the next week, native tree seedlings and willow stakes were planted on the terraced section and on top of the bank. Due to the hot, dry weather, the grasses and trees were watered approximately every three days for the first 2 weeks after planting.
