# The Atlantic Salmon Conservation Foundation

## Final Report

Organization: Nashwaak Watershed Association Inc.

Project title: Protecting and restoring MacPherson Brook, an important cold-water tributary to the Nashwaak River

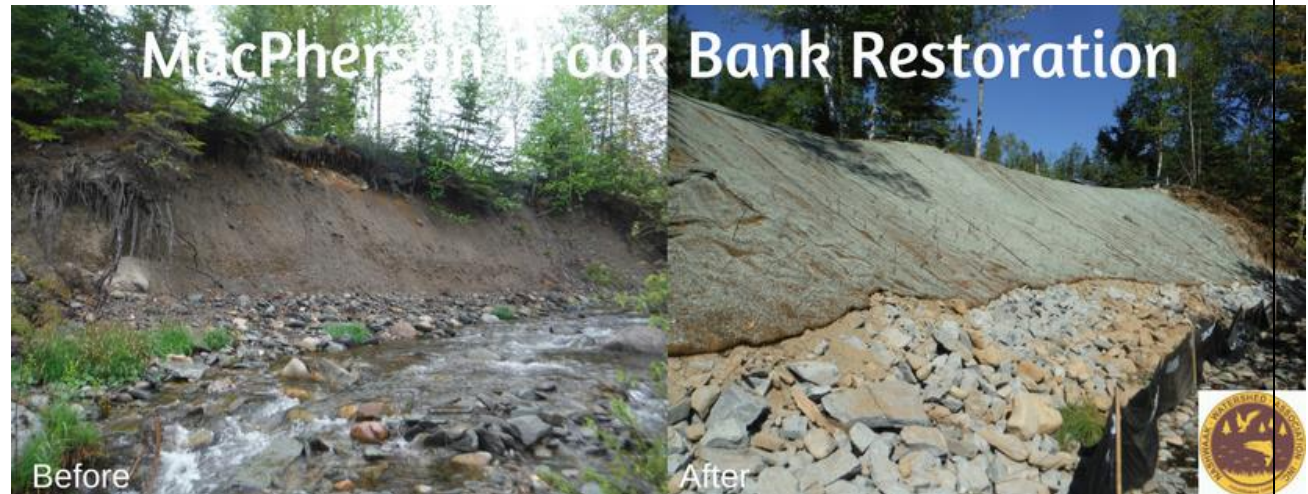
Previously (left), the bank was almost vertical and overhanging in places. After (right) the bank had been resloped to 1.5:1 and wrapped with erosion control blankets. The rock toe is made of R50 riprap mixed with existing brook material. Willow stakes are visible on the lower half of the hydroseeded bank.

The bank was reshaped to a 1.5:1 slope and a R50 (300 mm diameter rocks) rock toe was installed. The rock toe was buried ~0.5 m and extends ~1 m up the bank. Existing rocks were mixed in with the R50 to achieve a more natural look. Erosion control blankets were wrapped over the bank, hay was placed under the blankets and hydroseed was sprayed on top to ensure that vegetation would become

established this season. >200 live willow stakes were hammered into the lower half of the bank and on the opposing bank where the machinery had damaged some vegetation. The landowner agreed to water the bank daily. This work was completed by September 21<sup>st</sup>. Silver maple, sugar maple, red oak, and white oak seedlings were planted on top of the bank in early October.

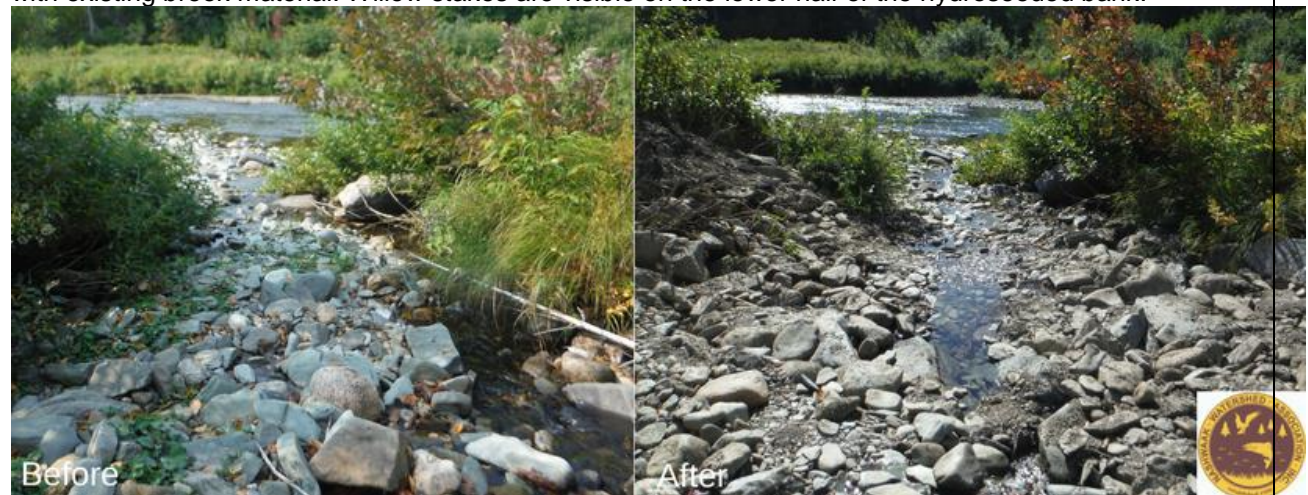
Looking downstream at the mouth of MacPherson Brook before (left) the rock weir was installed, a gravel island had built up and was channeling water to either side, which was causing more bank erosion. After (right) the installation of the sunken rock weir, water has been channelized into the middle, which will also improve fish passage at low flow conditions.

A rock weir consisting of 9 rocks that were 600 mm in diameter was placed at the downstream end of the repaired bank, close to the mouth of the brook. This weir will act as a grade control and reduce scouring of the channel bed. In low flow conditions, it will also concentrate flow to allow for fish passage into the cold-water tributary.

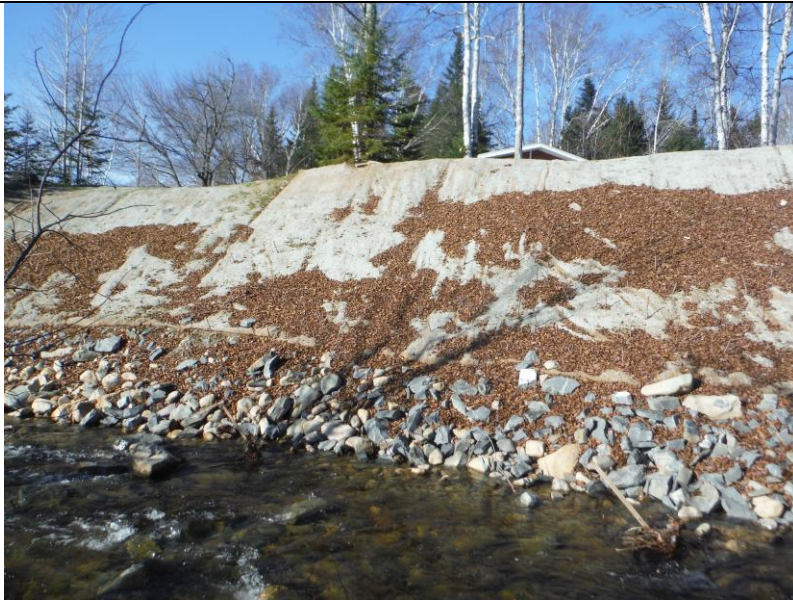
Looking straight on the bank in November 2017 after heavy rains. The rock toe has settled and is providing erosion protection for the bank. Though it is difficult to see in the photo, the grass has grown in despite the hot, dry dummer. Over 200 willow stakes were driven into the bank, which had lost their leaves at the time of this photo.

Due to weather conditions in the summer of 2017 (hot, dry, extreme low water), survival of willow stakes was low, and the grasses suffered despite being watered daily. The NWAI is committed to re-staking the willows in the spring when conditions are much better for growth, and reseeding the bank.

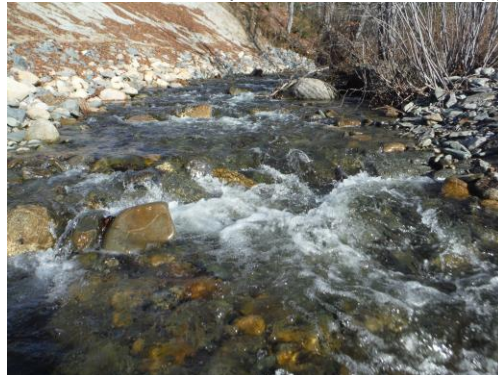
Visual inspection after a heavy rainfall revealed that there was much less fine suspended sediment and the rock weir was slowing the velocity of the water around the mouth. As of November, finer substrate had begun infilling gaps in the rock weir and rock toe, which will provide additional support.
