Multiyear Project End of Year Report

Organization: Nashwaak Watershed Association Inc.

Project title: Assessing and restoring aquautic connectivity in the lower Nashwaak River

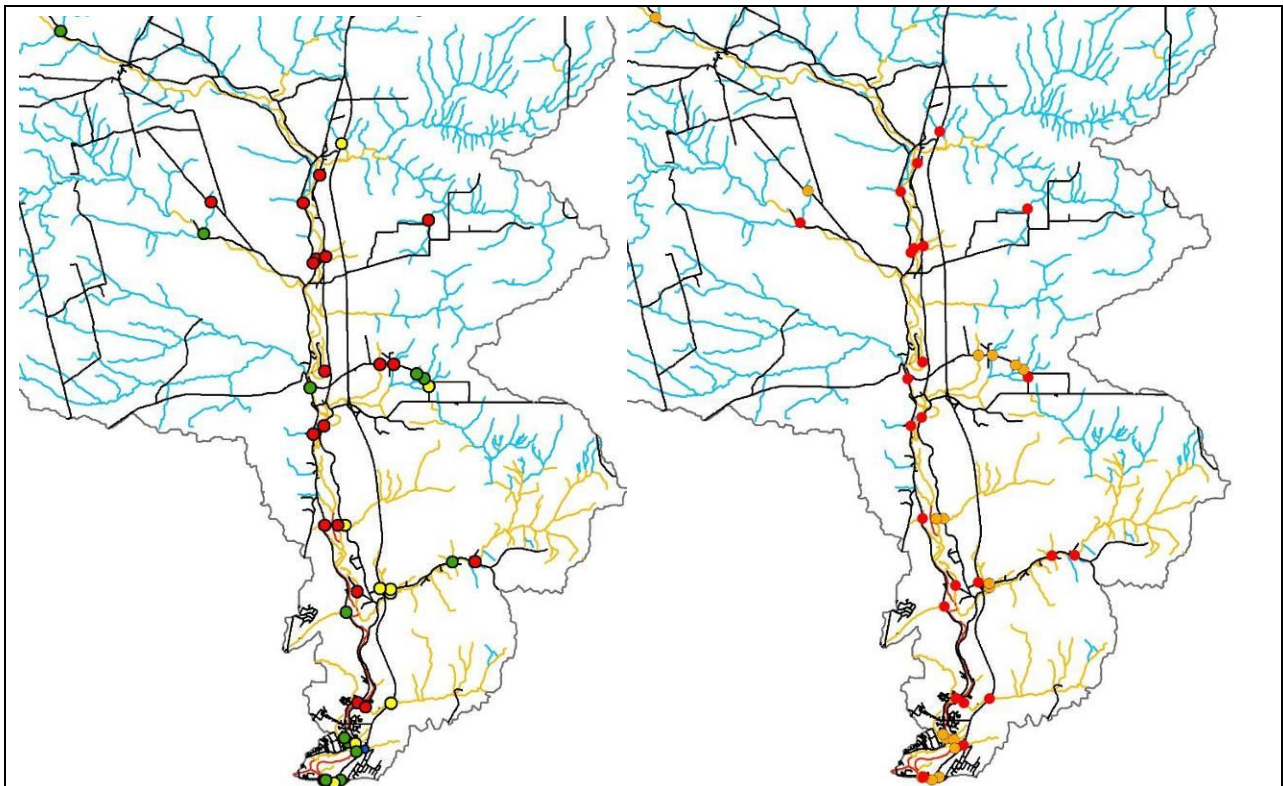
Figure 2. (left) Structural condition of the culverts assessed as barriers [green = good, yellow = fair, red = poor]. (right) Barrier classification [red = full barrier, orange = partial barrier].

Twenty-eight (42%) surveyed crossings were Full Barriers, 19 (28%) were Partial Barriers, and 20 (30%) were Passable. Major issues preventing fish passage included 1) beaver activity completely blocking a number of culverts, especially along Rte. 8 (reported to DTI), 2) older wooden box culverts on Rte. 148 and Rte. 628 collapsing (these are slated to be replaced by DTI in coming years, and, therefore, we were told not to focus remediation efforts on these culverts), and 3) culverts installed at steep slopes without baffles.

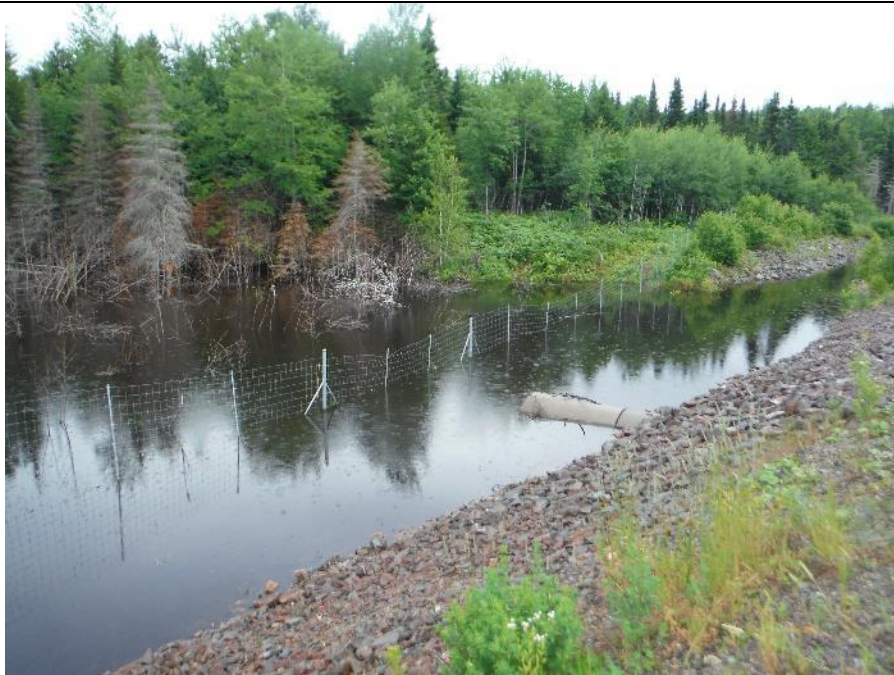
Figure 3. Beavers have flooded the upstream portion of this small stream by blocking the inlet of the culvert.

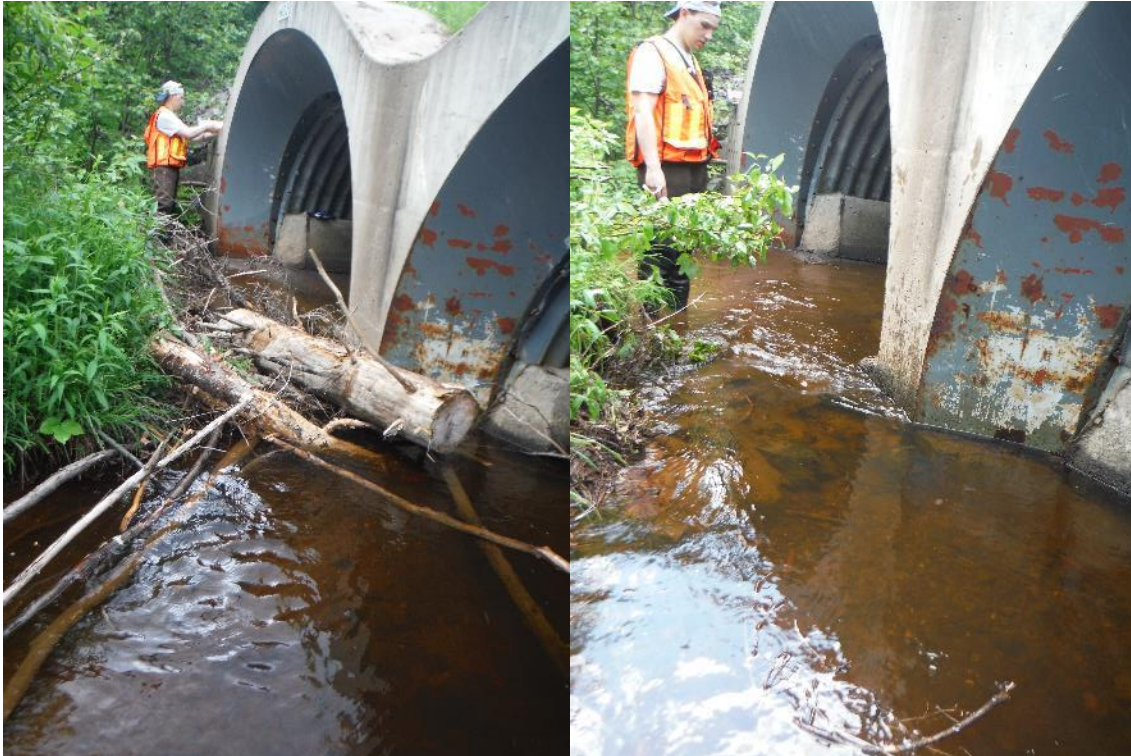
Figure 4. A debris blockage between culverts 2 and 3 at a culvert on Manzer Brook was removed, which improved the flow of water. Culvert 1 has a large tree inside of it that could not be removed with the equipment we had.

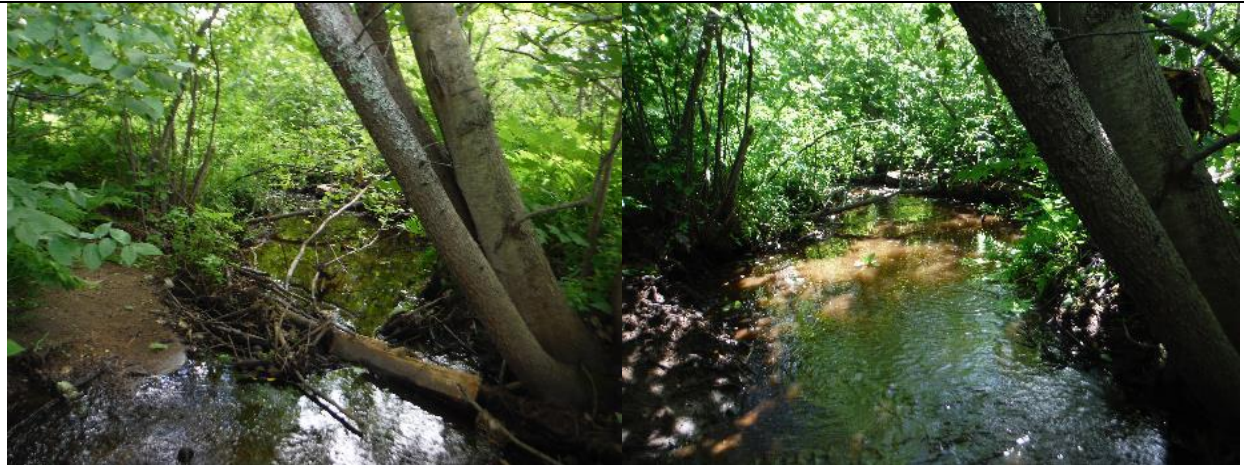
Figure 5. Before and after of a debris blockage removal downstream from a culvert on McLean Brook.

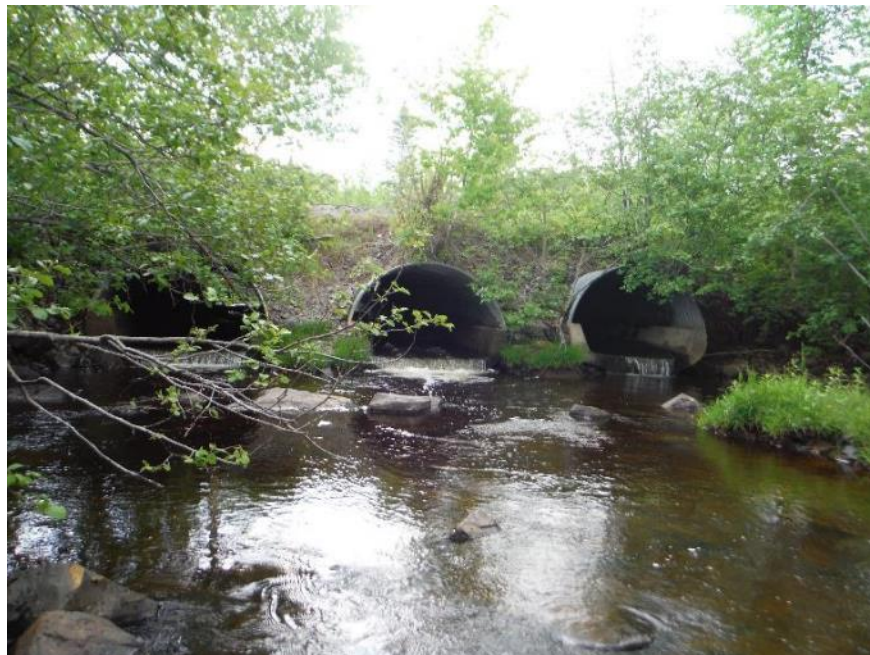
Figure 6. This triple culvert on Manzer Brook is a barrier to fish as all three culverts have outflow drops of between 38 and 62 cm. We are working on a remediation option to reinstate fish passage.

The results of our survey have led us to focus on a remediation of culvert M102 that will open up 28.04 km² of previously inaccessible habitat for salmonids. We chose this culvert to focus on because many of the culverts that we classified as Full Barriers were either 1) very old box culverts or cast in place arches that are slated to be replaced in the future, 2) the remediation was beyond our capacity (i.e., full replacement was needed), 3) were blocked by beavers, which we do not have a permit to move. Therefore, we will focus on culvert M102 as 1) Manzer Brook is one of the larger tributaries in the lower Nashwaak that has culverts as stream crossings, 2) it is on a well-travelled road meaning that it is higher priority for DTI, and 3) the culvert is structurally in good condition. DTI attempted to rehab this culvert in 2000 by lining the culvert with concrete, installing baffles for fish passage, and putting in three rock weirs downstream of the outlet. However, the rock weirs have since washed out and a blind weir was not installed in the higher two culverts (meaning that at low flow water still goes through all three culverts instead of being concentrate through the lowest culvert). The culvert is currently blocking 19.6 km stream. Drainage area upstream from the culvert is mostly forested with minor agricultural land. The stream has a moderate gradient and is cool water.

We have permission from DTI to move ahead with the design of a new fish passage option. The remediation will involve installing blind weirs on the higher two culverts to channelize the flow and building a mini-fish ladder to install on the lower culvert. The fish ladder was custom designed by HILCON Ltd., a locally owned engineering company specializing in hydraulics and hydrology, and will be custom-made over the winter by Tek Steel, a locally owned company. It will be light enough to be installed by hand and will be put in place in May/June 2018, depending on water levels. It will remain in place year-round and will be regularly cleaned by NWA staff and volunteers. Please see the attached preliminary engineering sketches.
