2019-2020

# Report on the health of the Nashwaak Watershed

Nashwaak Watershed Association

1/17/2020

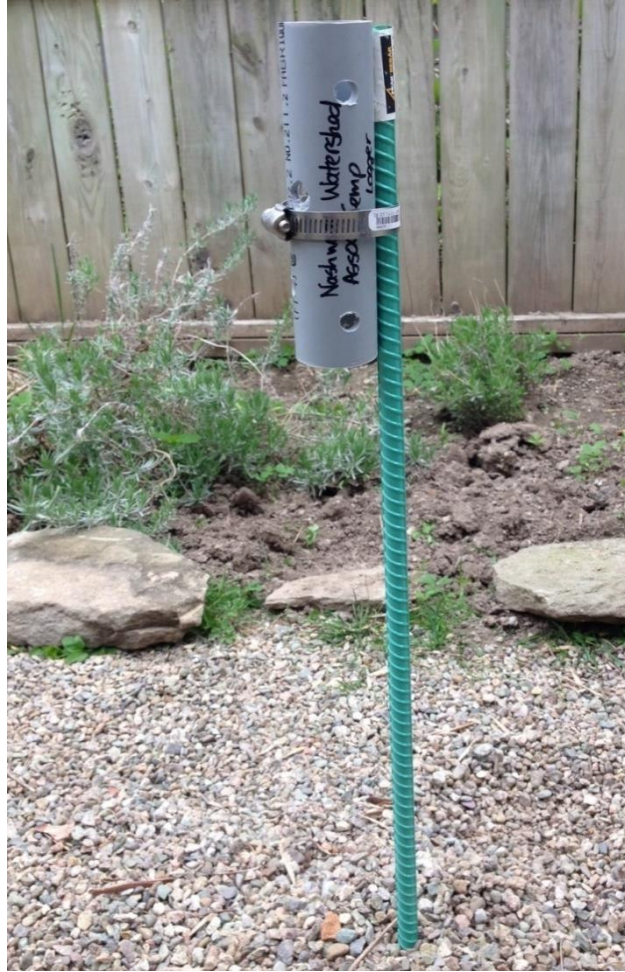
*Figure 2. A logger in its casing prior to deployment. Zip ties were added for extra security.*

Another challenge we faced in 2017 was that the wire used to secure the logger to the casing began to rust very quickly, despite being stainless steel. Therefore, zip ties were added to the casing to prevent the logger from floating to the top and being lost. In 2018 we changed from multistrand wire to solid picture wire and this held up better. We also added a small, thin zip tie to back up the wire. We continued to build loggers this was in 2019 and did not have any problems.
