2020-2021

Report on the health of the Nashwaak Watershed

Nashwaak Watershed Association

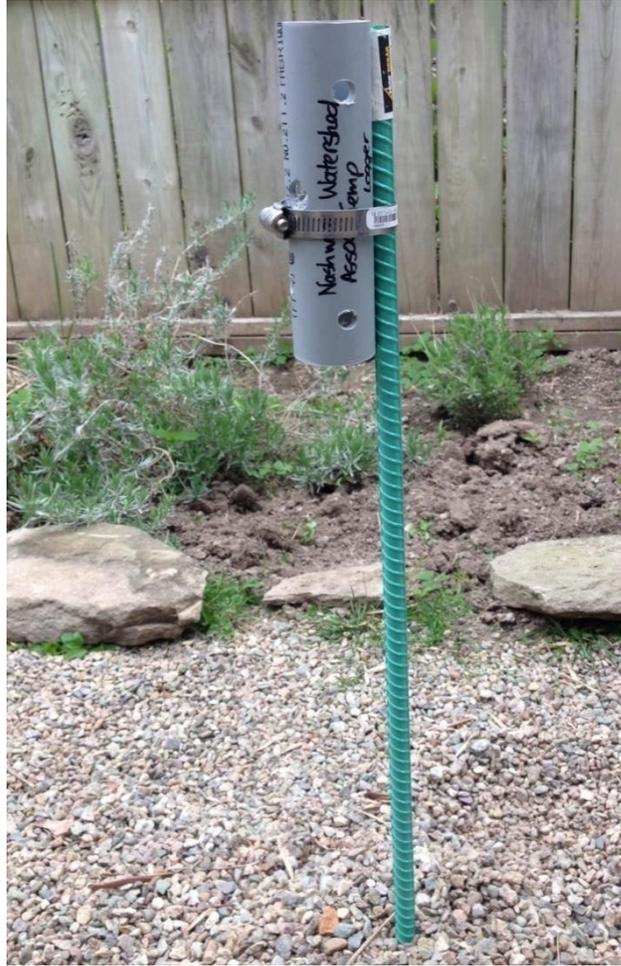
Figure 2. A logger in its casing prior to deployment. Zip ties were added for extra security.

HOBOWare software was used to set up and launch the loggers. A delayed start was chosen so that the loggers did not record the temperature of the office or vehicle before they were deployed. The loggers were set to record water temperature every six hours (00:00, 4:00, 12:00, and 16:00). The AEI loggers logged every hour. Casings were made to protect the loggers from UV radiation, current, and debris. The casings were made from grey PVC pipe cut to 15 cm lengths drilled with 5 mm diameter holes. The PVC was attached to a 60 cm piece of coated rebar with a hose clamp and two zip ties. After launching, the logger was inserted into the PVC pipe and secured with a length of high tensile picture wire and a zip tie. An additional zip tie was secured through the top of the pipe to prevent the logger from floating to the surface (Fig. 2). The design was similar to that used by students at the Canadian Rivers Institute (CRI) and by NWA staff at previous jobs.
