2023

Report on the Health of the Nashwaak Watershed

Nashwaak Watershed Association

3/20/2024

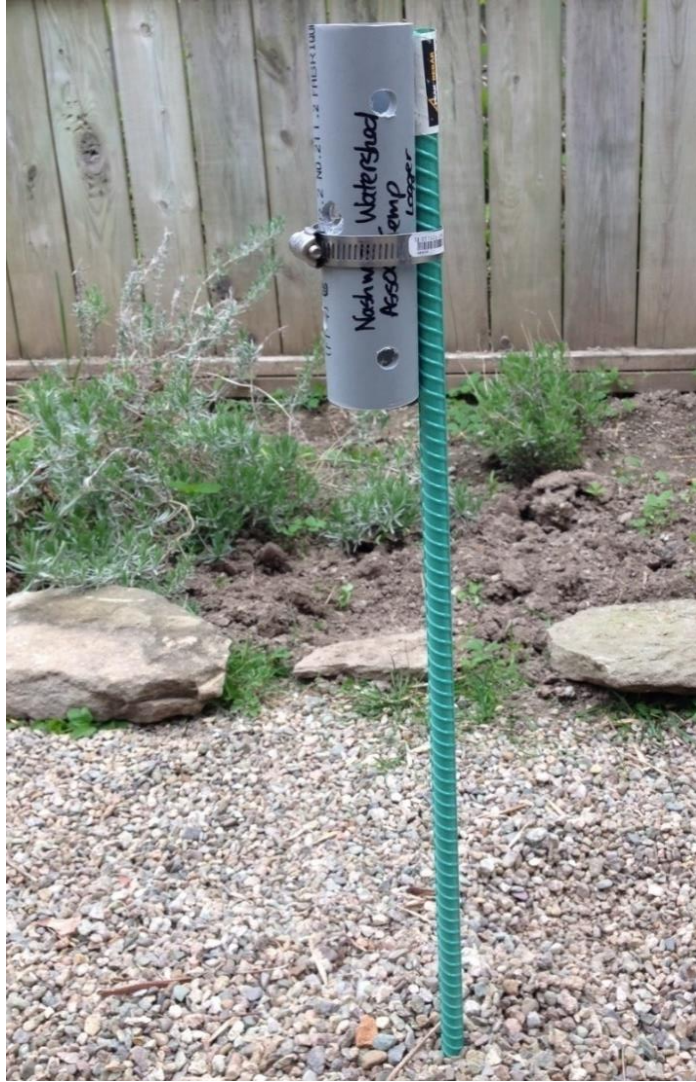
Figure 2. A logger in its casing prior to deployment. Zip ties were added for extra security.

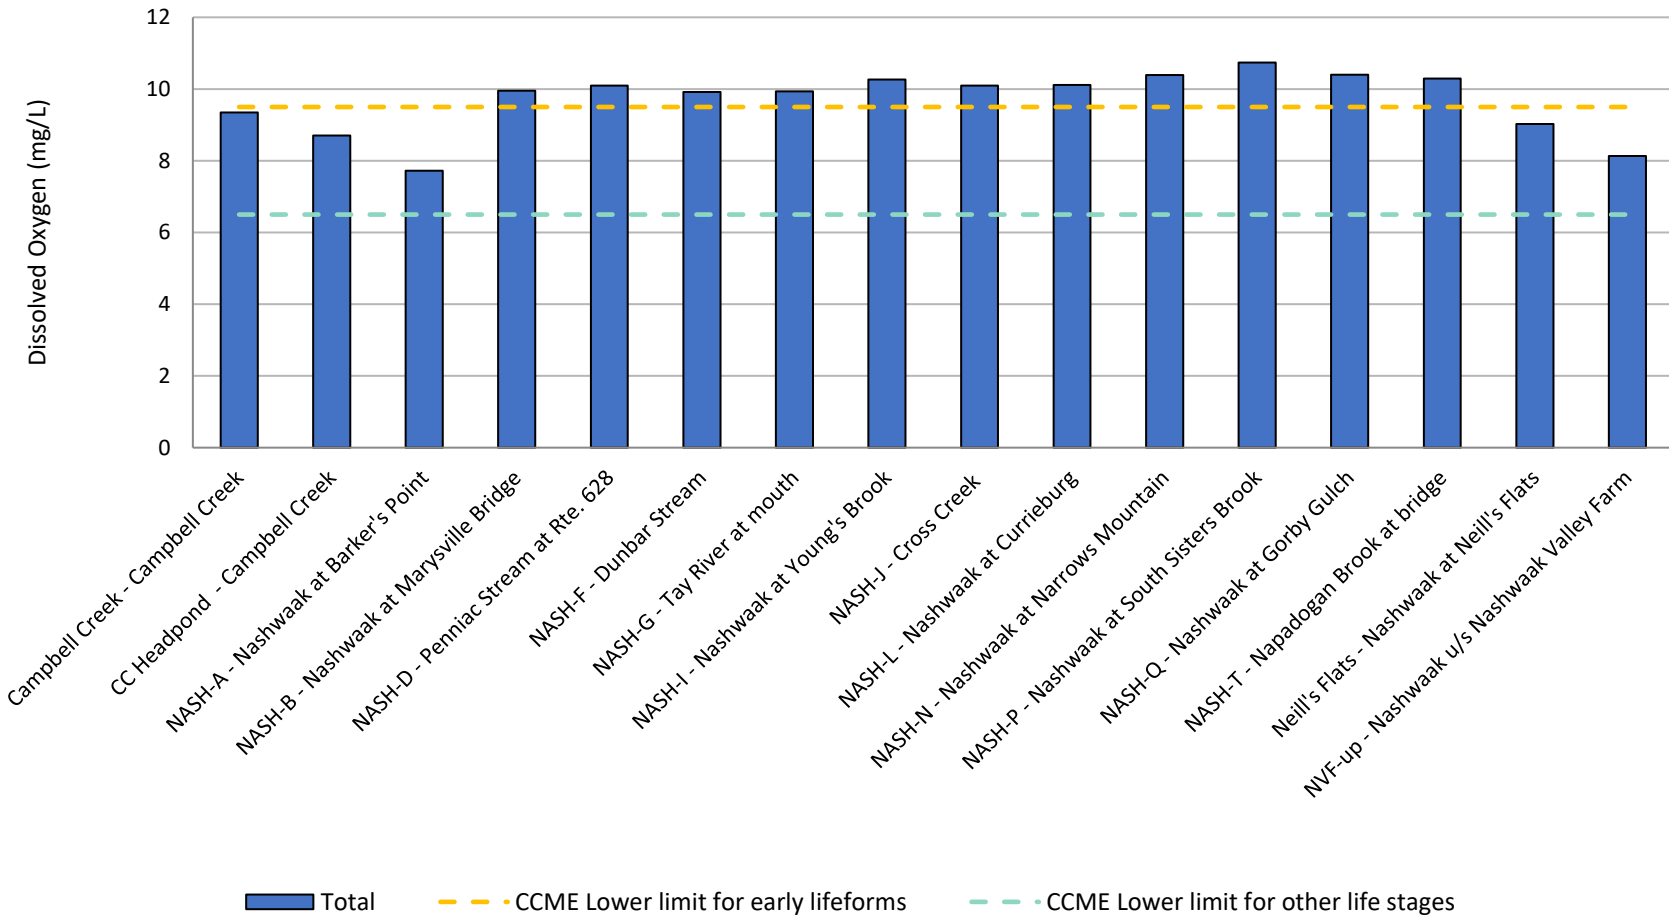
Figure 14. Average Dissolved Oxygen (mg/L) for sampling conducted between May-October 2023 in the Nashwaak watershed, NB, Canada. Orange line represents the CCME recommendation on the lowest DO concentration for early aquatic lifeforms. Green line represents the CCME recommendations for the lowest DO concentration for all other life stages of aquatic lifeforms.

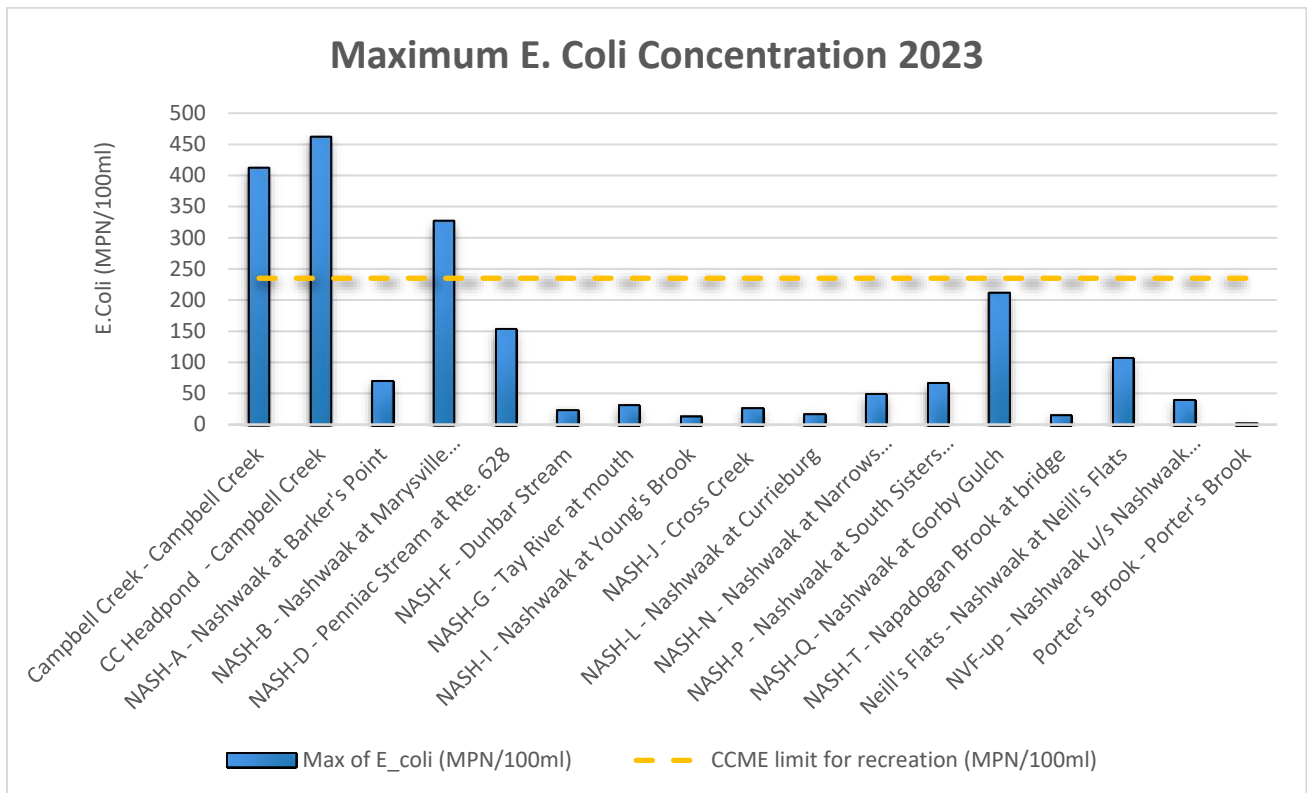
Figure 20. Maximum *E.coli* concentrations across all sampling sites in 2023 for the Nashwaak Watershed, NB, Canada. Orange dotted line indicates CCME safe limits for recreational use.

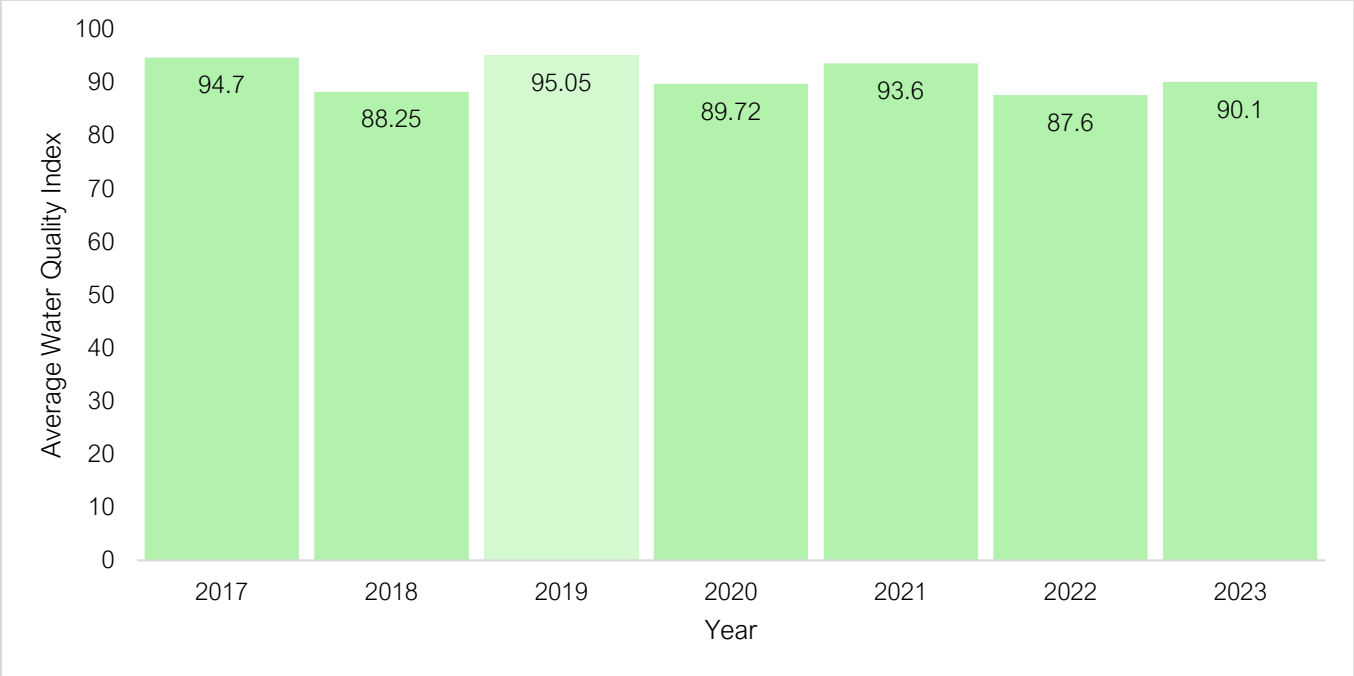
Figure 33 compares the 2023 average WQI for the entire watershed to those measured from 2017 to 2022. Overall, the WQI for the watershed has remained relatively constant over the last seven years. Notable, 2019 had the “healthiest” water quality rating in the last 7 years.

Figure 33. Average WQIs between 2017-2023 in the Nashwaak Watershed, NB Canada . Light green = excellent (95-100), darker green = very good (80-94).
