The Atlantic Salmon Conservation Foundation

Final Report

ORGANIZATION: NASHWAAK WATERSHED ASSOCIATION INC			
Project Title: Assessing and Restoring Aquatic Connectivity in the Central Nashwaak Watershed			
Year Grant Acquired:	2021	End date:	November 30 th , 2021
Contact Person: Marieka Chaplin, Executive Director & Natalie Deseta, Project Coordinator			
Address: PO Box 314, Station "A", Fredericton, NB E3B 4Y2			
Phone: 506 261- 4664		Fax:	
Email: director@nashwaakwatershed.ca and coordinator@nashwaakwatershed.ca

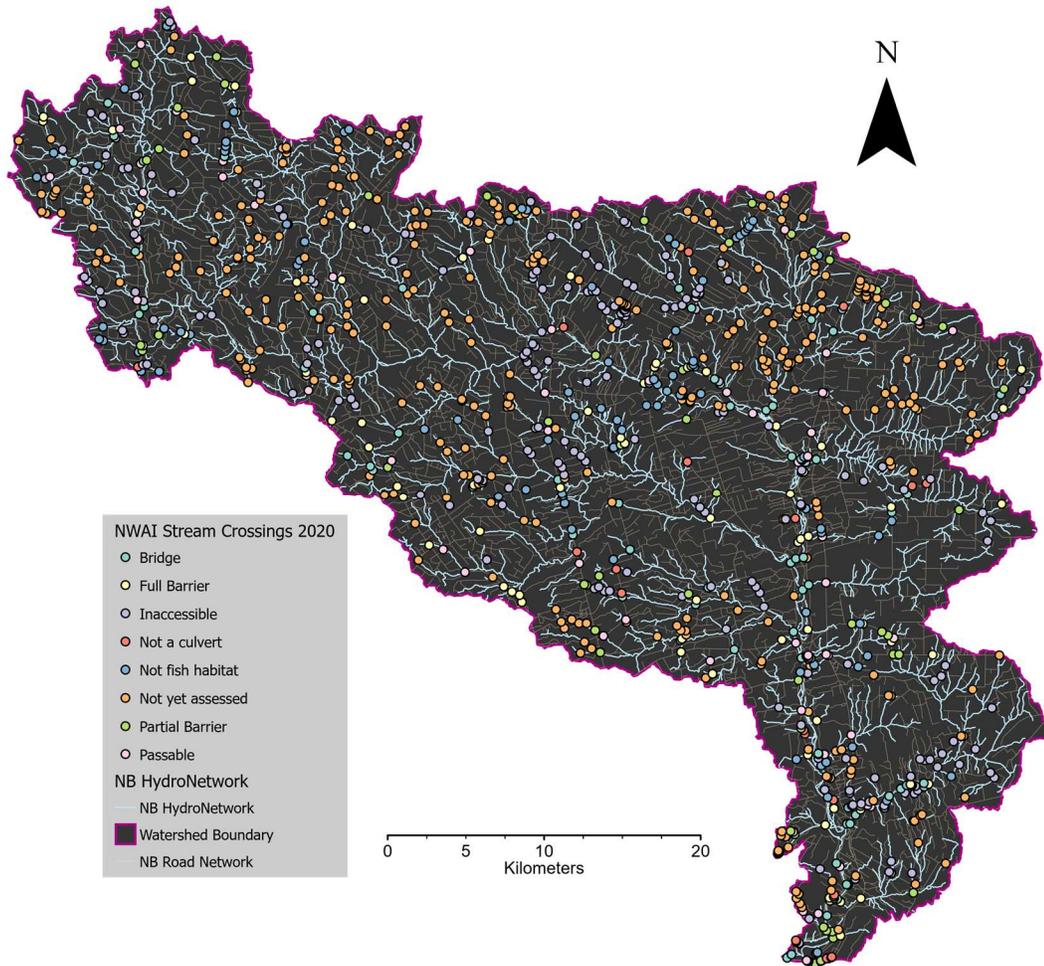
Fig. 1 2021 map of stream crossings in the Nashwaak watershed, with barriers symbolized by passability for fish.

Our 2021 survey information was entered into a central GIS database and use to generate an updated map of all the stream crossings in the watershed. These data will be shared with our partners at the end of the year. So far, we have visited 435 of the 985 crossings in the watershed (~44% complete) and we have done a full survey on 224 culverts. We have surveyed almost all accessible the crossings on public paved roads and logging or forest roads.

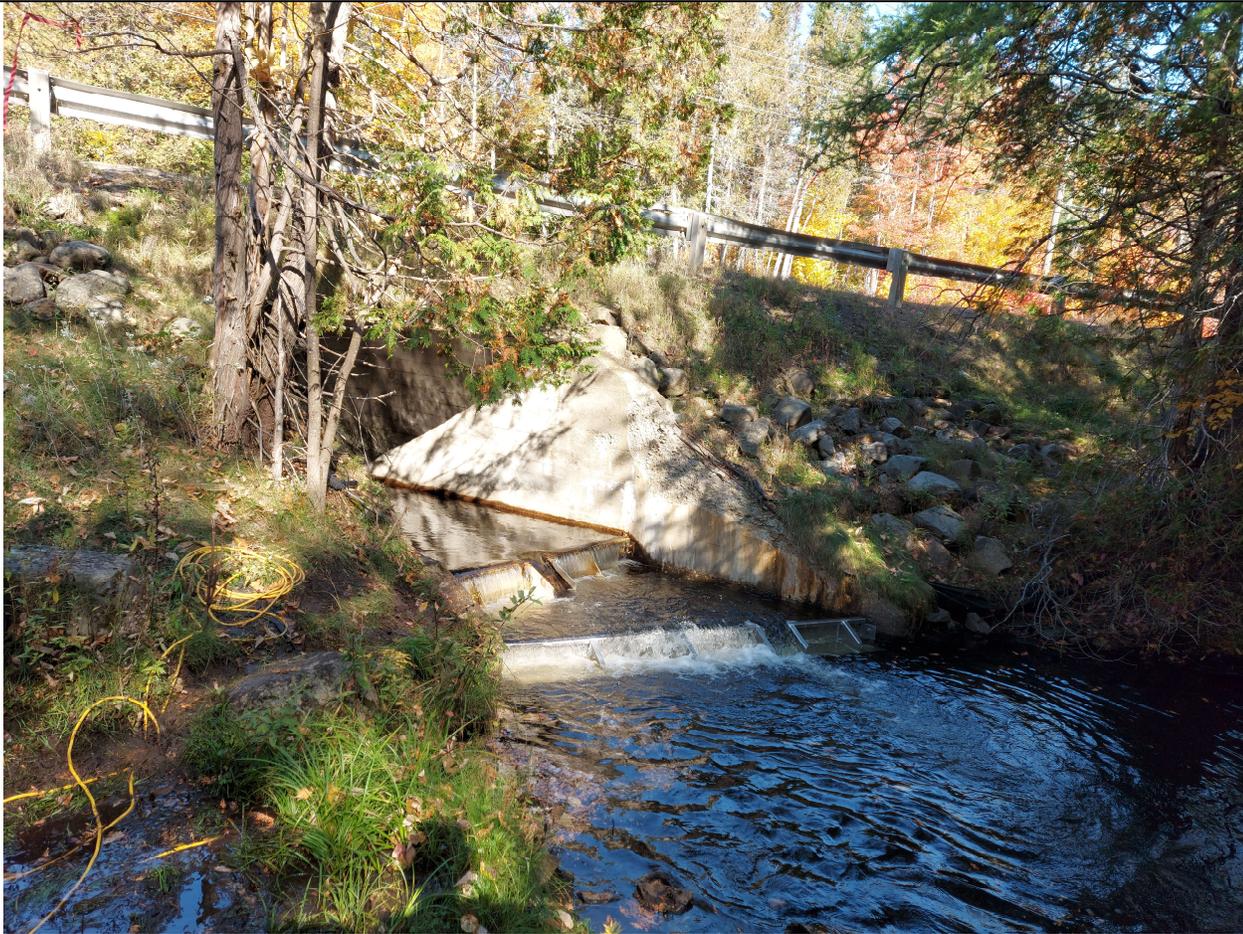
Throughout the summer season we conducted monthly monitoring of our previous 4 culvert projects to ensure they remained free of debris and were functioning as planned. It was noted that for one of our previous projects (culvert on Limekiln Brook), the drop at the outlet was higher (40 cm) than ideal to permit fish passage. To address the drop at the outlet we partnered with HILCON Ltd. to design an additional weir, that was built by TEK Steel and installed in fall.

Figure 2. Limekiln Brook, additional weir installation at the mouth of the culvert was carried out to ensure the outlet drop was low enough to facilitate fish passage.

The summer of 2021 incurred unusually high rainfall throughout the season, resulting in unusually high water levels, which hampered our culvert surveying as well as our efforts to install an additional weir at our Limekiln Brook project site by the end of September. That said, we managed to extend our WAWA permit into October and successfully installed the weir (Figure 2). The high rainfall also delayed our electrofishing effects, and high flow discharge likely resulted in lower recorded fish abundances than in 2020.

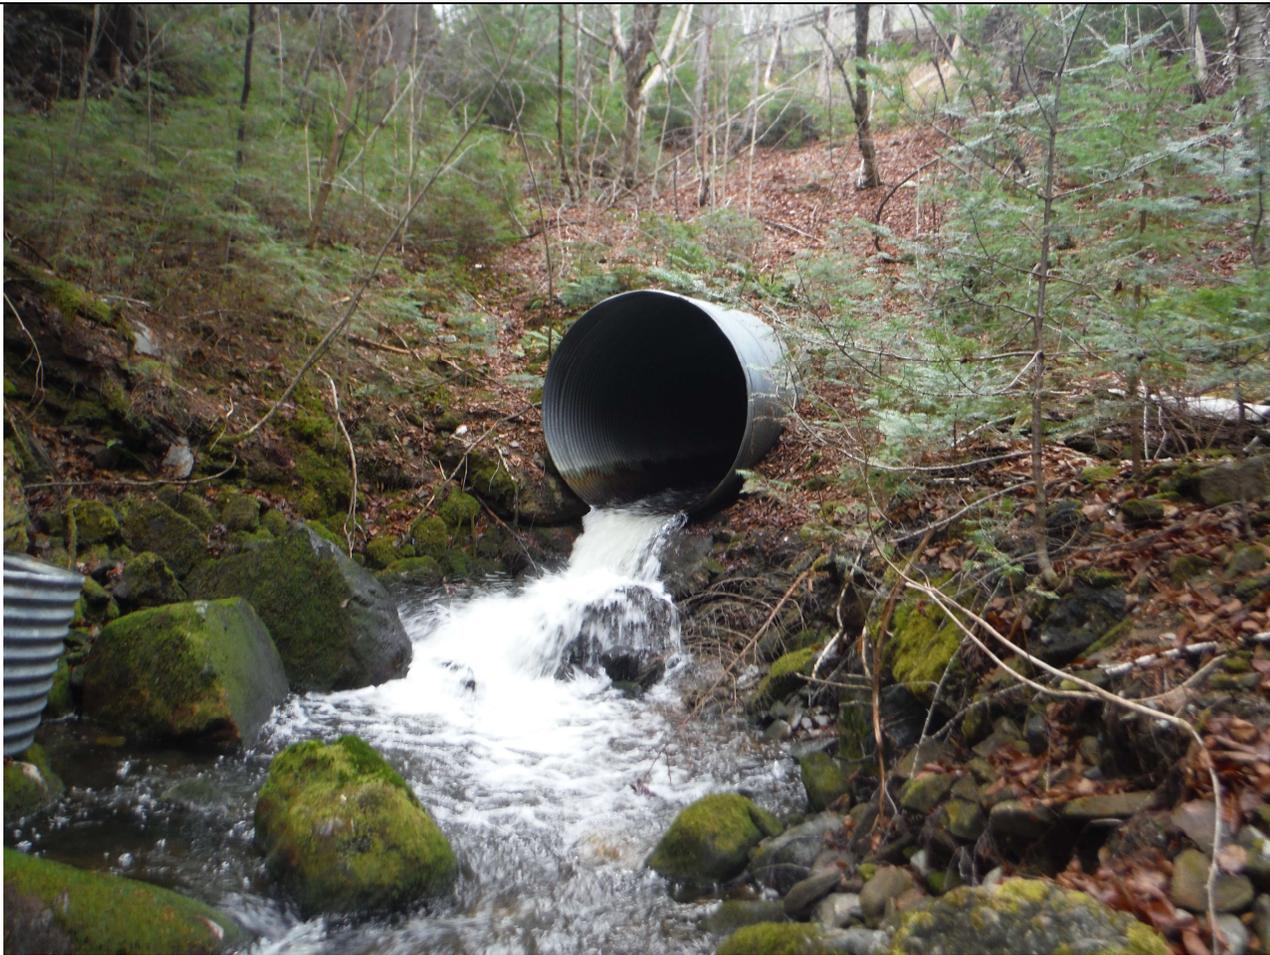
Figure. 3 Porter's Brook Culvert – proposed 2022 removal and stream restoration project. In 2021 we conducted baleline monitoring of the site, and developed a management plan for the culvert removal. This culvert is located on Nashwaak West road and is a severe barrier to fish. The pool at the mouth of this brook is an important salmon holding pool that DFO closes annually in June. Nashwaak West Road has been closed for many years and will not reopen. If this culvert blows out in a storm, the brook, the pool at the mouth of the brook, and downstream habitat in the Nashwaak River will be irreversibly damaged.

As part of our pre-removal work for the Porter’s Brook culvert removal project we carried out baseline monitoring of the site, upstream and downstream of the culvert. This included: flow monitoring, eDNA sampling for presence/absence of Atlantic salmon, American eel and wood turtle, and CABIN macro benthic invertebrate sampling. These data are being compiled into a baseline monitoring report that will be updated annually, as the project progresses.

In addition, we contracted Boreal Environmental to assist us with a fish habitat assessment of the watercourse and development of a management plan for the culvert removal tentatively planned for 2022 (pending funding).

Pending funding in 2022, and permission from DTI, we will remove the Porter's Brook culvert and restore the stream channel and fish passage, as per our management plan for the project.
