# The Atlantic Salmon Conservation Foundation

## Multiyear Project End of Year Report

Organization: Nashwaak Watershed Association Inc.

Project title: Assessing and restoring aquatic connectivity in the central Nashwaak watershed

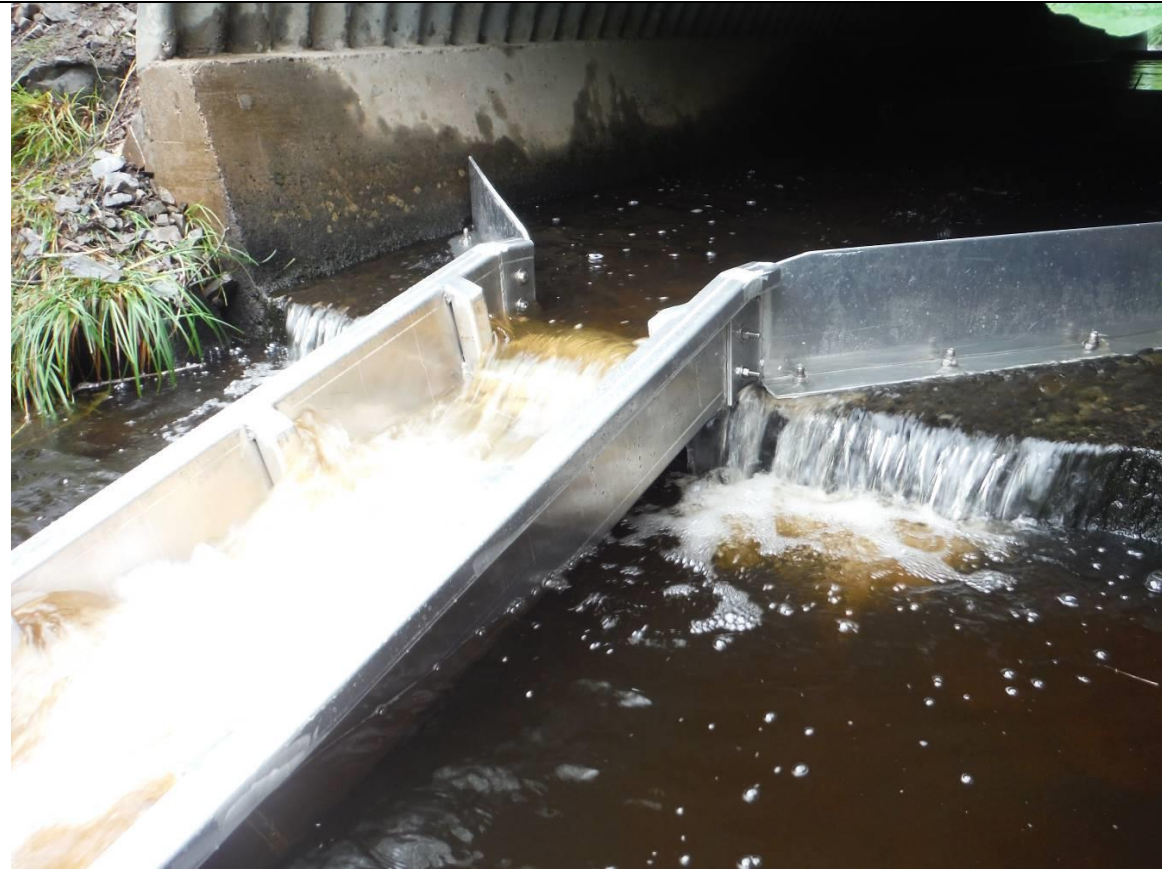
**Figure 2. The Manzer brook fish ladder, installed in August 2018**

We have been regularly checking on the Manzer Brook fish ladder, installed in 2018. It survived the last two winters well and has not been catching debris. Electrofishing in August 2018 prior to the install of the remediation found seven species downstream and five species upstream (a total of 54 fish downstream and 55 fish upstream). Electrofishing in September 2020 found six species downstream and five species upstream (a total of 154 fish downstream and 104 fish upstream). Unfortunately, no new species were found upstream that were not present there before; however, higher numbers of fish were found upstream after the remediation.

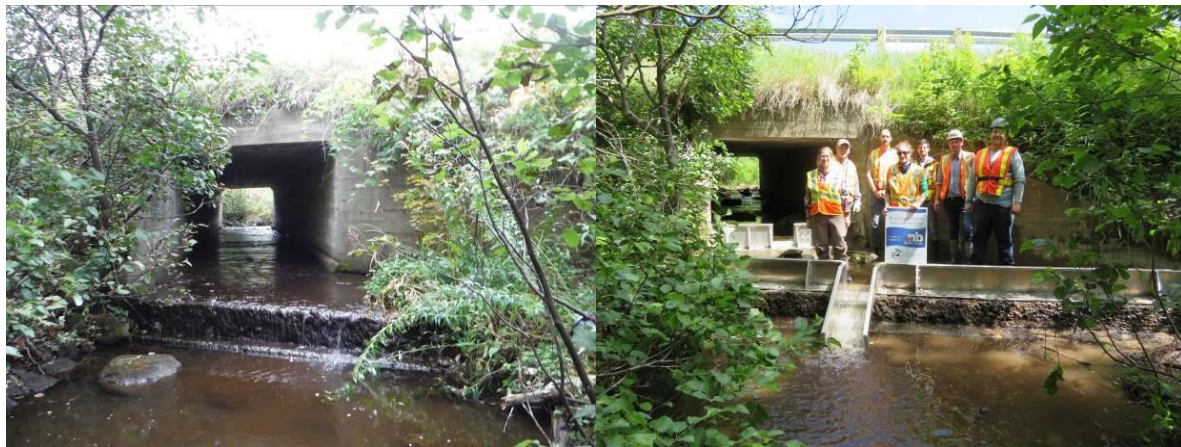
At East Ryan Brook, a cast in place 2,750 x 1,800 mm concrete box installed in the 1950s on Rte 107 was too steep (2.3% over 20 m) and had a 30 cm step at the outlet, preventing fish passage through the pipe. Water in the pipe was very shallow due to its wide, flat bottom. Electrofishing in 2019 showed that there were many brook trout using this cold water stream along with a single American eel.

**Figure 3. Before (left) and after (right) of the East Ryan Brook fish passage project**

The remediation took place in two phases: First, a baffle was placed at the end of the enclosed pipe and another just before the drop (Fig 3). Baffle height was 350 mm and notch width and depth were 200 mm and 150 mm, respectively for both. These allowed the water in the pipe to backflood and velocity to decrease. A short chute was installed over the drop at the end of the structure. The chute contained roughness bars to prevent sheet flow. The second baffle was fitted with a small slide to allow fish to

This project opened 1.8 km<sup>2</sup> of habitat and 800 m of stream length above it. Electrofishing results pre- and post-remediation showed similar numbers of the same species (mainly brook trout and a few American eel). We hope that electrofishing in 2021 during higher water conditions will yield higher numbers upstream and perhaps the presence of other species. A temperature logger installed over the summer of 2020 gave an average temperature between 21 June and 21 Septemeber of only 13.33°C and a peak temperature of 18.7°C, indicating that this brook is an excellent thermal refuge for salmonids in the summer.

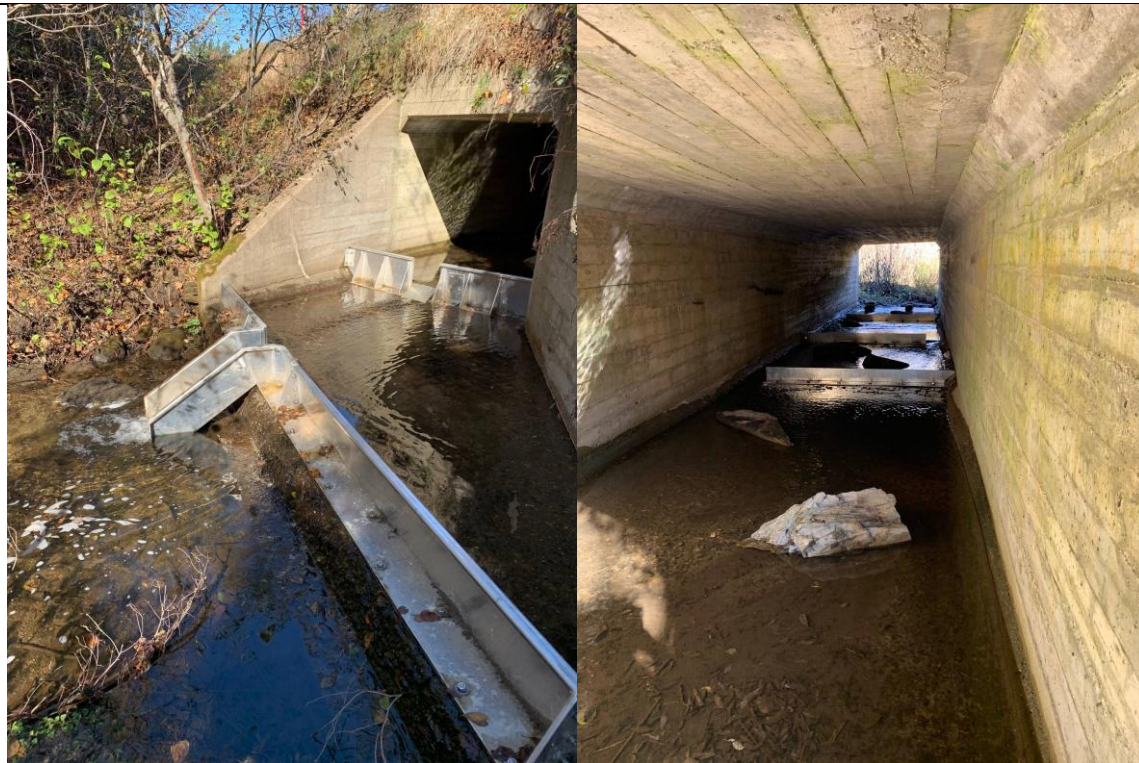
**Figure 4.** Details of the East Ryan Brook fish passage project showing the chute and first two baffles (left) and the upper three partial baffles (right) as well as the large rocks placed to provide microhabitat in the pipe.

swim up and over. The second phase, installed a few weeks later, involved three shorter baffles that extended 4/5ths of the way across the pipe (Fig 4). We alternated what side of the baffle was open to create a sinous channel through the pipe. These helped backflood the remainder of the pipe. Large rocks were placed throughout the pipe to create microhabitat. Water will eddy behind the rocks and they will provide protection for small fish.

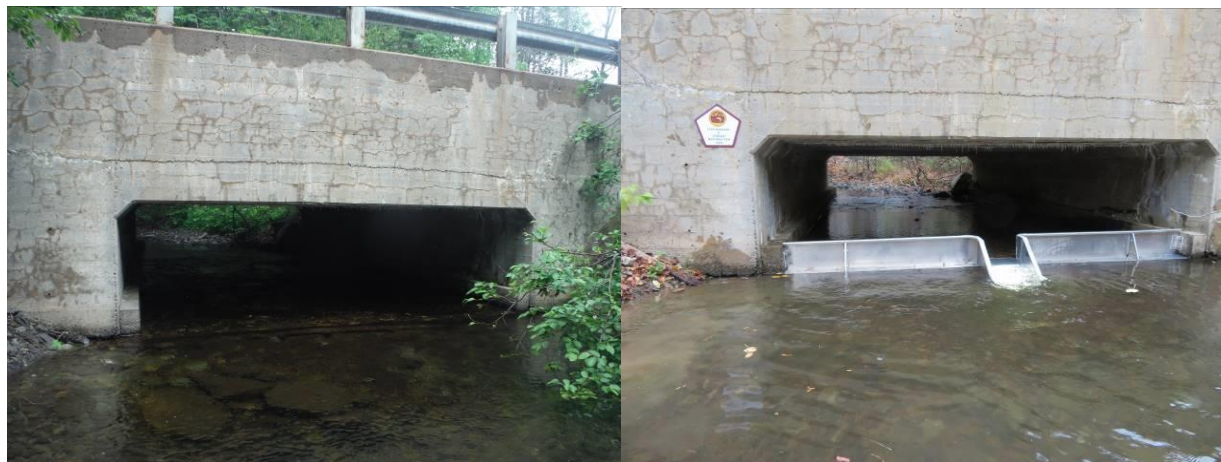
The McGivney Brook pipe is a cast in place concrete box (4,580 x 1,260 mm) on route 625. The remediation work at this site was completed in October 2020. This culvert was slightly too steep (0.9% over 9.8 m) to allow for fish passage. Its wide, flat bottom meant that there were only a few millimetres of water depth during low flow. Pre-remediation electrofishing found three species downstream and four species upstream (American eel was found upstream but not downstream). Similar numbers of

Figure 5. Before and after of the McGivney Brook fish passage project

Remediation work involved the installation of one aluminum baffle and chute at the outlet of the pipe. The baffle was 300 mm high with a notch width and depth of 400 mm and 300 mm, respectively. The chute was 400 mm wide and 615 mm long. The baffle allows water to backflow in the culvert, becoming deeper and slower (and easier for fish to swim in). The chute allows fish to swim into the culvert during low flow and it was fitted with roughness bars to prevent sheet flow. This project opened 10.2 km<sup>2</sup> of habitat and 8,913 m of stream length above it.

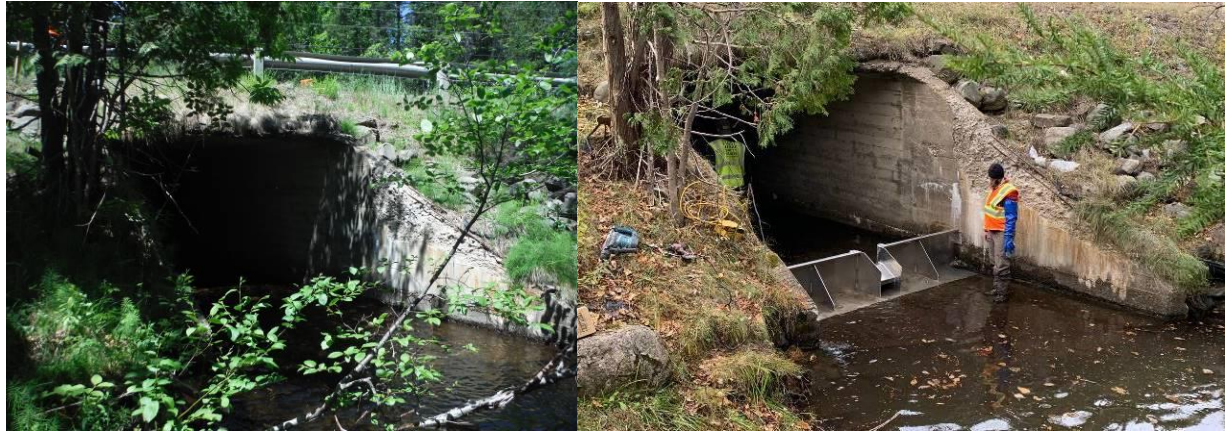
The Limekiln Brook pipe is a cast in place concrete box (3,000 x 2,400 mm) on route 620. The remediation work at this site was completed in October 2020. This culvert was too steep (2.11% over 28 m) to allow for fish passage. Its wide, flat bottom meant that there were only a few millimetres of water depth during low flow. Pre-remediation electrofishing found 4 species downstream and 2 species upstream. American eel and black nose dace were not found above the pipe. A total of 14 fish were found downstream versus 6 fish upstream. Post-remediation electrofishing will be completed in 2021. A temperature logger installed over the summer of 2020 gave an average temperature between 21 June

**Figure 6. Before (left) and after (right, below) of the Limekiln Brook fish passage project**

The remediation involved the installation of 4 fish weirs spaced 7 m apart throughout the pipe. The baffles were 500 mm high with a notch width and depth of 300 mm and 200 mm, respectively. This project opened 7.25 km<sup>2</sup> of habitat and 10,732 m of stream length above it.

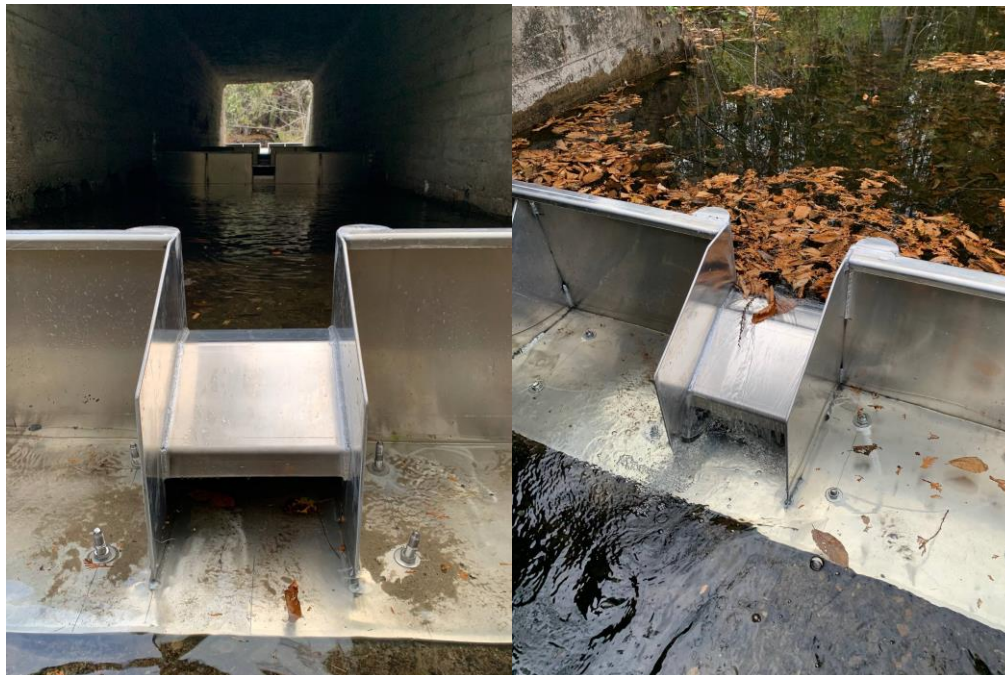
**Figure 7. A close up shot showing the weirs installed for the Limekiln Brook fish passage project. The weirs were not fully installed at this point so water was just starting to flow over the chute.**

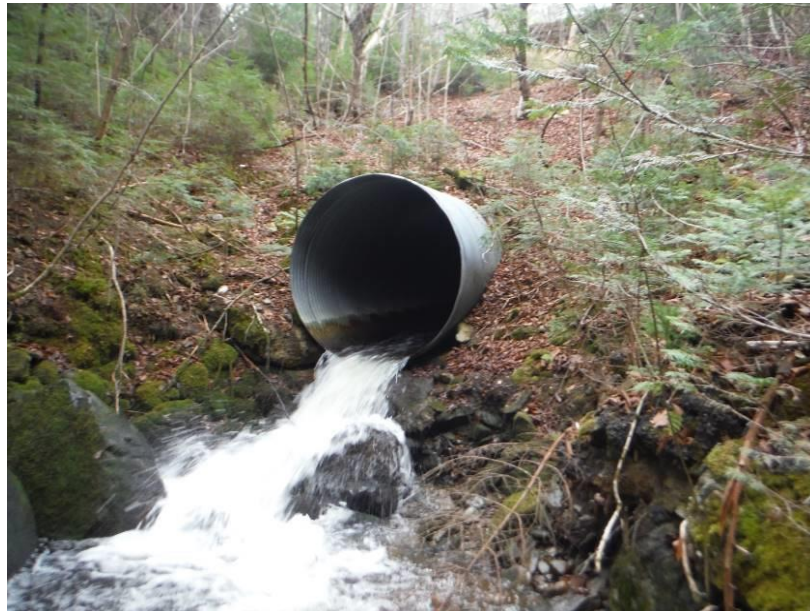
**Figure 8.** The Porter's Brook culvert on Nashwaak West road is a severe barrier to fish. The pool at the mouth of this brook is an important salmon holding pool that DFO closes annually on June 15. Nashwaak West Road has been closed for many years and will not reopen. If this culvert blows out in a storm, the brook, the pool at the mouth of the brook, and downstream habitat in the Nashwaak River will be irreversibly damaged.

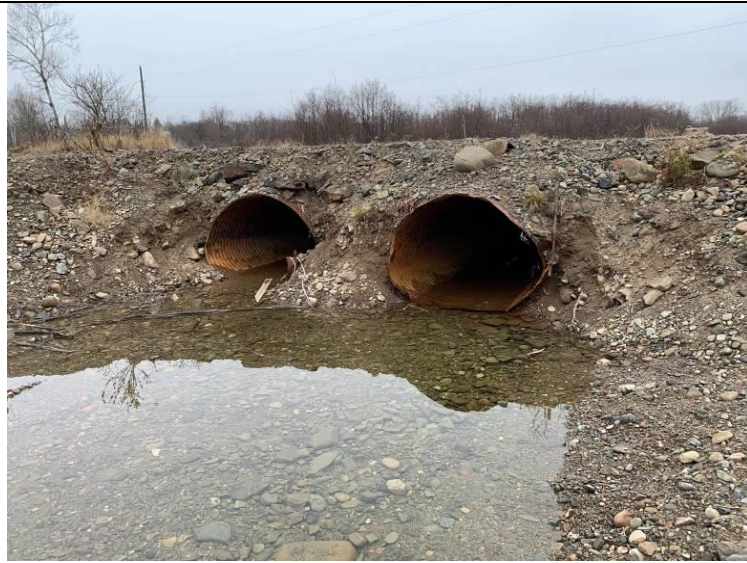
**Figure 9.** This pipe on McLean Flats Roads is in very poor shape and fills with gravels annually during the freshet. These pipes need to be replaced. Local residents described many fish including Atlantic salmon using this stream in previous years.

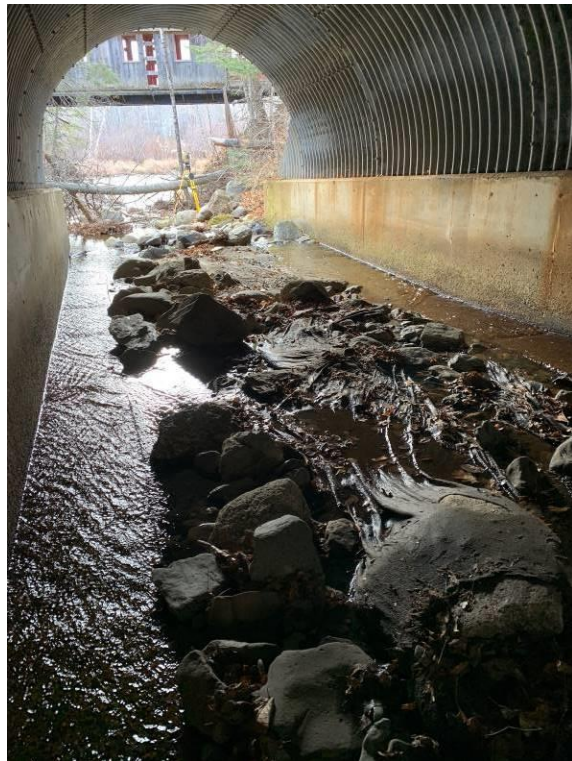
**Figure 10.** This pipe on Sands Brook on Giant's Glen road has experienced major deterioration of the substrate in the last few years. Though it has open bottom it appears as though this culvert is no longer passable to fish. Black sediment control fabric is shown exposed in the photo above.
