2021-2022

Report on the health of the Nashwaak Watershed

Nashwaak Watershed Association

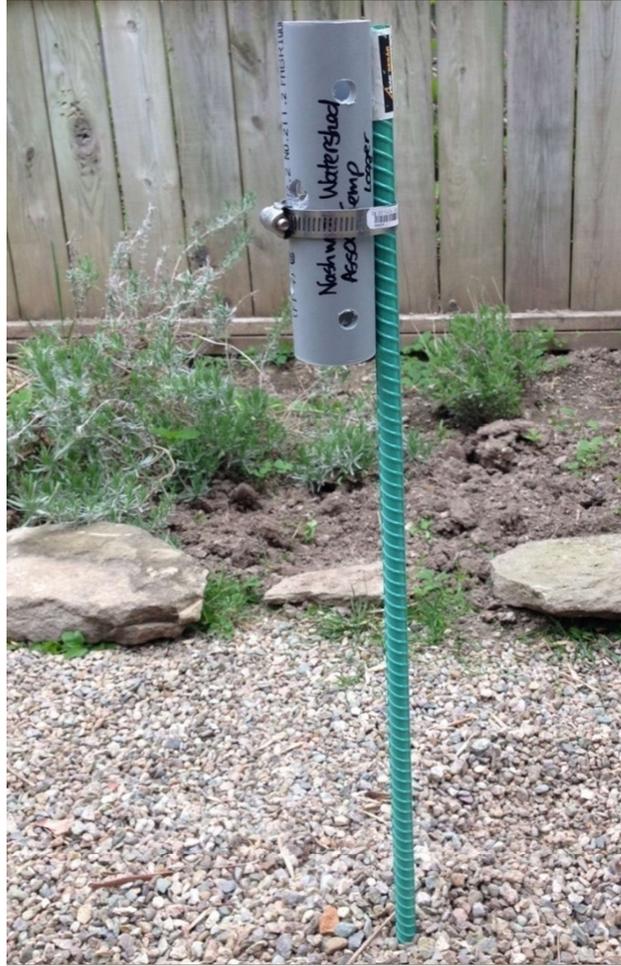
Figure 2. A logger in its casing prior to deployment. Zip ties were added for extra security.

HOBOWare software was used to set up and launch the loggers. A delayed start was chosen so that the loggers did not record the temperature of the office or vehicle before they were deployed. The loggers were set to record water temperature every six hours (12 am, 4 am, 12 pm, and 4 pm). The AEI loggers logged every hour. Casings were made to protect the loggers from UV radiation, current, and debris. The casings were made from grey PVC pipe cut to 15 cm lengths drilled with 5 mm diameter holes. The PVC was attached to a 60 cm piece of coated rebar with a hose clamp and two zip ties. After launching, the logger was inserted into the PVC pipe and secured with a length of high tensile picture wire and a zip tie. An additional zip tie was secured through the top of the pipe to prevent the logger from floating to the surface (Fig. 2). The design was similar to that used by students at the Canadian Rivers Institute (CRI) and by NWA staff at previous jobs.

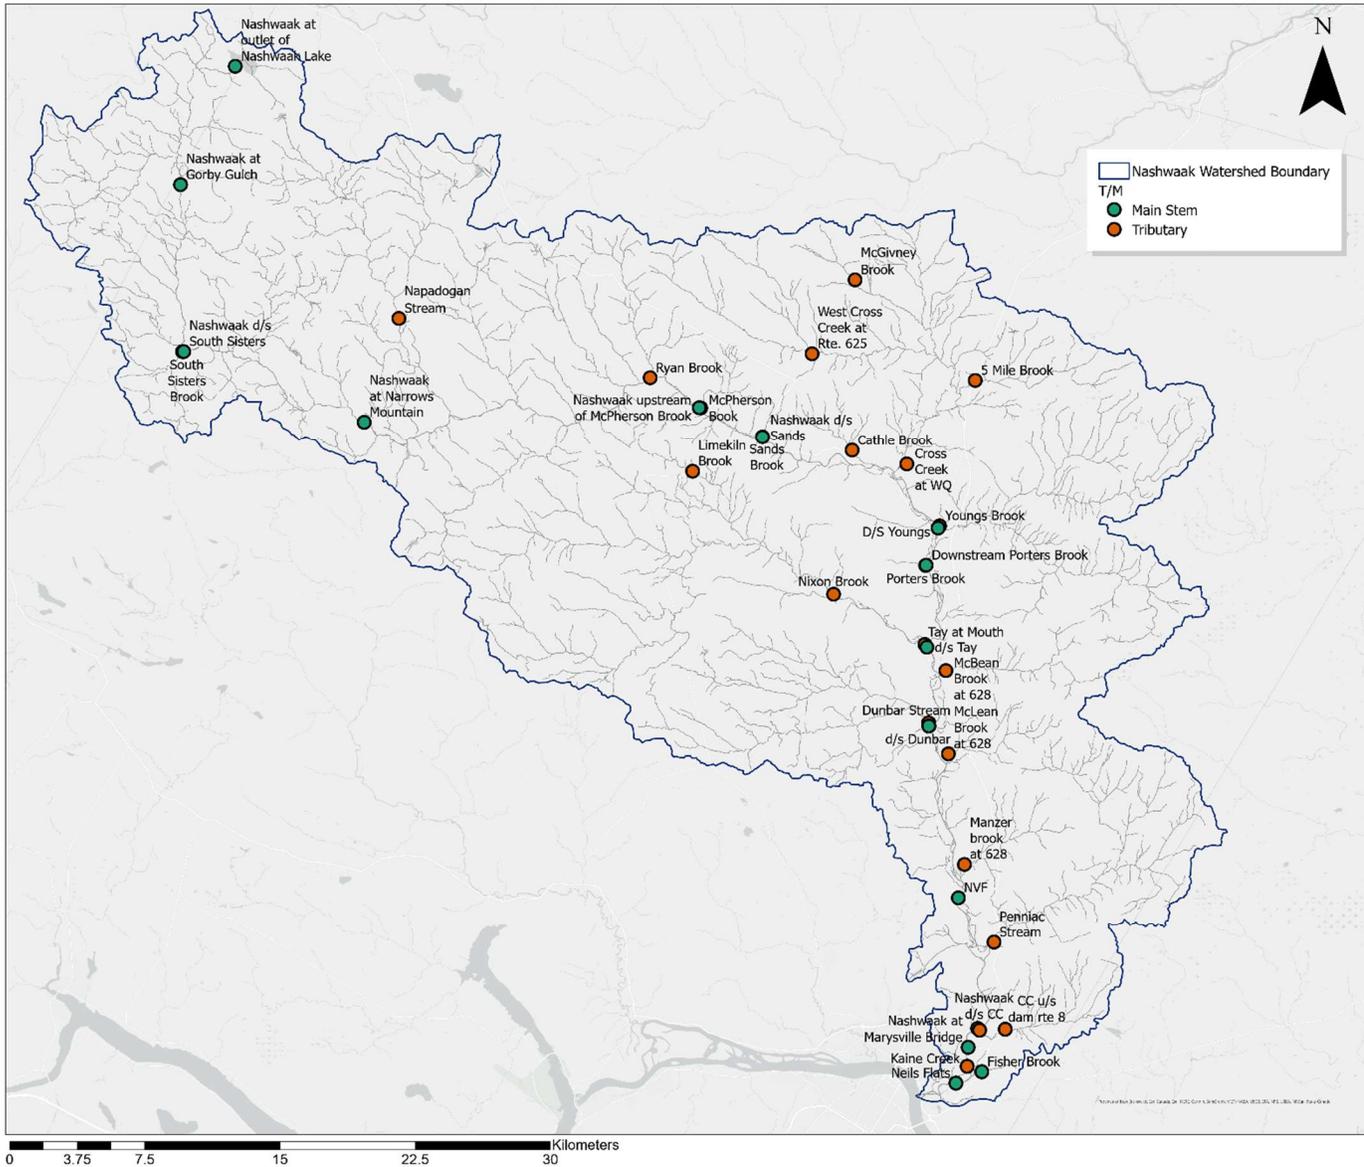
Figure 3. A map of the location of the 39 loggers installed in 2021. Pink denotes the loggers placed in the main stem of the river and green denotes the loggers placed in the tributaries.

The loggers were deployed throughout the watershed between 4th and 10th of June (Fig. 3). We placed 25 loggers in tributaries and 14 in the main stem. We chose locations where water was at least knee deep and there was appropriate substrate. Sand, gravel, and cobble substrates were the easiest; silty substrate and bedrock provided challenges. The rebar was hammered into the substrate at least 1 foot so that the bottom of the PVC casing sat flush with the substrate. The pendant logger was pushed down inside the casing to ensure that it was in the deepest water possible. Rocks were piled in a cairn around the logger to prevent it from moving too much and to help us in locating it. A waypoint was taken at each logger location.

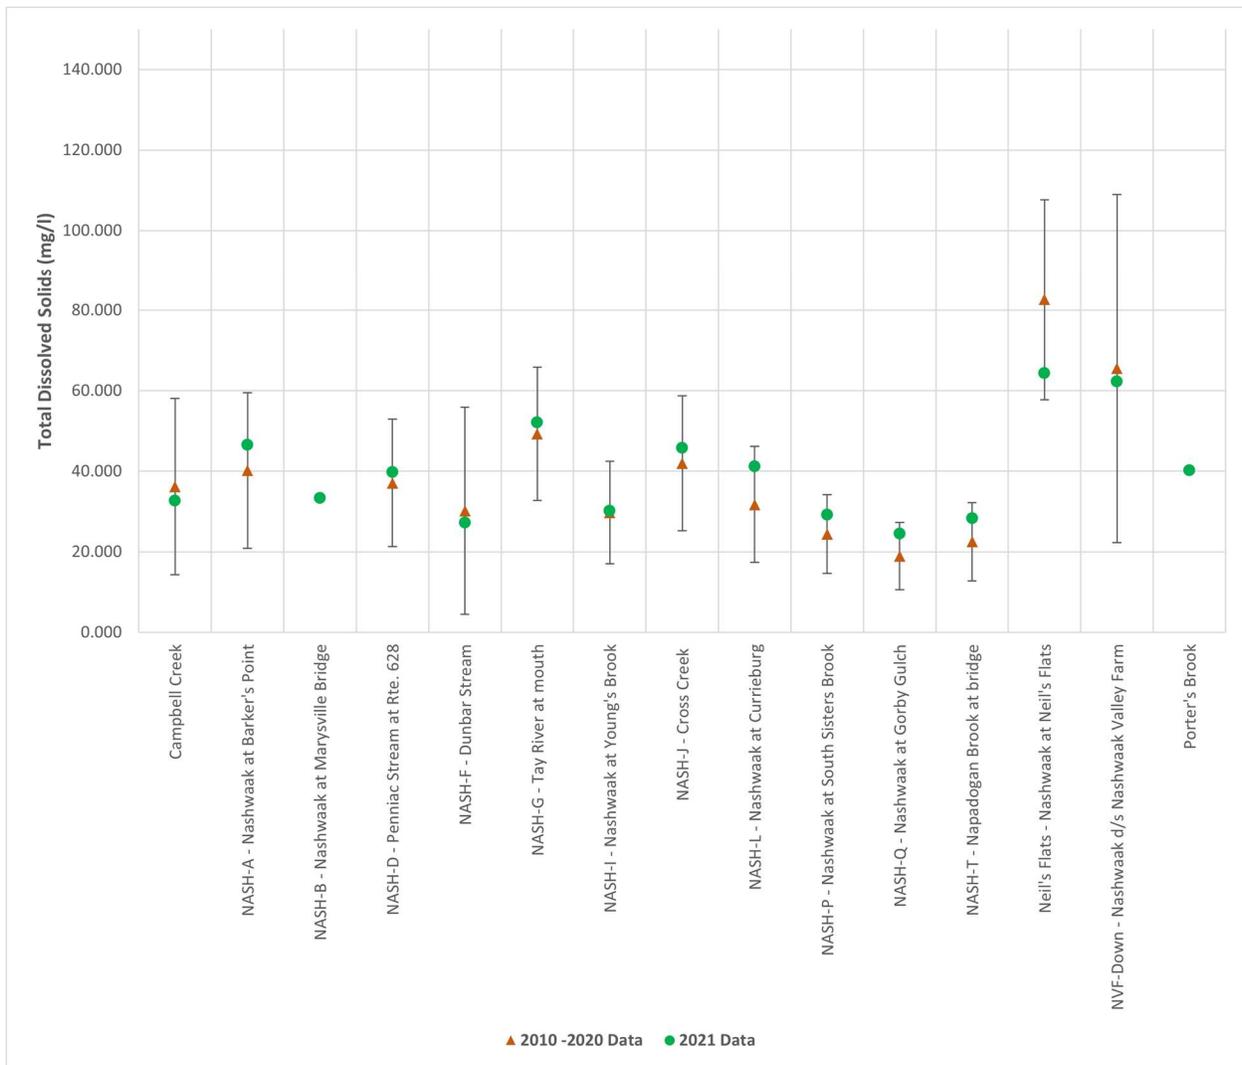
Figure 4 Mean total dissolved solid contents (mg/L) per site for the Nashwaak watershed. Error bars represent standard deviation.

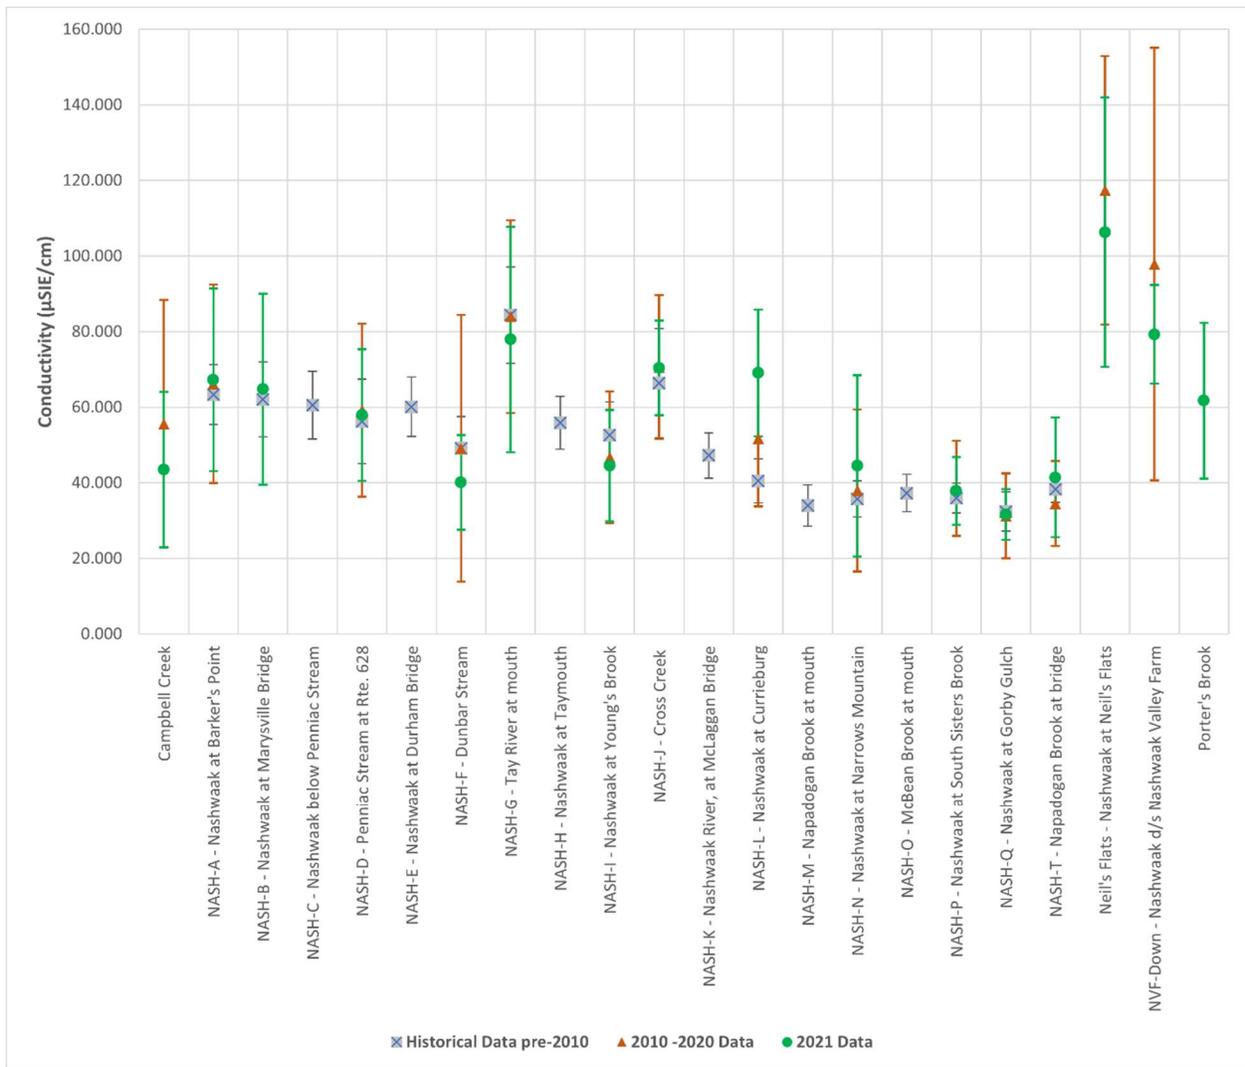
Figure 5. Conductivity measured in $\mu\text{SIE}/\text{cm}$ per site across the Nashwaak watershed. Error bars represent standard deviation.

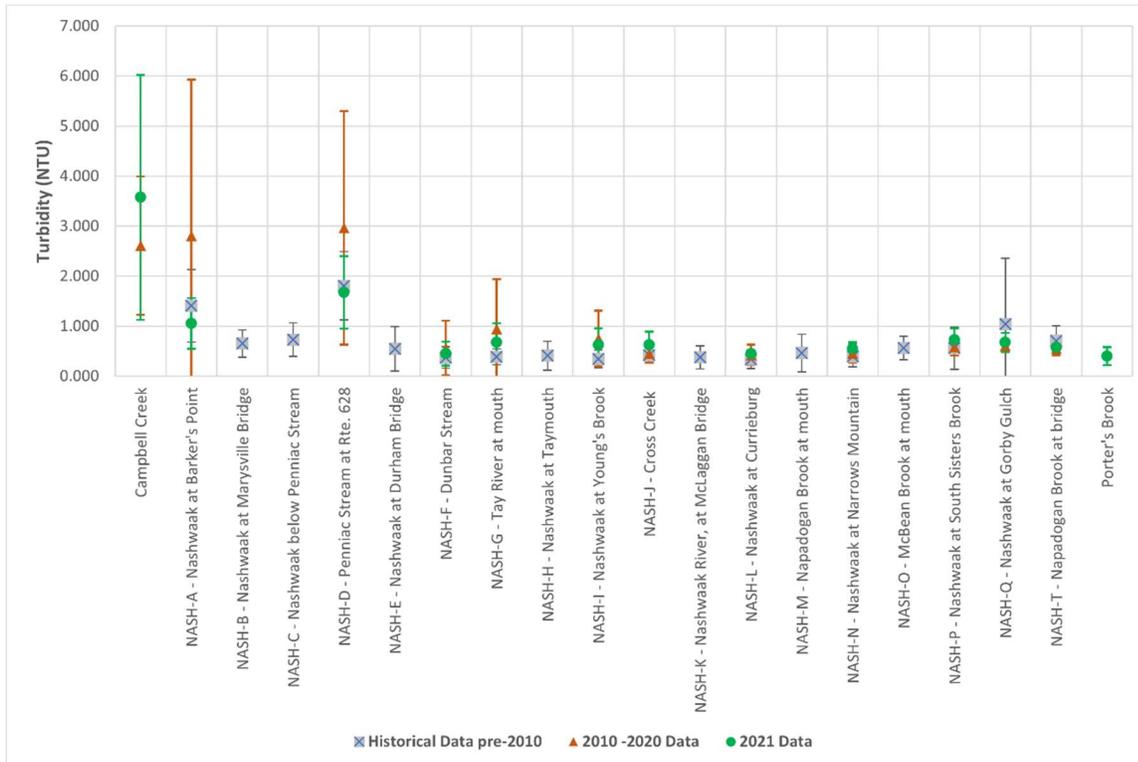
Figure 6 Turbidity (NTU) per site in the watershed. Error bars represent standard deviation.

Values in 2021 were, in general, very low for all sites (median values of 0.4 to 3.6 NTU) (Fig. 6). Values were highest in the lower watershed, decreasing towards the headwaters. 2020 values were, on average, slightly lower than 2010-2019 values in the lower watershed and very similar to historic values in the rest of the watershed. In 2018, increases in background level were observed near Marysville, Campbell Creek, Barker's Point, and Penniac Stream. These increases mostly coincided with a rainfall event on 28 June. Though nine samples were taken in October 2020 after a rainfall event, turbidity values were not significantly higher from those samples compared to other samples from the same sites taken earlier in 2020. Values were slightly elevated at Campbell Creek this year, the highest of all sites sampled. This was likely due to the dam removal and construction work that took place upstream of the sampling site. Values at this site ranged from 0.9 NTU prior to the onset of construction to 6.6 NTU just after the dam removal was completed in September.

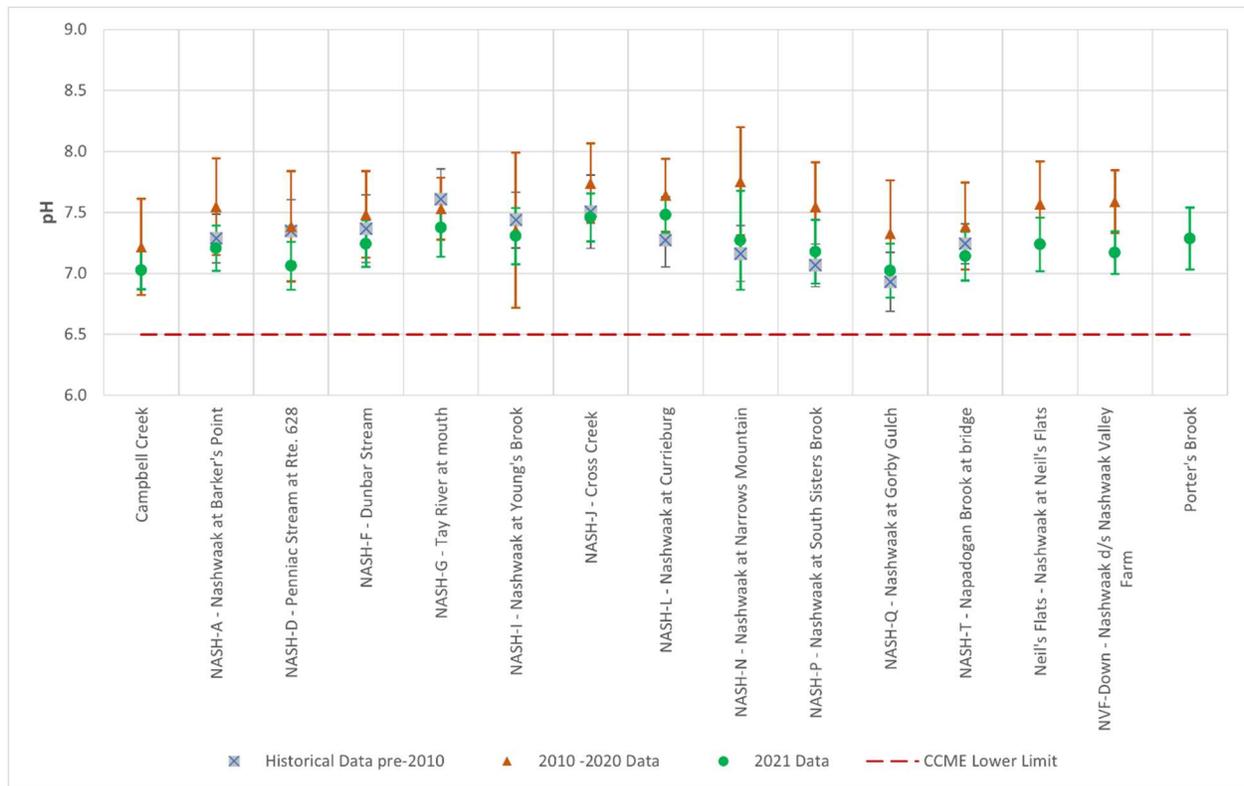
Figure 7. pH (values measured in the field) per site in the watershed (for those sites where data were available). Errors bars represent standard deviation. Historic field measurements were not available for most sites.

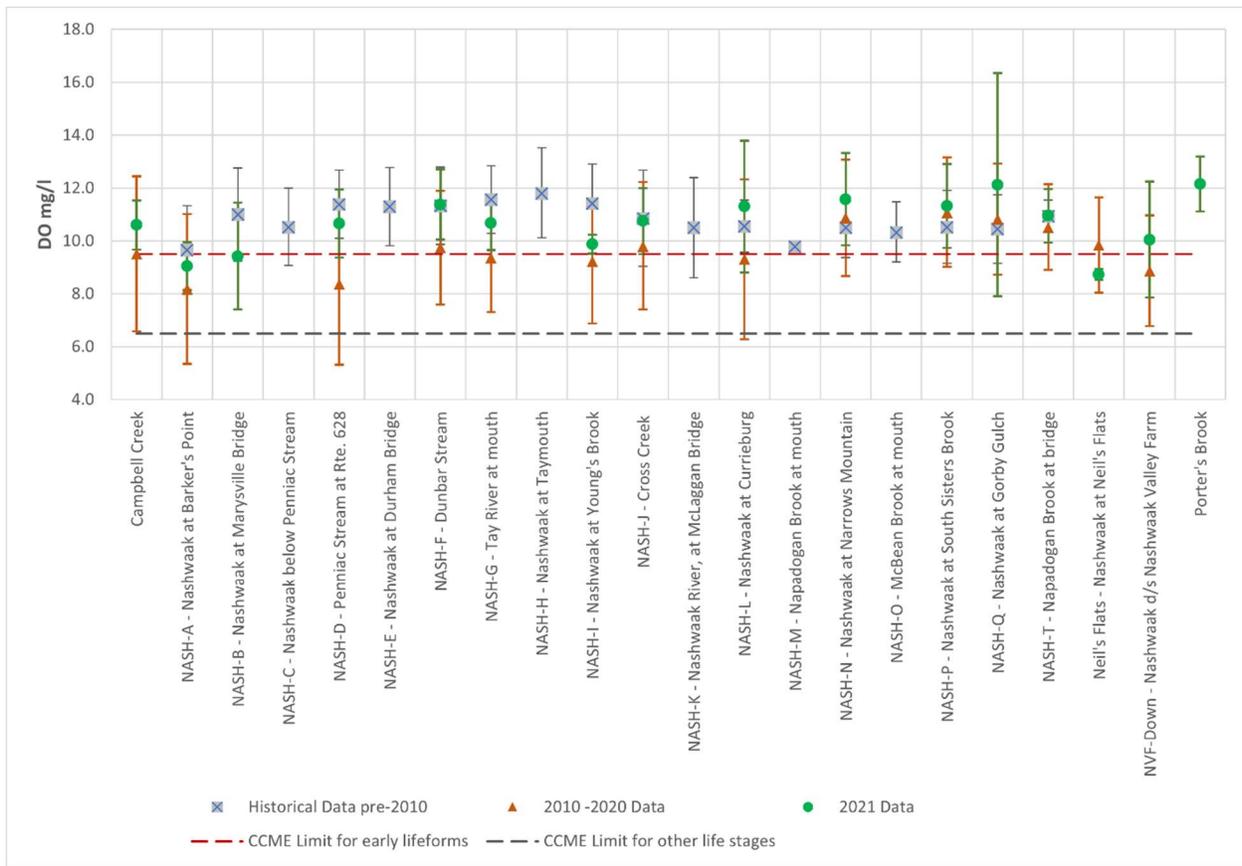
Figure 8 Mean dissolved oxygen content (mg/L) per site. Error bars represent standard deviation. Dashed lines indicate CCME limits for early life forms (9.5 mg/L) and all other life stages (6.5 mg/L).

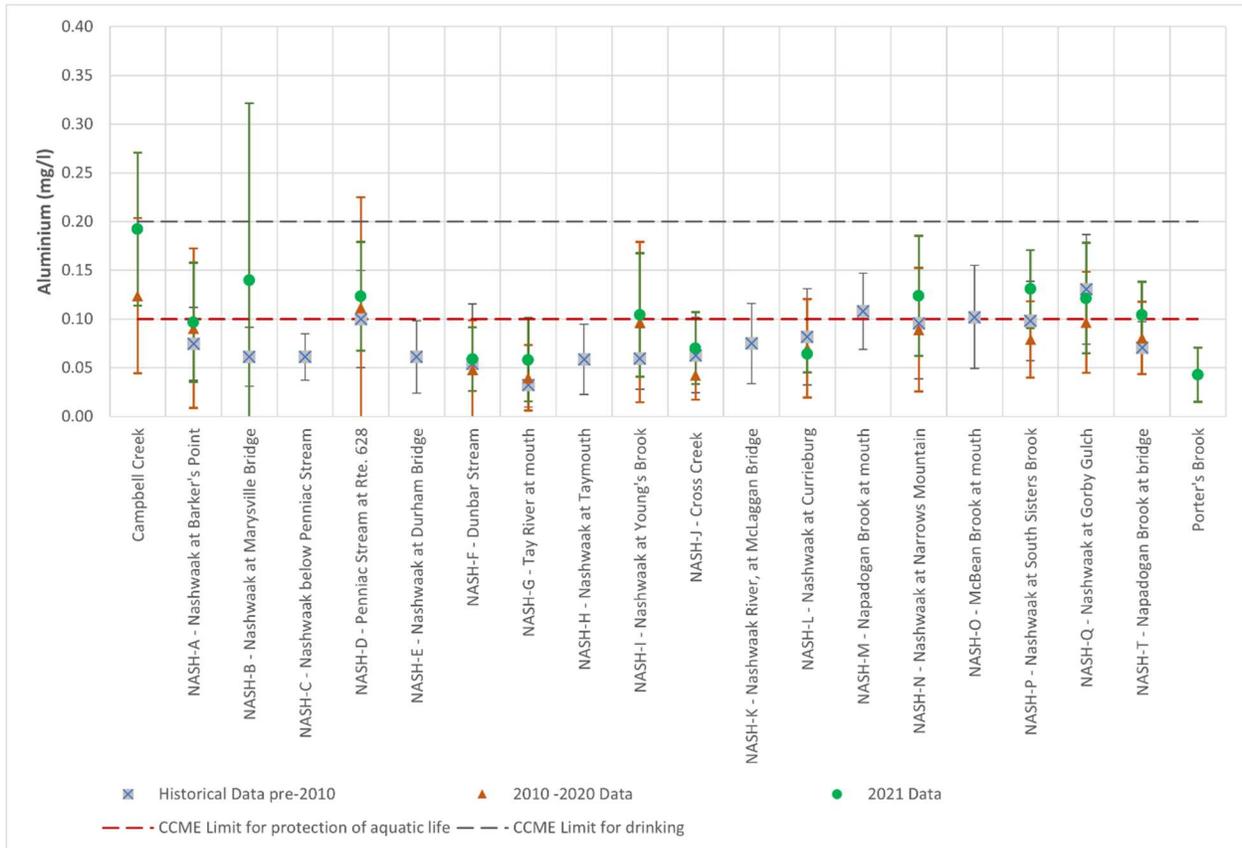
Figure 9 Aluminum content (mg/L) per site. Error bars represent standard deviation. The black dotted line represents the CCME limit of 0.2 mg/L for drinking and the red dotted line represents the CCME limit for the protection of aquatic life (0.1 mg/L).

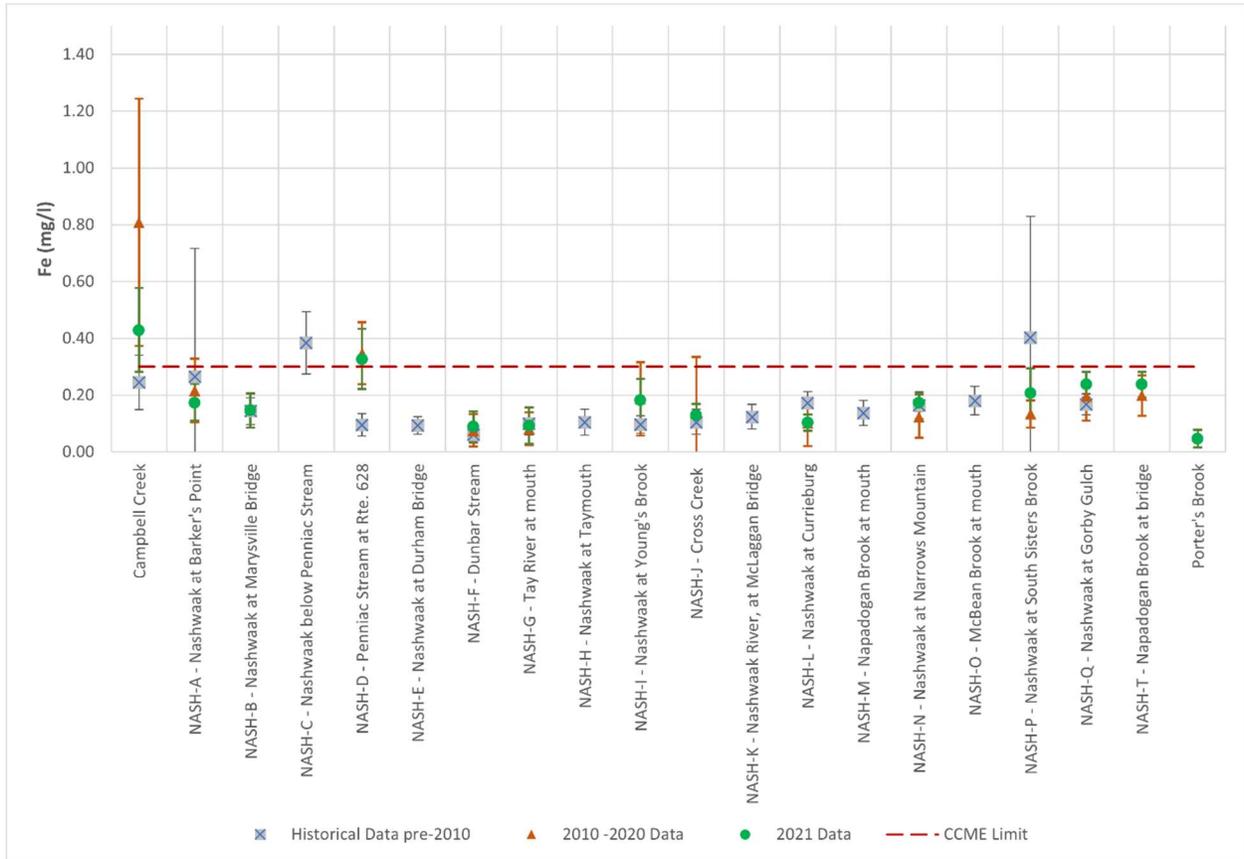
Figure 10 Mean iron content (mg/L) per site in the watershed. Error bars represent standard deviation. The dotted line represents the CCME limit of 0.3 mg/L.

Iron contents have not changed significantly at any site since the 1980s. Mean iron contents for the Nashwaak watershed were well below the CCME limit of 0.3 mg/L at all sites except for two: Penniac Stream, which has consistently just exceeded the limit throughout sampling history; and Campbell Creek, which has exceeded the CCME limit for every sample taken since 2017. (Fig. 10). The only other site to exceed the CCME limit in 2021 was NASH-P in a single sample taken in September, after a heavy rainfall. We have previously observed that heavy rainfall leads to spikes iron concentrations at some sites. Exceedances in the historical data may have been due to precipitation-related runoff.

Soil erosion and water sedimentation are the likely causes of elevated iron contents observed at Penniac and Campbell Creek. Both watercourses displayed high levels of both Al and Fe in 2021, indicating that soil erosion and sedimentation were likely at or upstream from these site. Iron concentrations were very high at Campbell Creek due to sediment flushing from the headpond and construction in summer 2021.

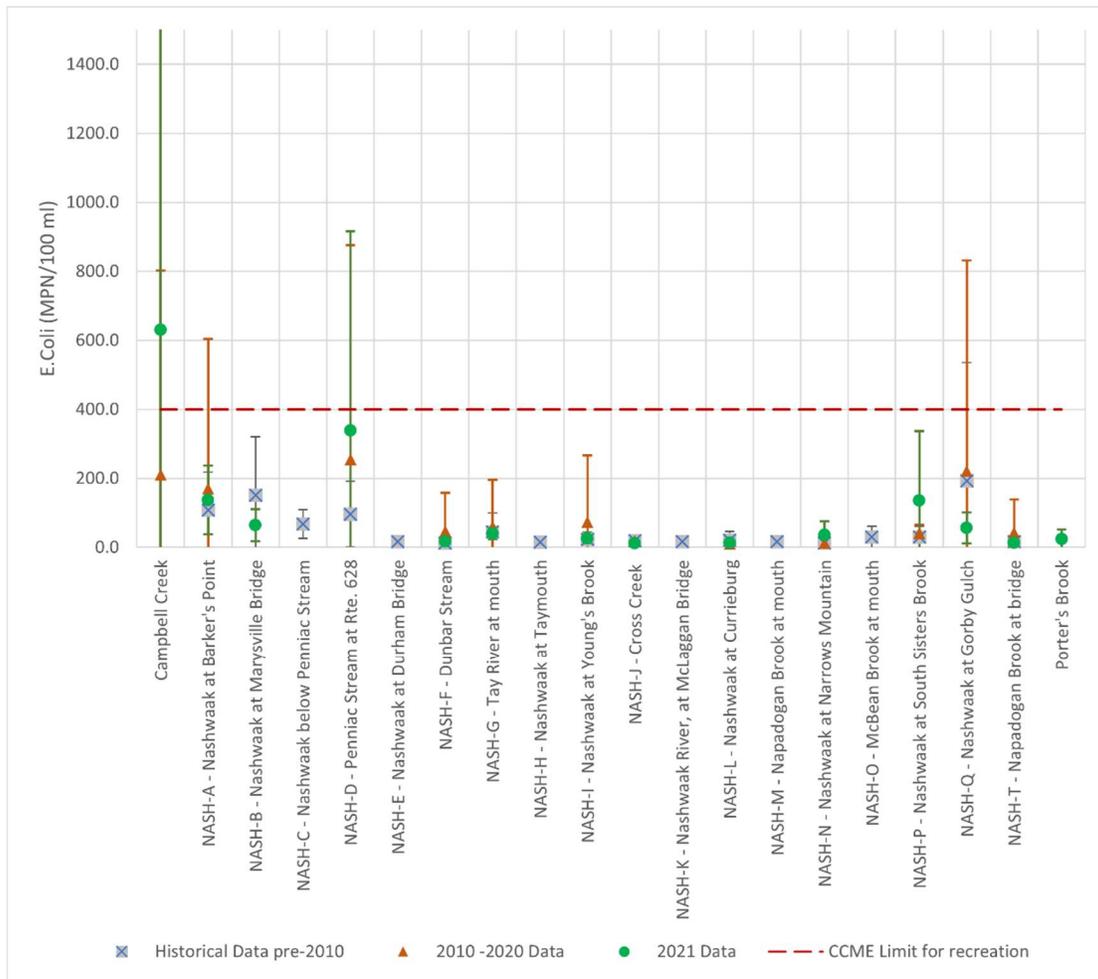
Figure 11 Mean *E. coli* contents (MPN/100 mL) per site in the watershed. Error bars represent standard deviation. The CCME limit is 400 MPN/ 100 mL for a single grab sample.

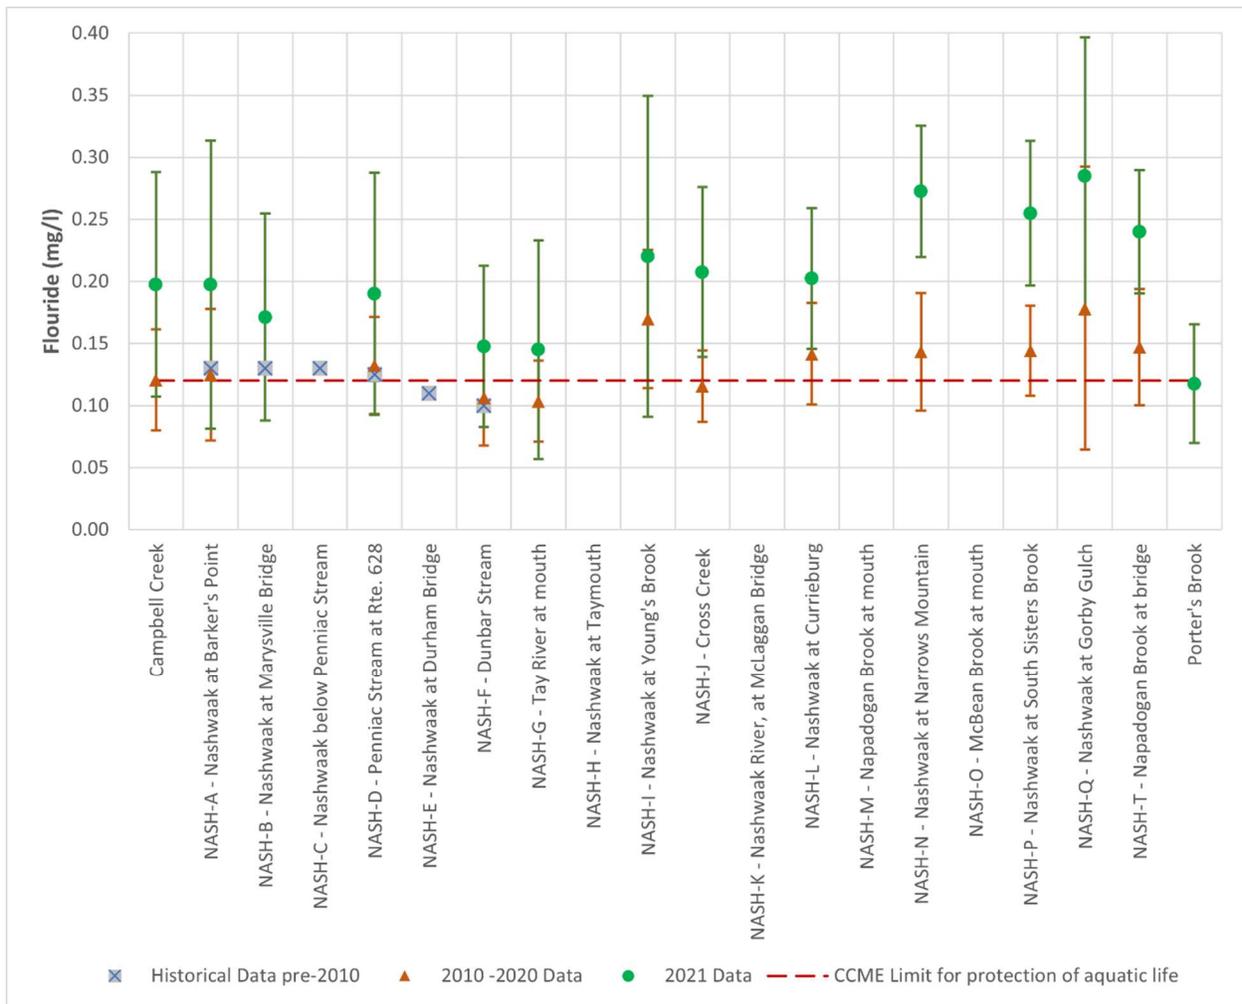
Figure 12. Fluoride concentrations (mg/L) per site in the watershed. Error bars represent standard error. The dashed line represents the CCME guideline of 0.12 mg/L.

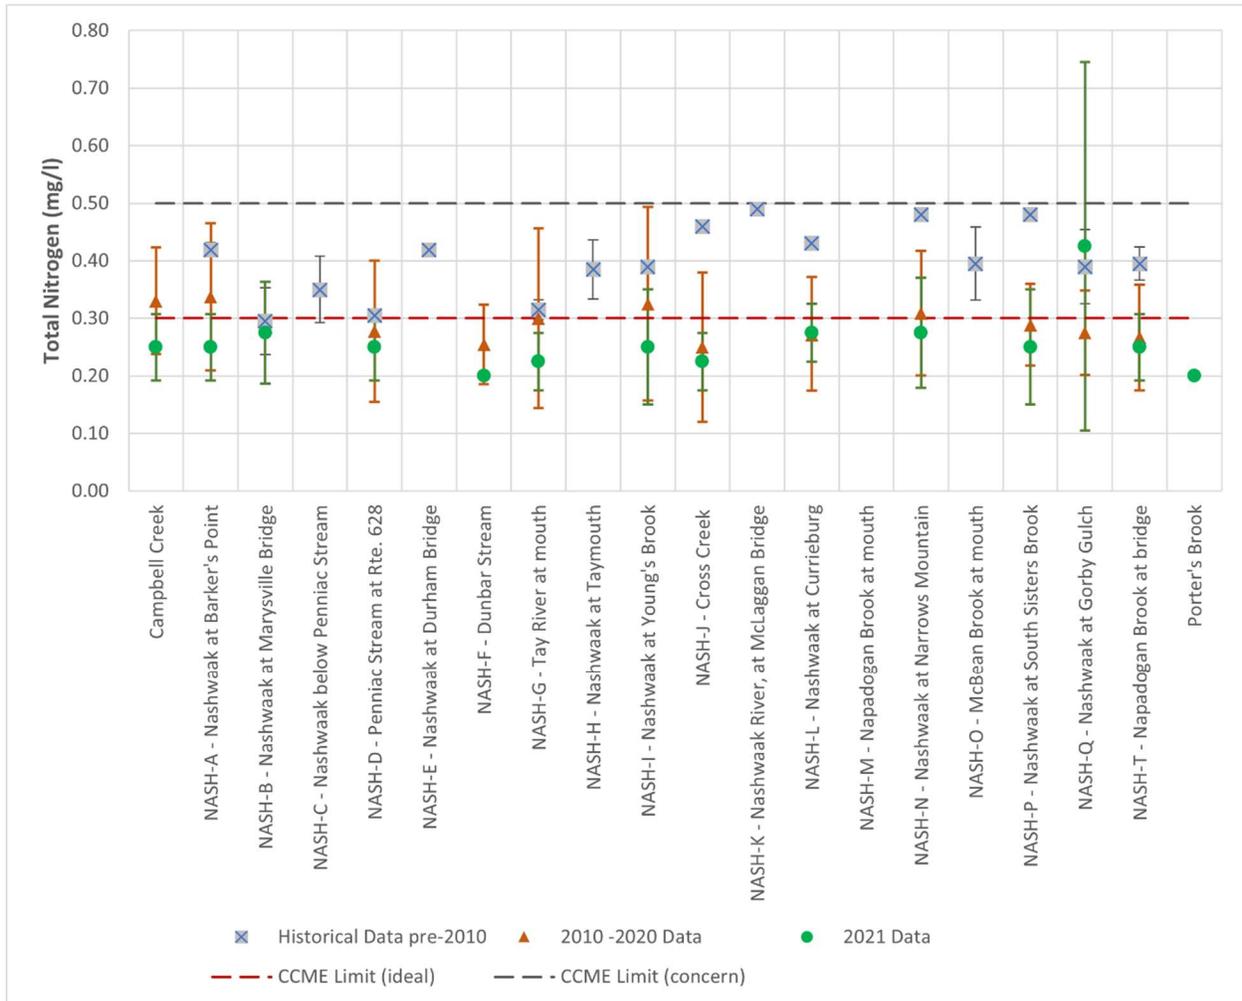
Figure 13. Total Nitrogen concentrations (mg/L) per site across the Nashwaak watershed. Error bars represent standard deviation. Dashed lines represent the limit of ideal levels (0.3 mg/L) and of concern (0.5 mg/L). The limit of detection has changed from 0.3 mg/L in historic samples to 0.2 mg/L after 2017.

(ammonia, organic and reduced nitrogen) and nitrate-nitrite. Total nitrogen per site is shown in Fig. 13. The CCME limit for total nitrogen is 0.3 for “ideal” and 0.5 mg/L for “concern”.

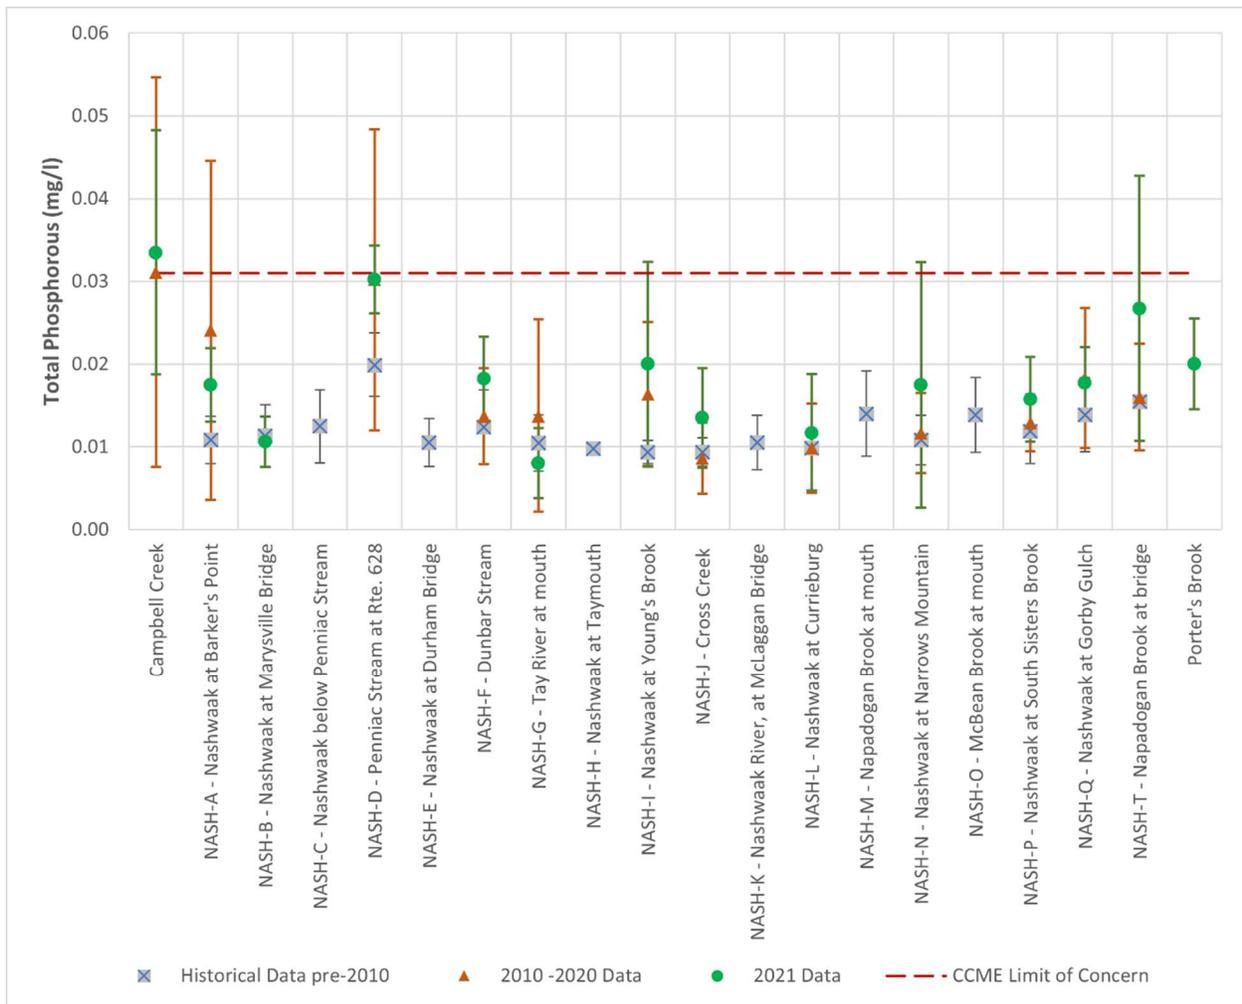
Figure 14. Total phosphorus concentrations (mg/L) per site in the watershed. Error bars represent standard deviation, and the dashed line represents the level of concern (0.031 mg/L).

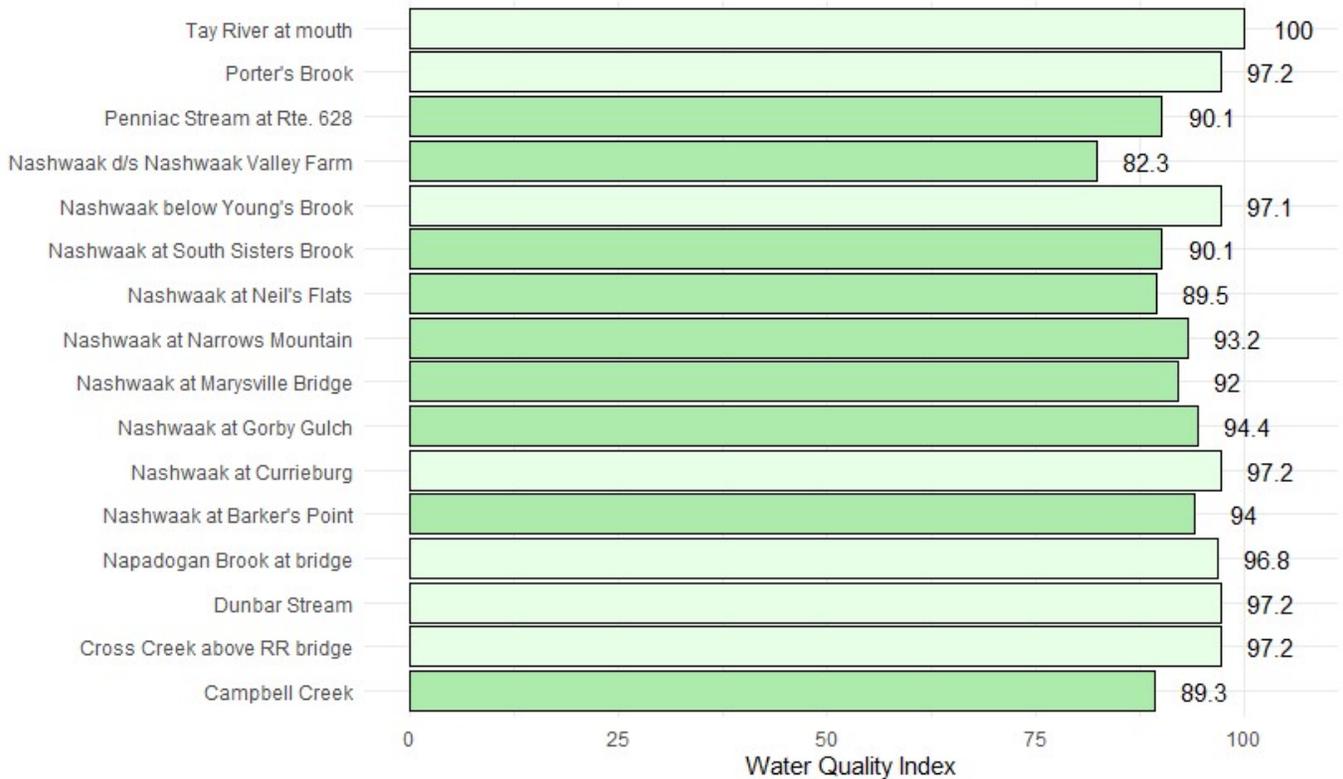
Figure 16. 2021 WQIs. Light green = Excellent, darker green = Very good

Parameters used to calculate the 2021 WQI were: arsenic, cadmium, chloride, dissolved oxygen, E. coli, iron, ammonia, molybdenum, nitrite, nitrate, lead, pH, total dissolved solids, temperature, phosphorus, turbidity, selenium, silver, thallium, and zinc. Results for the 2021 WQI calculations can be found in Figure 16. Water quality was very good overall throughout the watershed.

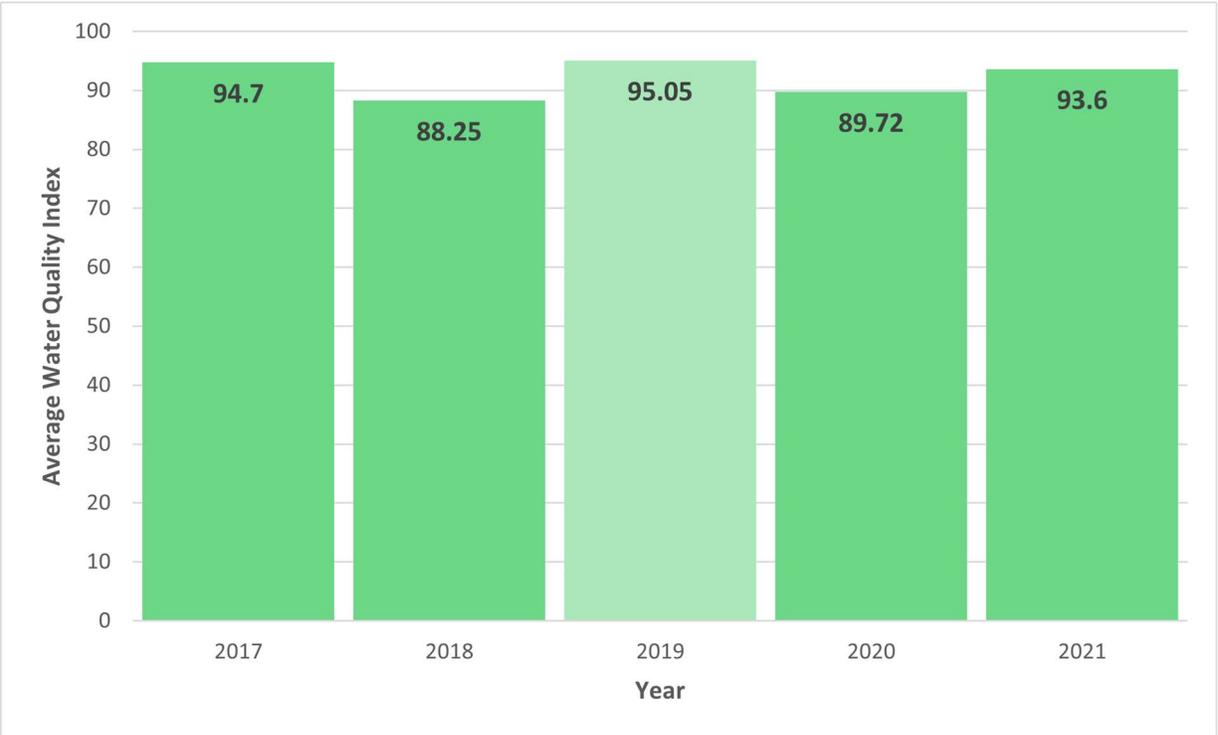
Figure 17. Comparing 2021 WQIs to previous years.

Figure 17 compares the 2021 average WQI for the entire watershed to those measured from 2017 to 2020. Overall, the WQI for the watershed has remained relatively constant over the last four years. 2019 had the healthiest water in the last five years.

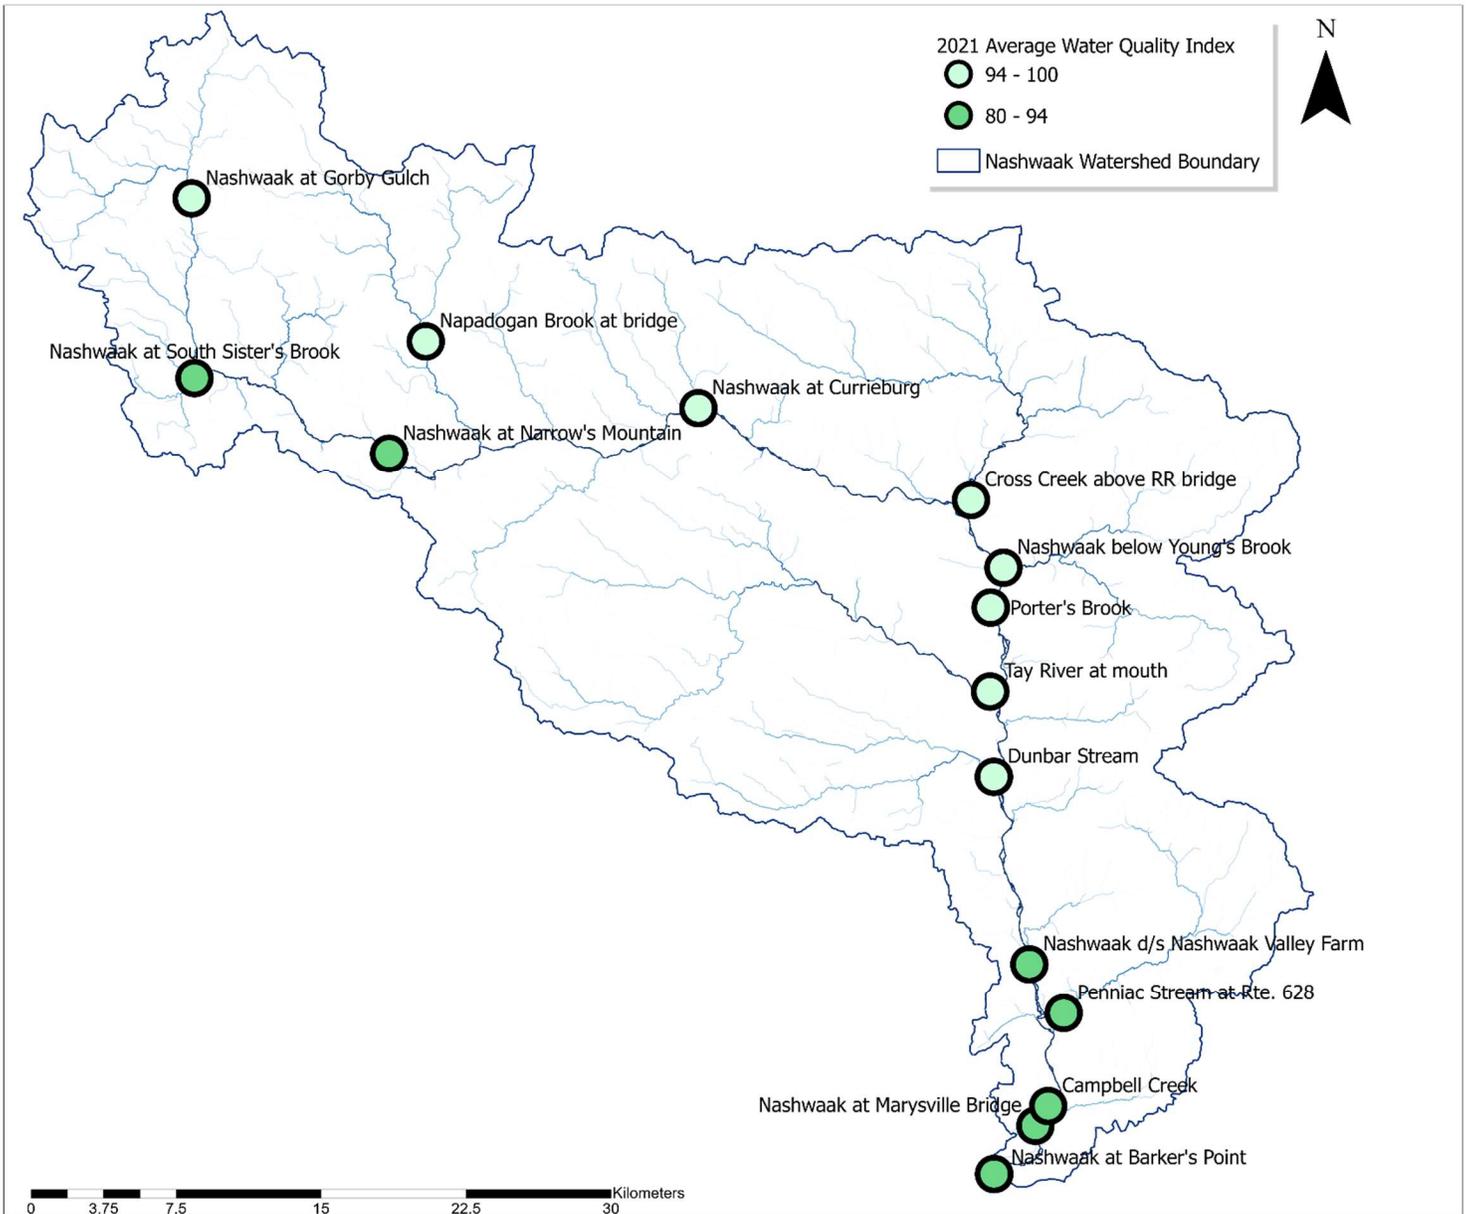
Figure 18. Map of WQIs in 2021 in the watershed.

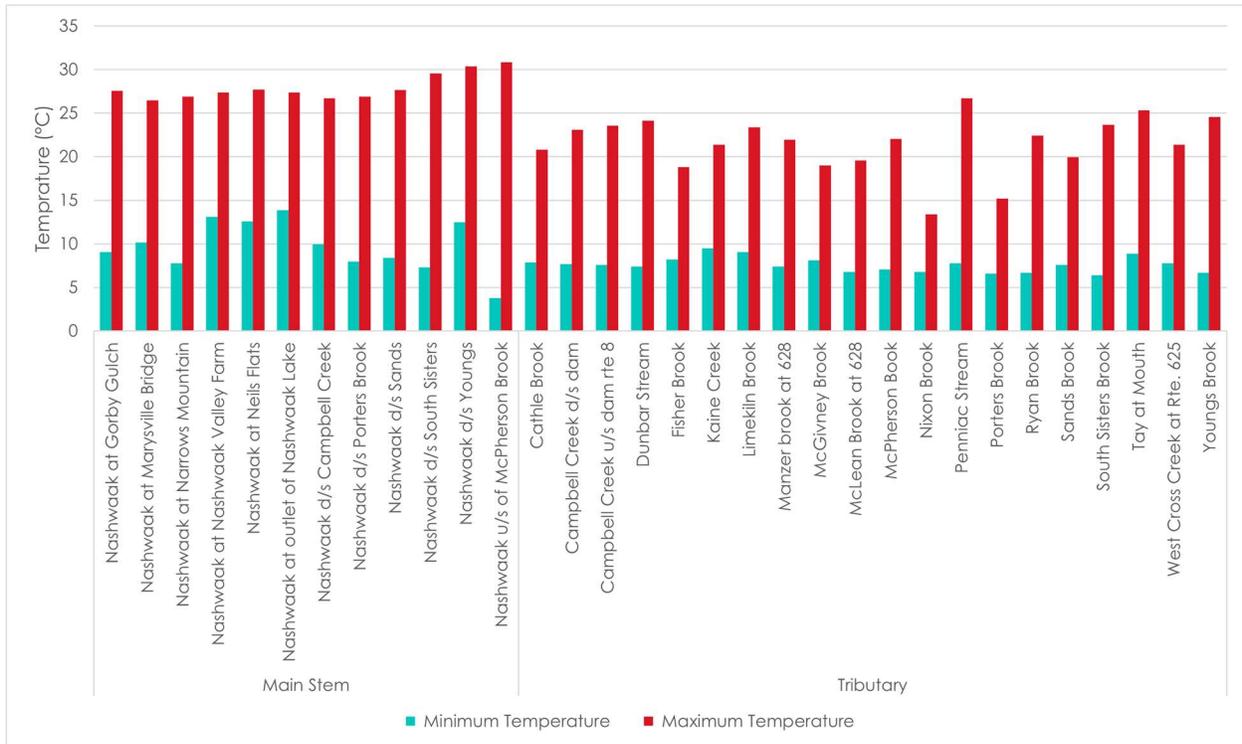
Figure 19. Maximum and minimum temperatures recorded for each logger, grouped by tributaries and main stem.

Peak temperatures ranged from a low 13.37°C in Nixon Brook to 30.9°C in the Nashwaak u/s of McPherson Brook (Figure 19). Average maximum temperature was 21.5°C in the tributaries (compared with previous years in Table 2) and 28.0°C in the main stem of the river (compared to previous years in Table 2). Most peak temperatures were recorded on August 25th at 17:00 during the week of August 19th to 26th. According to Environment and Climate Change Canada (ECCC), annual air temperatures in Fredericton peaked at 34.6°C on June 7th (the hottest day of the year), but the longest sustained heatwave took place in the 4rd week of August, with temperatures peaking at 32.8 °C. 2022 was an anomalous year in terms of air temperature and rainfall with June and August being warmer and drier than usual and July cooler and wetter (Environment and Climate Change Canada, Maritimes Weather and Climate Summary Reports). The anomalously cold and wet July, followed by a cooler start to August is thought to have resulted in the markedly fewer days where minimum water temperatures were above 20 °C and maximum temperatures were above 23 °C, as compared to 2021, which was quite the opposite (Table 2). In addition, the July average temperature in both the main stem and tributaries was lower than in previous years (Table 2).

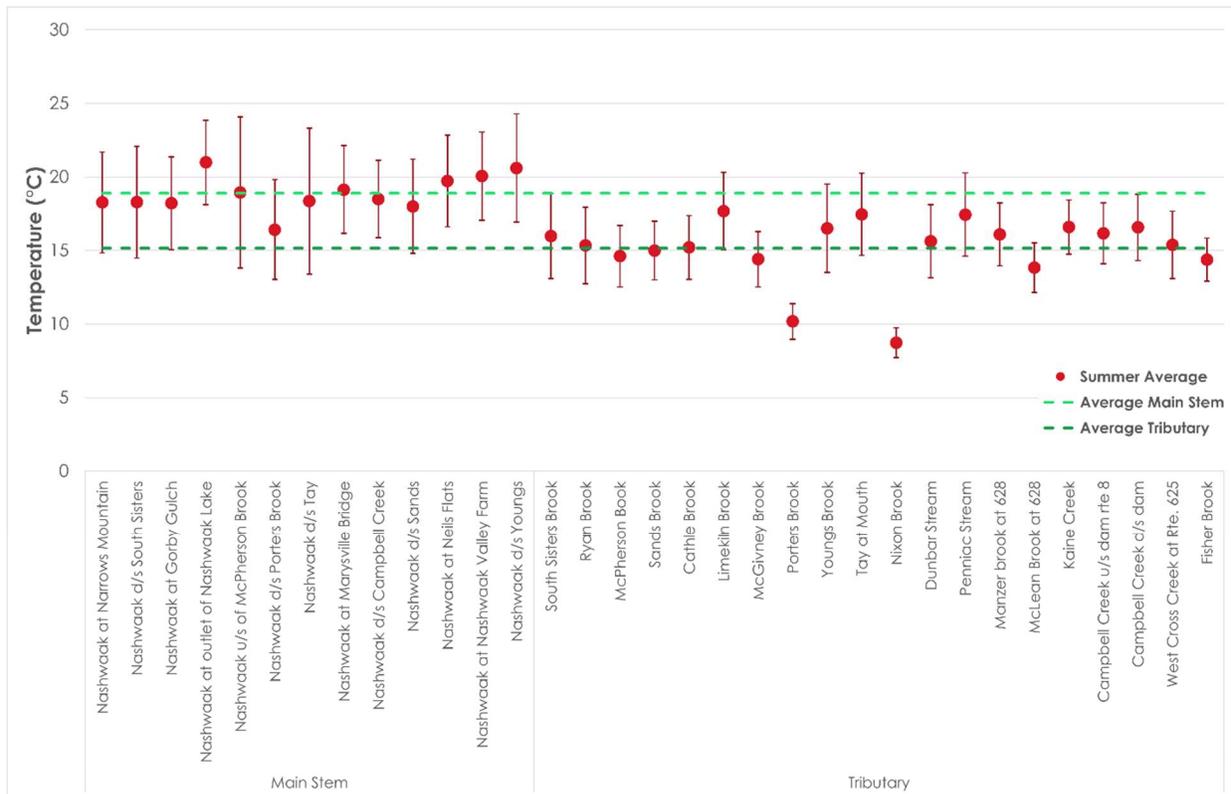
Figure 20. Average summer water temperatures (21 June to 21 September) separated by tributaries and main stem.
