2021-2022

Report on the health of the Nashwaak Watershed

Nashwaak Watershed Association

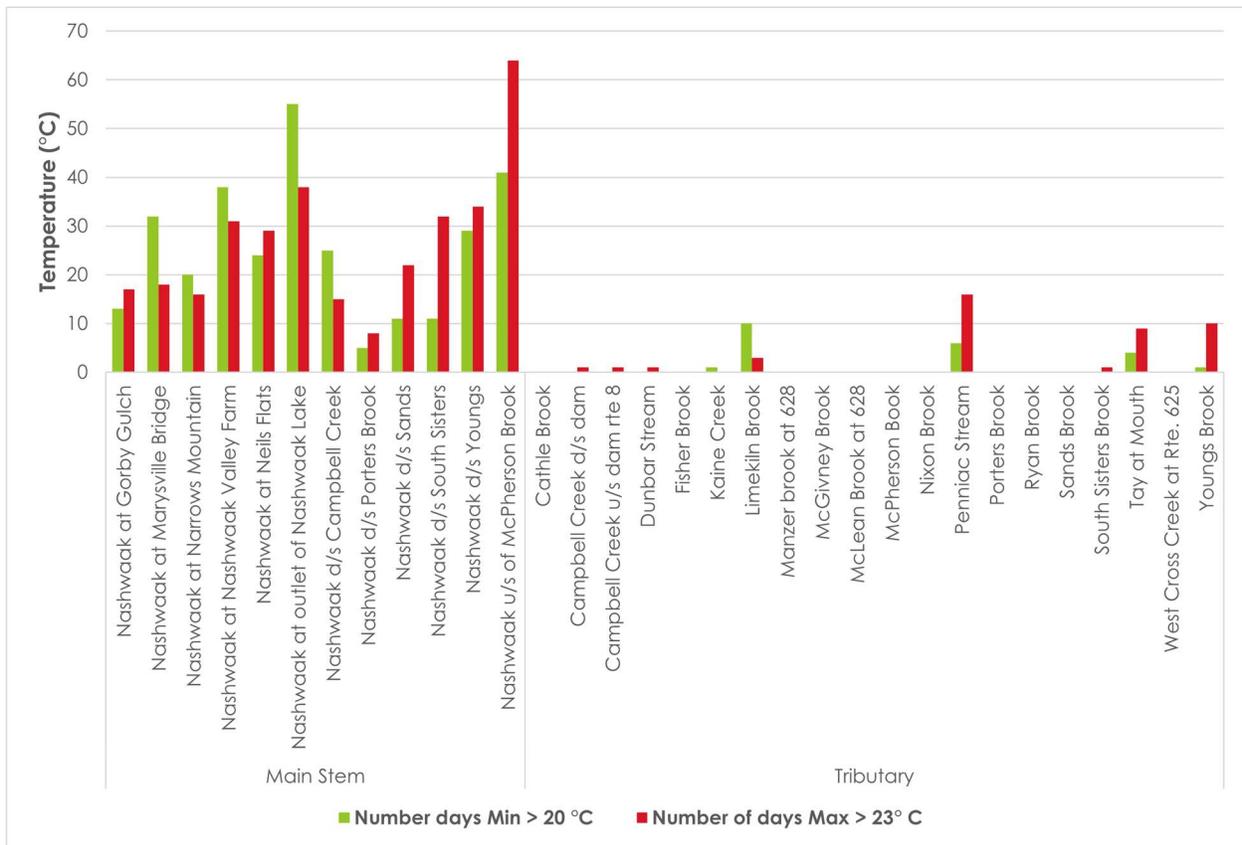
Figure 21. Number of days when minimum water temperatures exceeded 20°C and number of days when maximum daily water temperatures exceeded 23°C.

On average, the number of days when the minimum daily water temperature was above 20°C (i.e., it remained over 20°C all day) was 25 days in the main stem and 1 day in the tributaries, with comparisons to previous years shown in Table 2 and comparisons between sites in Fig. 21. The number of days when the maximum temperature exceeded 23°C was 25 days for the main stem and 2 days for the tributaries (Table 2, Fig.21).

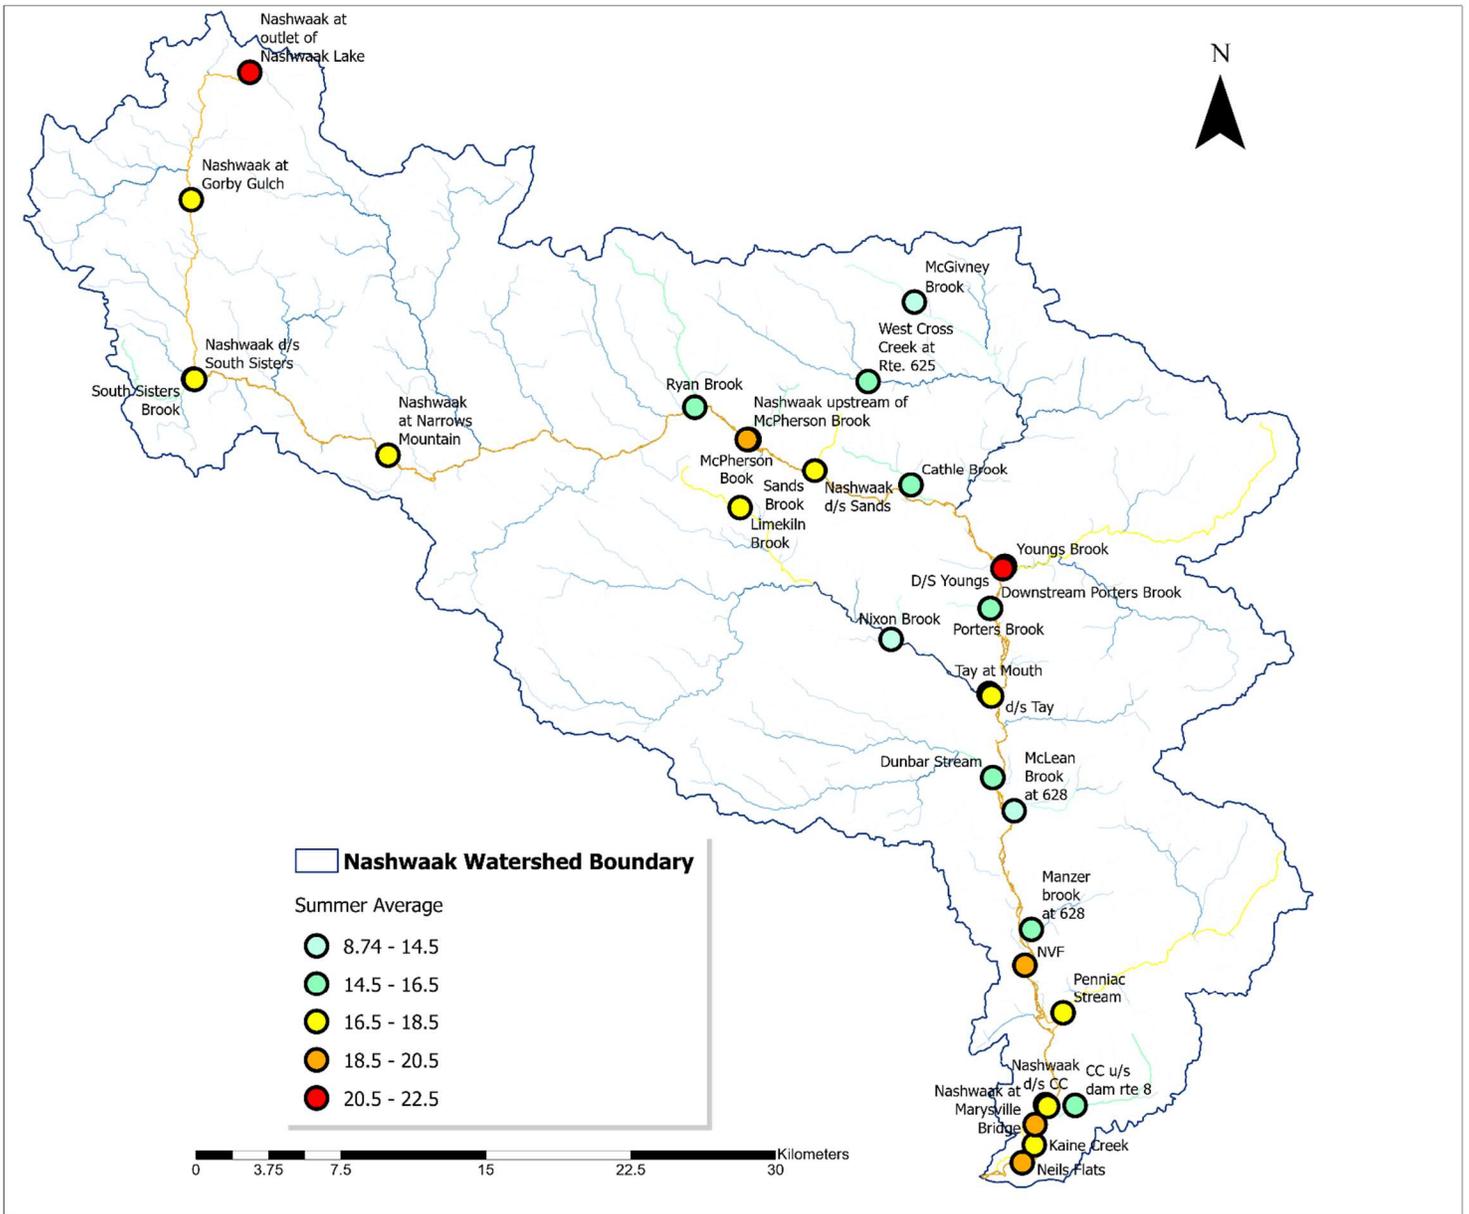
Figure 22. Map of the loggers placed in the watershed in 2020. Coloured symbols show average summer water temperature from green (cooler) to red (warmer).
