2021 NASHWAAK WATERSHED AQUATIC CONNECTIVITY REPORT

Written by: Natalie Deseta & Lauren Murdock Nashwaak Watershed Association Inc.

2021 Aquatic Connectivity Report

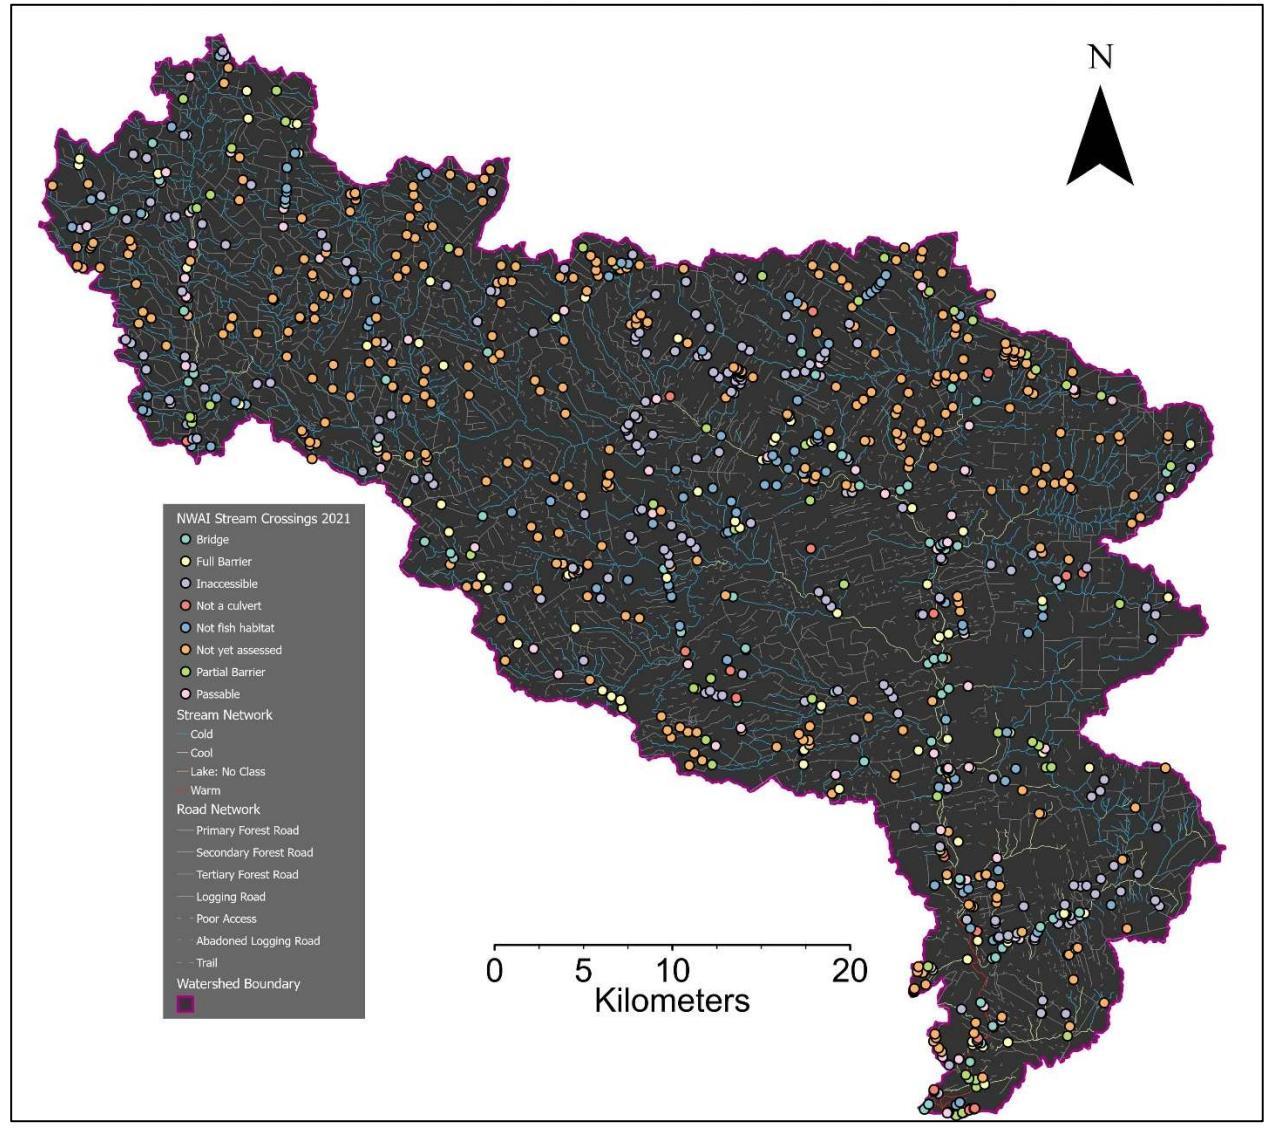
FIGURE 1. UPDATED GIS MAP WITH ALL CULVERTS SURVEYED TO DATE, CATEGORIZED IN TERMS OF PASSABILITY TO FISH

This survey information was entered into a central database and a GIS map, which will be shared with our partners at the end of the year. So far, we have visited 435 of the 985 crossings in the watershed (Fig 1 & 2) in the watershed (~50% complete) and we have done a full survey on 222 culverts. We have surveyed almost all the crossings on public paved roads and the main logging or forest roads. We have done at least 6 major debris removals and 15 smaller debris removals, which have improved flow and fish passage in those culverts and improved water quality in those streams. Of the 434 stream crossings surveyed in the watershed thus far, 212 were identified as fish habitat, and of those 172, or 76.8 % were full or partial barriers to fish passage. Our field experience and GIS survey have determined that only 538 stream crossings (56 %) in the watershed are accessible to survey, with many inaccessible culverts on trails or logging roads that are not currently maintained or abandoned. It is assumed therefore, that any stream crossings intercepting the fish habitat along these routes are full barriers. Of the remaining 526 barriers that have not yet been surveyed in watershed, only 104 are deemed accessible for survey by vehicle (Fig. 2), and will be targeted for future surveys from 2022 and beyond.

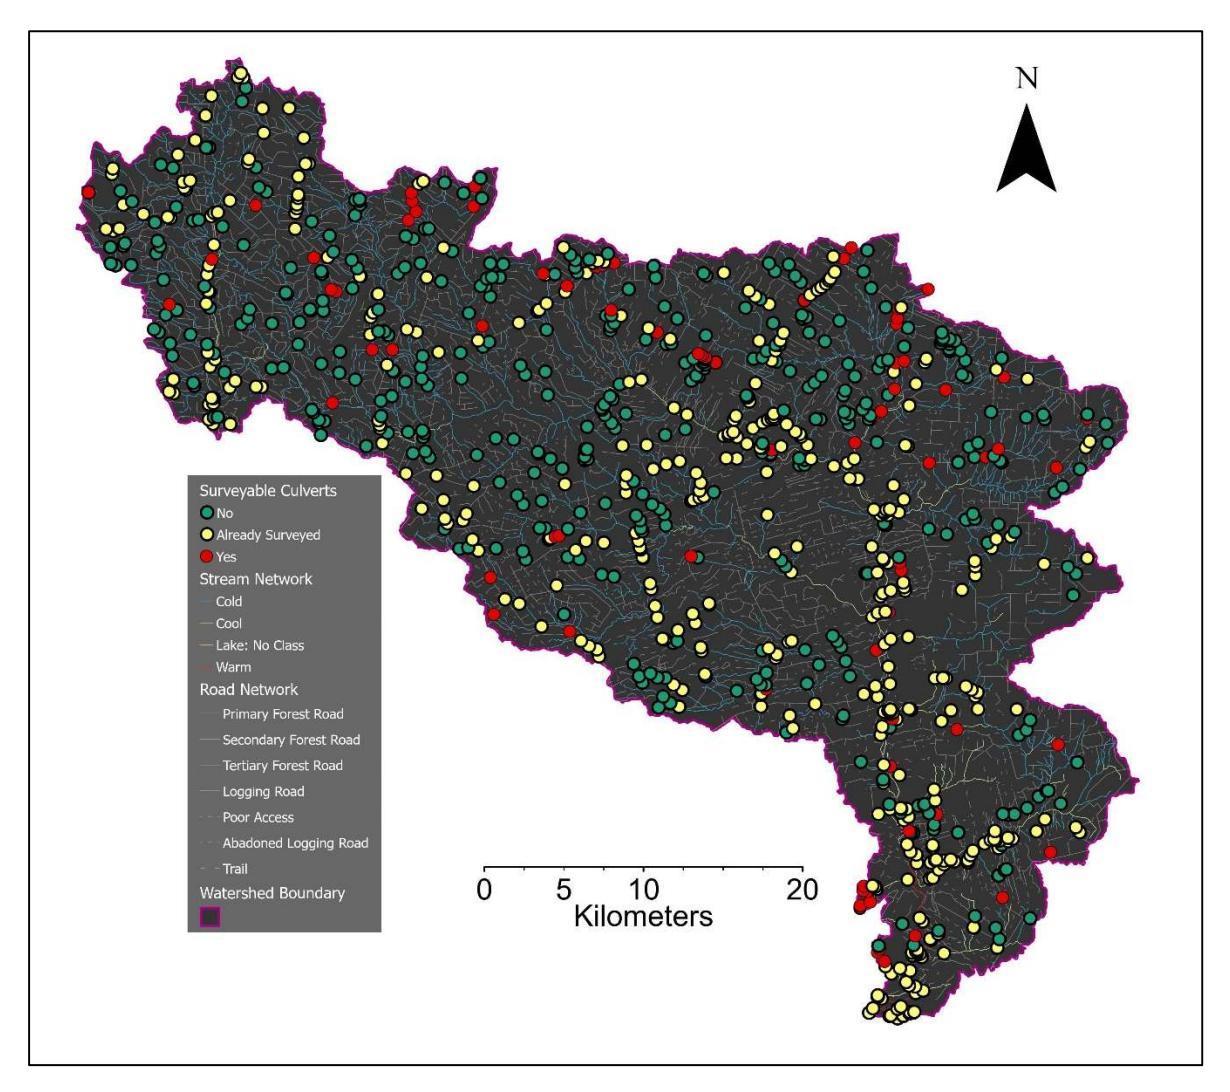
FIGURE 2. MAP OF SURVEYABLE CULVERTS IN THE NASHWAAK WATERSHED

include: poorly maintained roads; being located on private land; and being too remote for easy access. Out of the total remaining culverts, only 104 can be surveyed (Fig. 2).
