Introduction

MacPherson Brook, a cold-water stream in the community of Giants Glen, was identified during a 2016 geomorphic assessment and in our 2017-2020 Action Plan as an important source of cold water that should be protected and restored. The site is located between 269 and 273 Giant's Glen Road near the mouth of MacPherson Brook [46.2990, -66.7842] (Fig. 1). Approximately 14 years ago the landowner 269 Giant's Glen Road placed a number of large rocks on the edge of the brook to reduce flooding. This reduced the capacity of the floodplain and pushed the water into the opposing bank, which began to collapse. The substrate of this bank is fine and sandy, which allowed the water to cut into the bottom of the bank, leading it to slump down. The landowner of the collapsing bank estimated that he had lost ~3-5 m of land over the last 14 years, along with many trees.

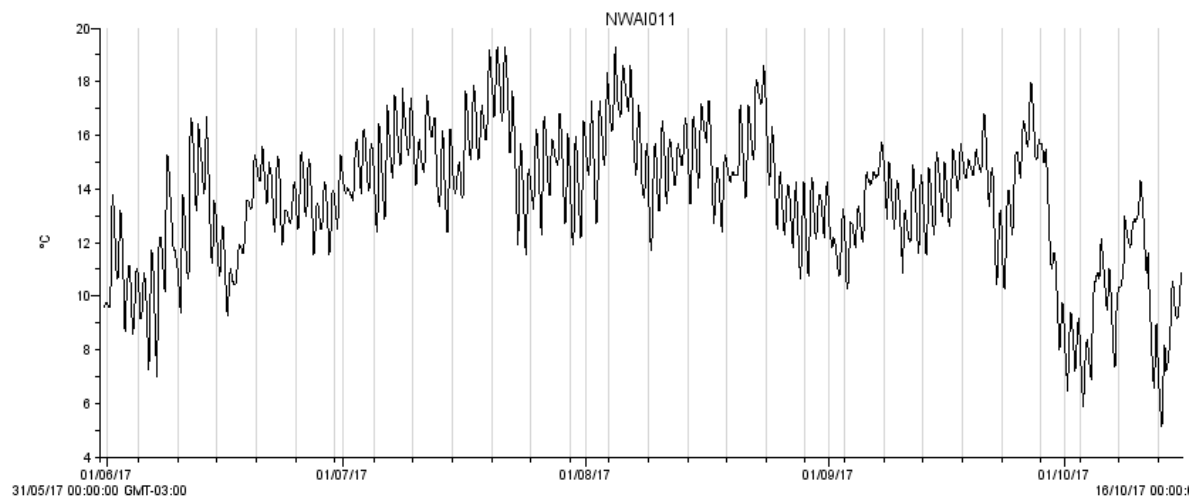
The brook was known as a thermal refuge for fish in mid-summer, based on conversations with locals. This was confirmed by placing temperature loggers in the brook and in the main stem of the river. The brook remained below 20°C all summer (Fig. 4), and was the only tributary analyzed in the watershed this summer to do so, while the main stem rose to 28°C or higher in some locations. Restoration of this site would reduce sediment loading and enhance a cold-water source to the Nashwaak River - safeguarding the thermal diversity of the watershed and improving water quality and aquatic habitat for native salmonids. The Nashwaak River is an important salmon-producing tributary of the Saint John River and is one of DFO's priority rivers for restoration under their 2014 Recovery Potential Assessment.

Figure 4. The temperature profile from the logger just upstream from the eroding bank. This was the only tributary recorded that remained under 20°C all summer.

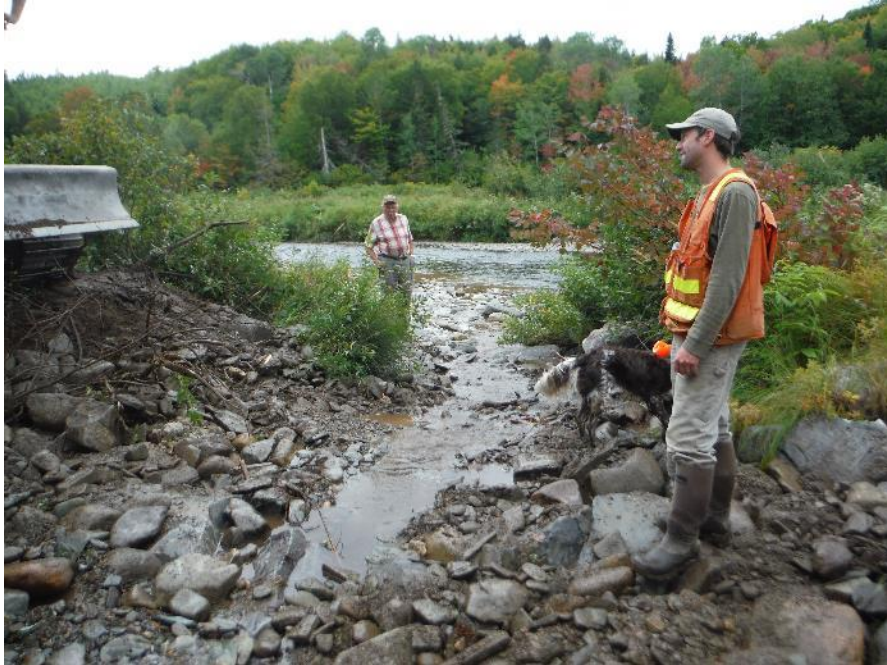
Figure 13. Nathan Wilbur from Atlantic Salmon Federation designed the rock weir and supervised the work.

A rock weir consisting of 9 rocks that were 600 mm in diameter was placed at the downstream end of the repaired bank, close to the mouth of the brook. This is where there was a build up (island) of sediment that had some off of the bank. The island was pushing water into both banks and exacerbating the erosion. Machinery sat on the lower bank and reached into the stream. Staff watched for sedimentation of the stream and was prepared to stop work if large turbidity became too high. However, due to low flow conditions we did not have to stop and the sediment dropped out of the suspension very quickly.

This weir will act as a grade control and reduce scouring of the channel bed. In low flow conditions, it will also concentrate flow to allow for fish passage into the cold-water tributary. Fish (juvenile brook trout and black nosed dace) were noted swimming through the rock weir almost immediately upon completion of work.
