Soil Erosion Survey of the Nashwaak River and the Tay, Penniac and Cross Creek Streams

The New Brunswick Department of the Environment and Local Government
P.O. Box 6000
Fredericton, NB
E3B 5H1
March, 2005

The Nashwaak Watershed Association Inc.
P.O. Box 20037
Fredericton, NB
E6B 6Y8

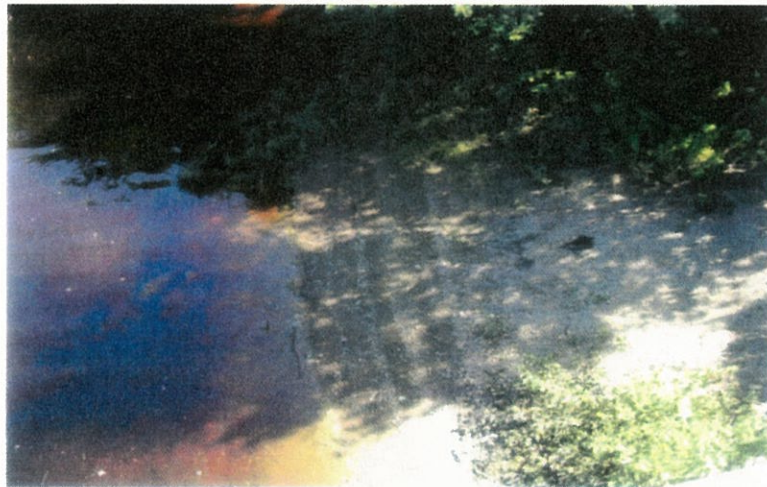
Photo # ER-2c

NWAJ Eroding Bank Survey, ETF Project 2004/2005			
Eroding Bank Number:	ER-2		
General Location:	Main Street Bridge - Fredericton		
GPS Coordinates:	Northerly	45	57.282
	Westerly	66	37.377
Erosion Severity:	Minor		
Recommended Remedial Action:	Grasses		
Eroding Bank Height (approx meters):	<1		
Eroding Bank Length (approx meters):	60		
Channel Location:	Left Hand Channel		
Bank Location:	Left Hand Bank

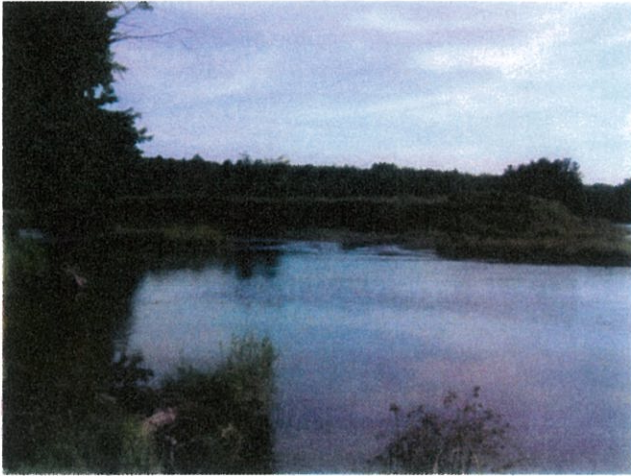
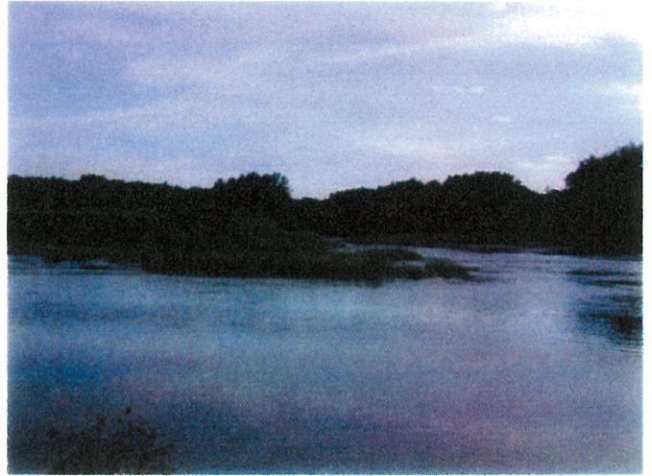
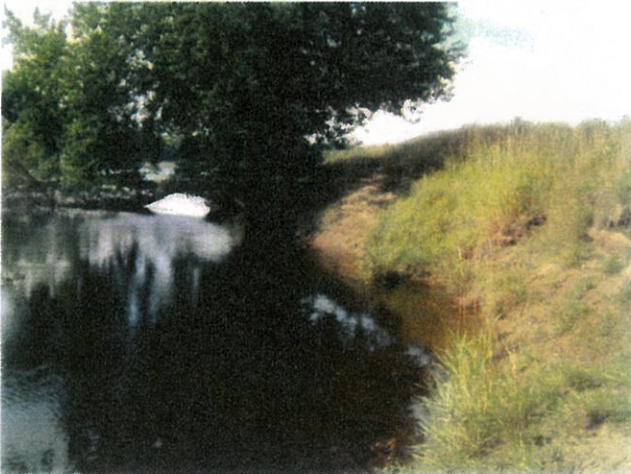
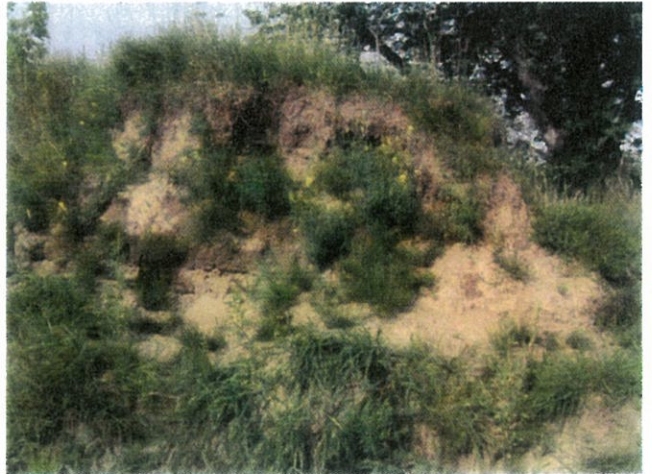
NWAJ Eroding Bank Survey, ETF Project 2004/2005			
Eroding Bank Number:	ER-4		
General Location:	Top of 1st island below Cotton Mill		
GPS Coordinates:	Northerly	45	58.145
	Westerly	66	35.192
Erosion Severity:	Moderate		
Recommended Remedial Action:	Trees/shrubs		
Eroding Bank Height (approx meters):	1 to 3		
Eroding Bank Length (approx meters):	270		
Channel Location:	Both - mostly on Left Hand Channel		
Bank Location:	Both - mostly on Left Hand Bank and island tip

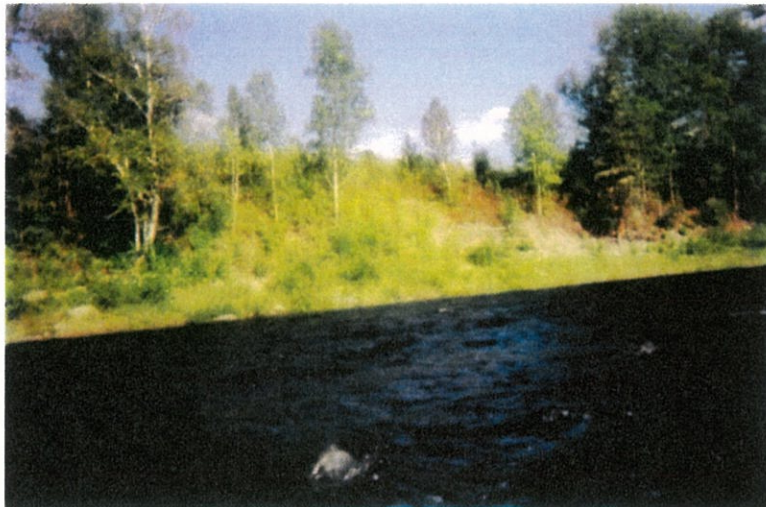
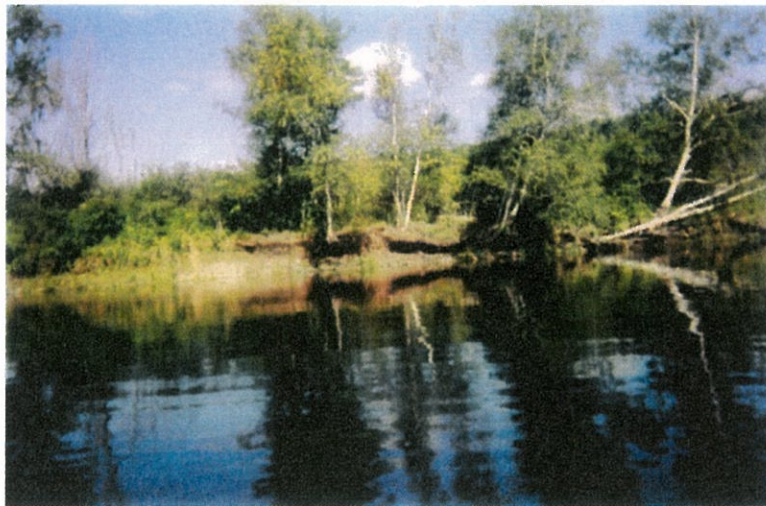
NWAJ Eroding Bank Survey, ETF Project 2004/2005			
Eroding Bank Number	ER-9		
General Location			
GPS Coordinates	Northerly	46	12.386
	Westerly	66	36.716
Erosion Severity	Minor - Moderate		
Recommended Remedial Action	Trees/shrubs		
Eroding Bank Height (approx meters)	1		
Eroding Bank Length (approx meters)	12		
Channel Location	Main		
Bank Location	Left Hand Bank

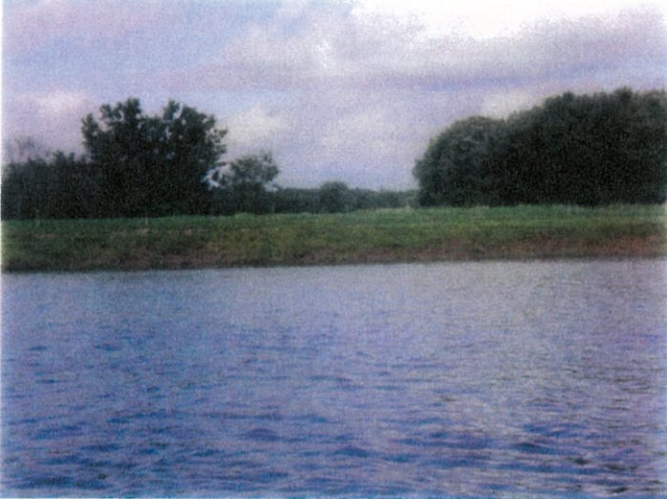
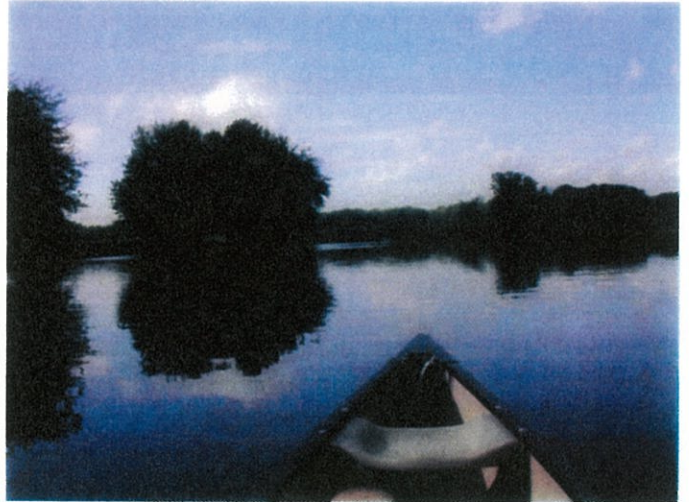
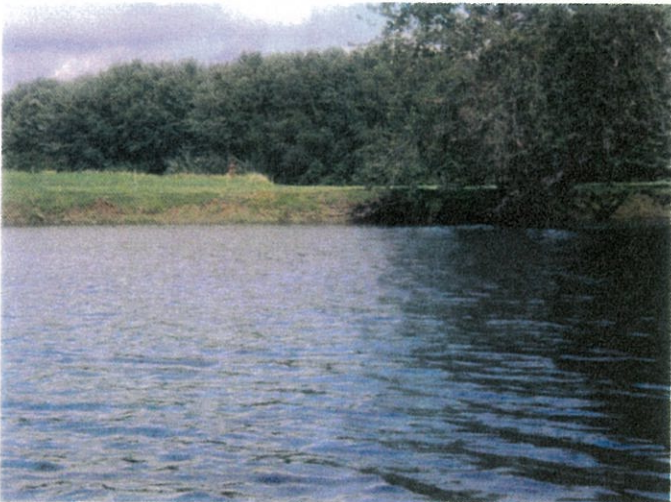
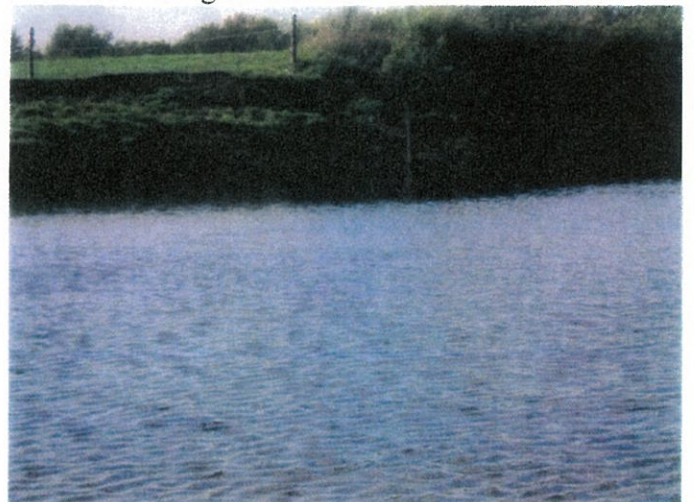
NWAJ Eroding Bank Survey, ETF Project 2004/2005			
Eroding Bank Number:	ER-12	180 degree turn above main Street Bridge --	
General Location:	Fredericton	Start	End
GPS Coordinates:	Northerly	45 57.427	57.633
	Westerly	66 36.749	36.636
Erosion Severity:	Moderate		
Recommended Remedial Action:	Trees/shrubs		
Eroding Bank Height (approx meters):	1 to 3		
Eroding Bank Length (approx meters):	350		
Channel Location:	Main and Right Hand Channel		
Bank Location:	Right Hand Bank

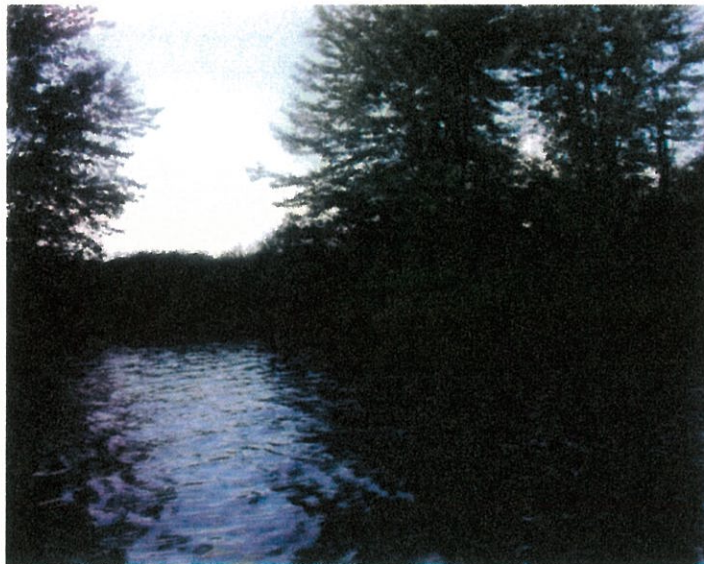
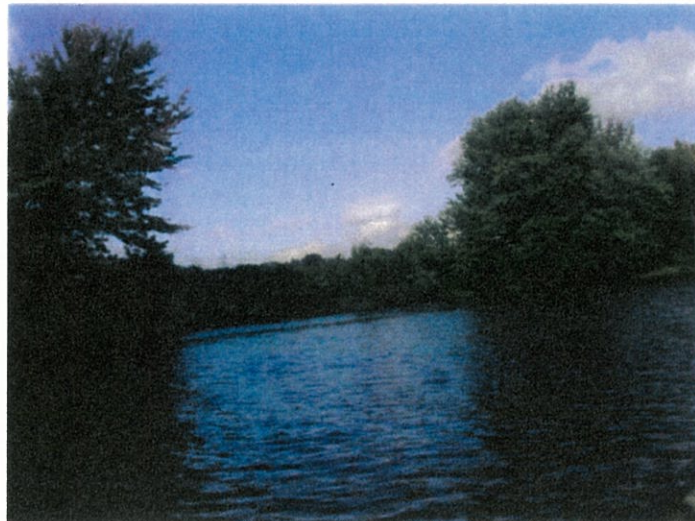
NWAJ Eroding Bank Survey, ETF Project 2004/2005			
Eroding Bank Number:	ER-13		
General Location:	Just above ER-12		
GPS Coordinates:	Northerly	45	57.690
	Westerly	66	35.965
Erosion Severity:	Moderate		
Recommended Remedial Action:	Trees/shrubs		
Eroding Bank Height (approx meters):	1 to 2		
Eroding Bank Length (approx meters):	80		
Channel Location:	Main		
Bank Location:	Right Hand Bank

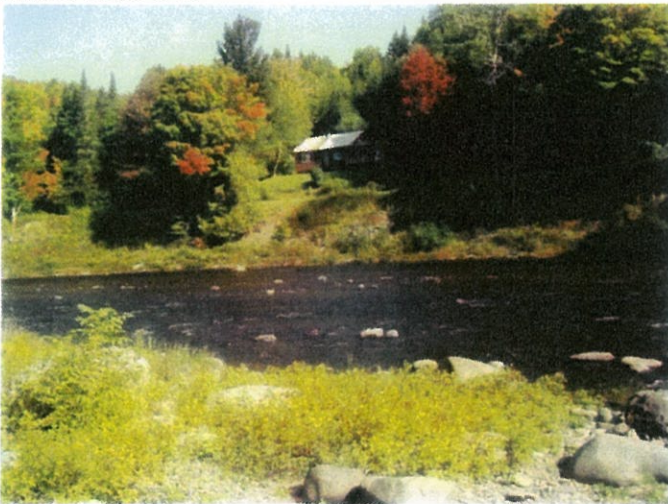
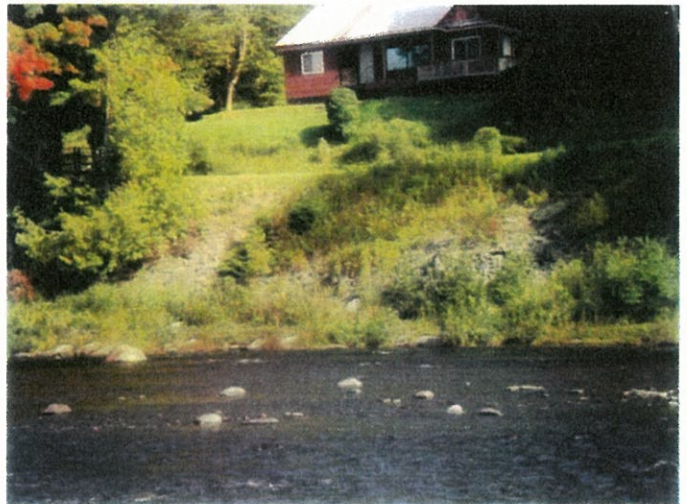
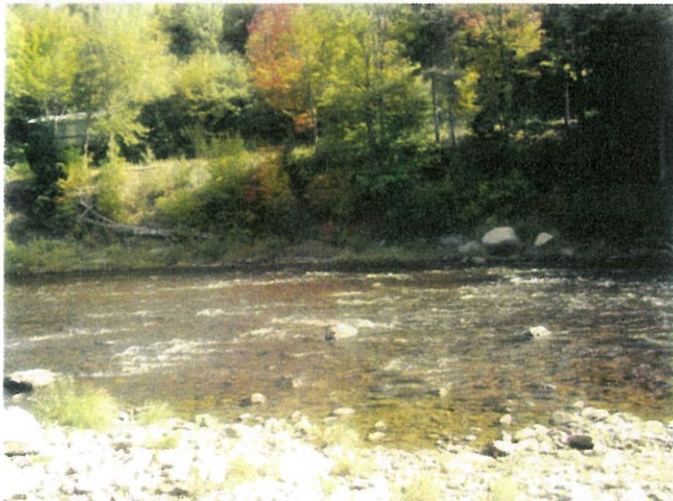
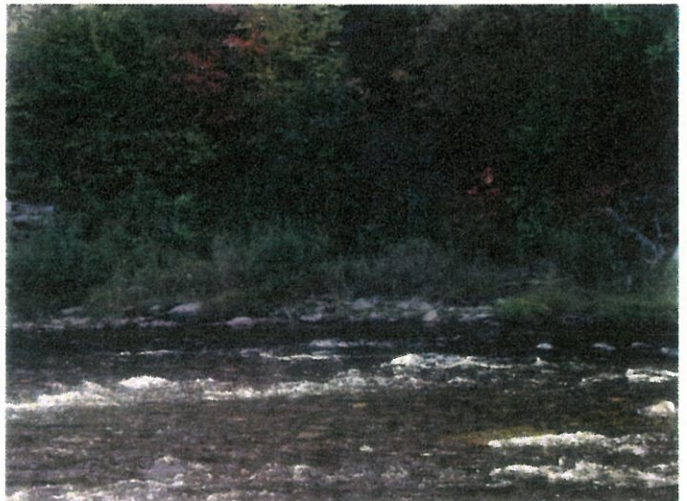
NWAJ Eroding Bank Survey, ETF Project 2004/2005			
Eroding Bank Number:	ER-14		
General Location:	Above Rock Cut (Danny's)		
	Pool		
GPS Coordinates:	Northerly	46	18.831
	Westerly	66	48.517
Erosion Severity:	Moderate		
Recommended Remedial Action:	Trees/shrubs		
Eroding Bank Height (approx meters):	3.5		
Eroding Bank Length (approx meters):	50		
Channel Location:	Main		
Bank Location:	Left Hand Bank		
Special Location Instructions:	GPS Marked on RHB @ Rock Cut, 50m downstream

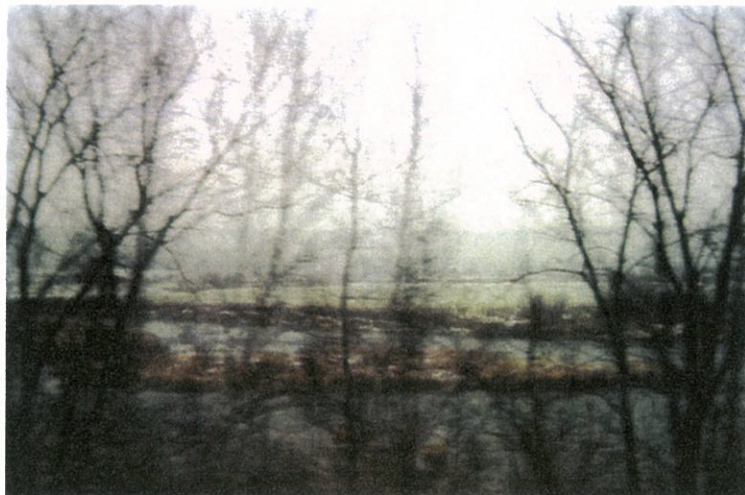
Photo # ER-17c

NWA I Eroding Bank Survey, ETF Project 2004/2005				
Eroding Bank Number:	ER-17			
General Location:	Golf Course		Start	End
GPS Coordinates:	Northerly	46	06.312	06.063
	Westerly	66	36.628	36.734
Erosion Severity:	Moderate			
Recommended Remedial Action:	Trees/shrubs			
Eroding Bank Height (approx meters):	2			
Eroding Bank Length (approx meters):	750			
Channel Location:	Main and Left Hand Channel			
Bank Location:	Left Hand Bank with some erosion on Right Hand Bank			
Special Location Instructions:	GPS Marked @ site

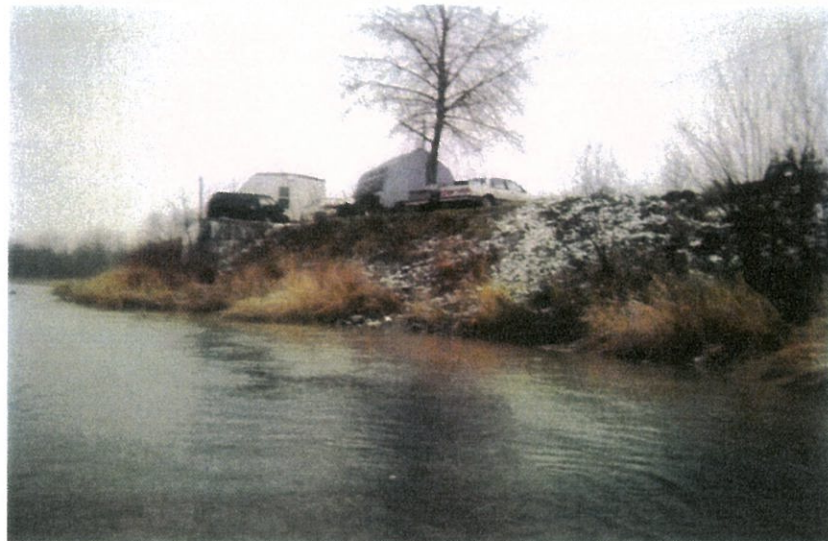
Photo # ER-18b

NWAJ Eroding Bank Survey, ETF Project 2004/2005			
Eroding Bank Number:	ER-18		
General Location:	Behind former Robert's Restaurant		
GPS Coordinates:	Northerly	46	05.907
	Westerly	66	36.672
Erosion Severity:	Moderate		
Recommended Remedial Action:	Trees/shrubs		
Eroding Bank Height (approx meters):	2.5		
Eroding Bank Length (approx meters):	15		
Channel Location:	Main		
Bank Location:	Right Hand Bank		
Special Location Instructions:	GPS Marked @ site

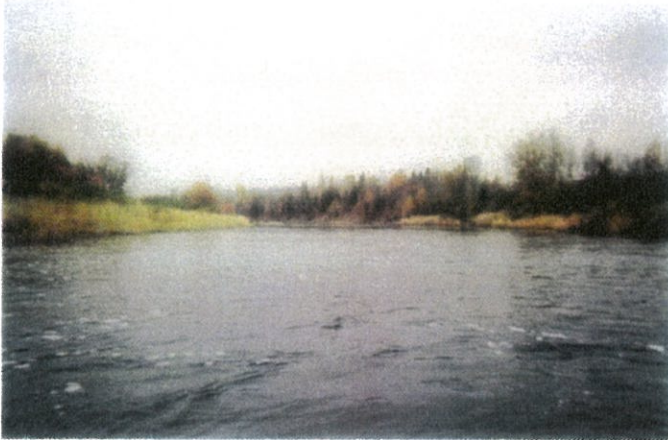
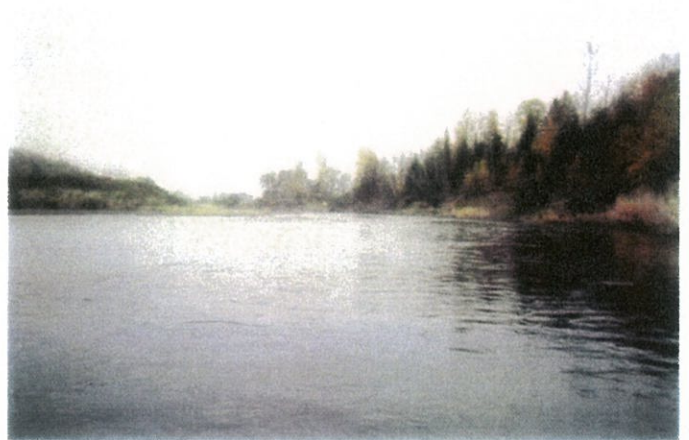
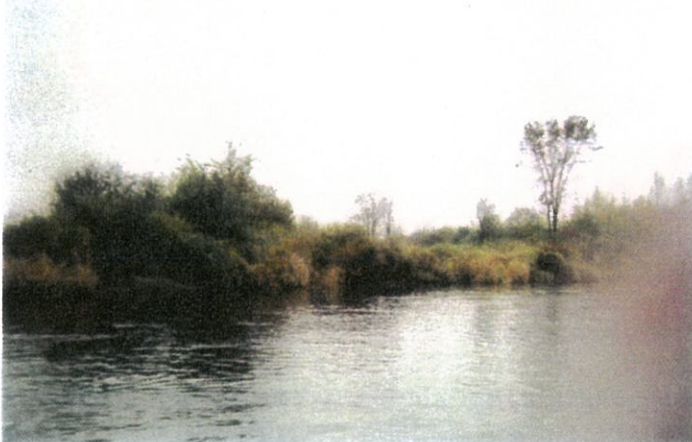
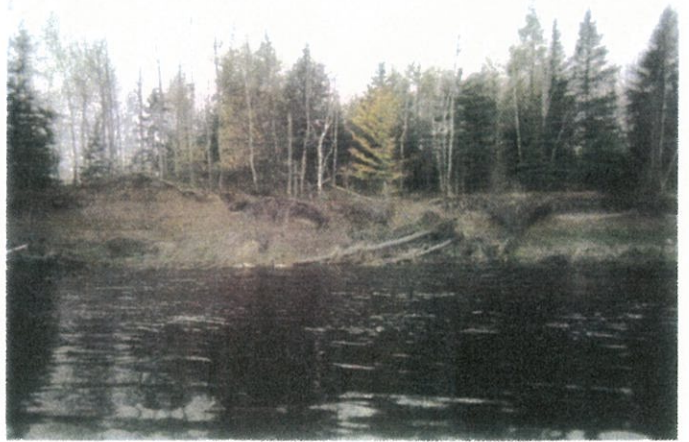
NWA I Eroding Bank Survey, ETF Project 2004/2005			
Eroding Bank Number:	ER-21		
General Location:			
GPS Coordinates:	Northerly	46	04.682
	Westerly	66	36.170
Erosion Severity:	Major		
Recommended Remedial Action:	Uncertain		
Eroding Bank Height (approx meters):	4.2		
Eroding Bank Length (approx meters):	90		
Channel Location:	Right Hand Channel		
Bank Location:	Right Hand Bank		
Special Location Instructions:	GPS Marked @ site

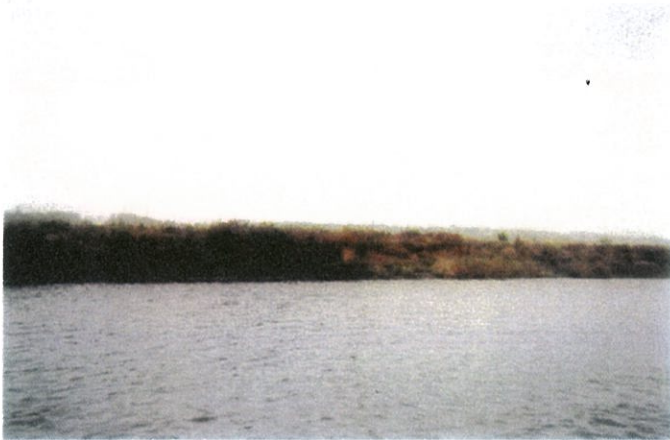
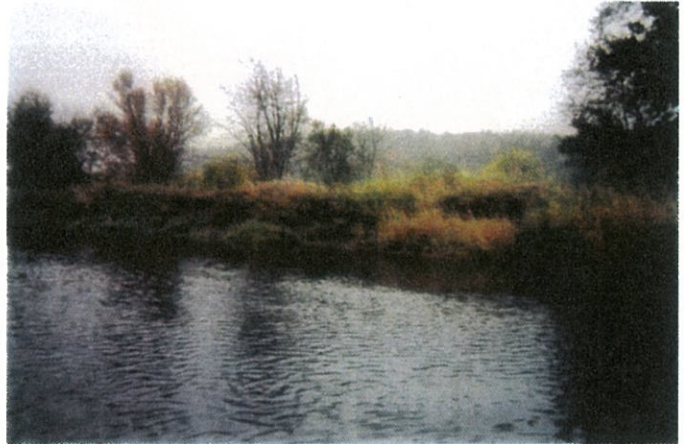
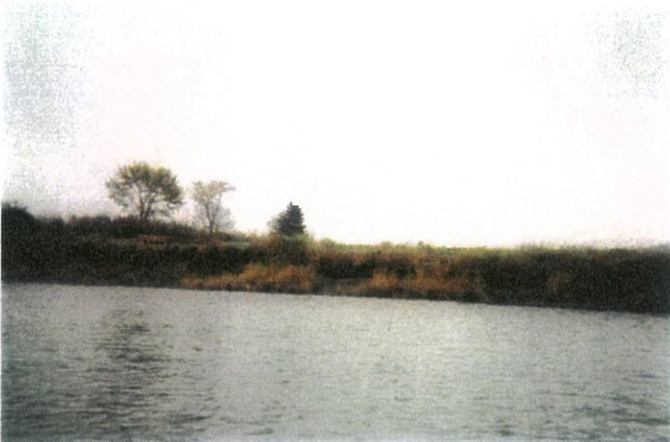
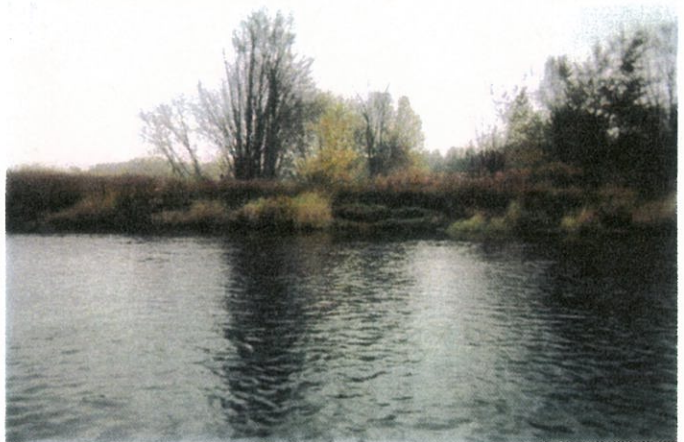
NWA I Eroding Bank Survey, ETF Project 2004/2005			
Eroding Bank Number:	ER-22		
General Location:			
GPS Coordinates:	Northerly	46	04.102
	Westerly	66	36.030
Erosion Severity:	Moderate		
Recommended Remedial Action:	Trees/Shrubs		
Eroding Bank Height (approx meters):	1.5		
Eroding Bank Length (approx meters):	450		
Channel Location:	Main		
Bank Location:	Left Hand Bank		
Special Location Instructions:	Mammalian inputs from here to bottom of ER-29

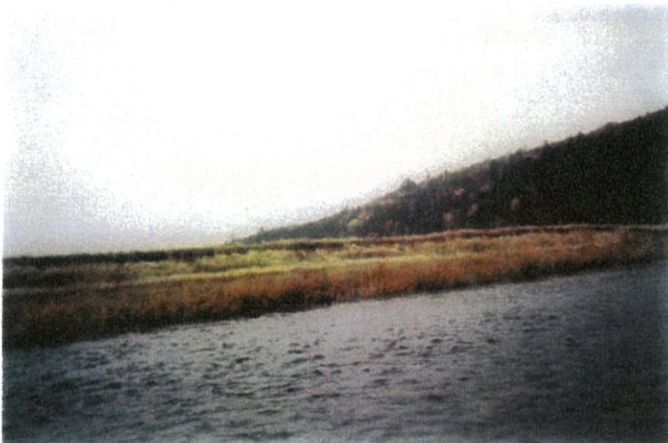
Photo # ER-25d

NWA I Eroding Bank Survey, ETF Project 2004/2005				
Eroding Bank Number:	ER-25			
General Location:	Cell tower visible		Start	End
GPS Coordinates:	Northerly	46	03.263	02.570
	Westerly	66	35.693	35.343
Erosion Severity:	Moderate			
Recommended Remedial Action:	Trees/Shrubs			
Eroding Bank Height (approx meters):	1 – 3			
Eroding Bank Length (approx meters):	1 480			
Channel Location:	LHC & RHC (RHC observed @ start/end of island)			
Bank Location:	LHB for 2000m and all around island (less @ RHC-LHB near bottom)			
Special Location Instructions:	GPS Marked @ start and finish

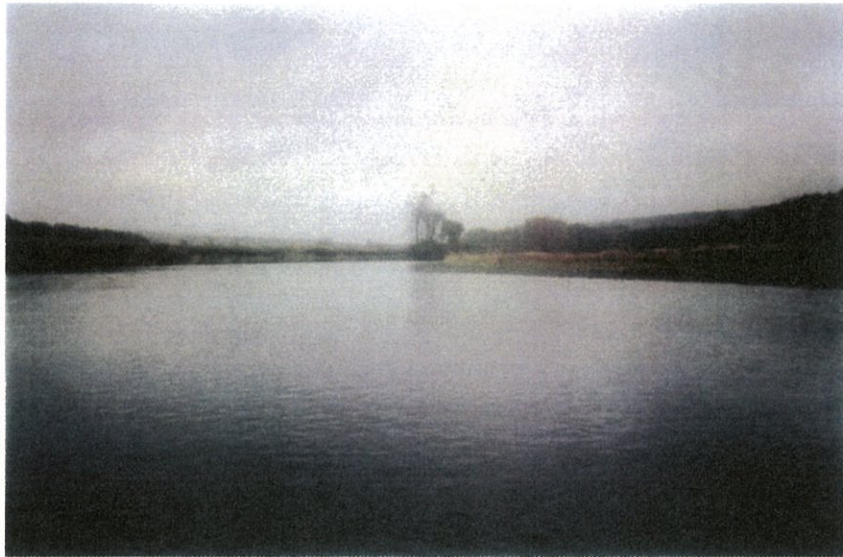
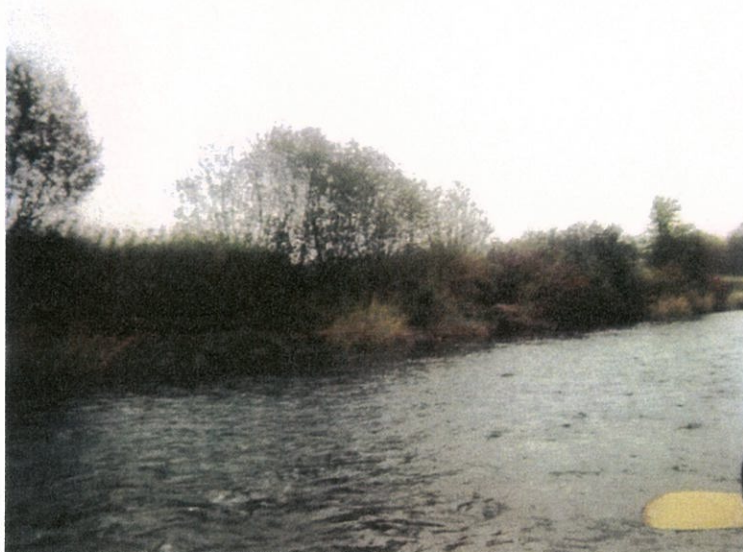
NWAJ Eroding Bank Survey, ETF Project 2004/2005			
Eroding Bank Number	ER-26		
General Location		Start	End
GPS Coordinates	Northerly	46 02.162	01.968
	Westerly	66 35.306	35.145
Erosion Severity	Moderate & minor		
Recommended Remedial Action	Trees/Shrubs		
Eroding Bank Height (approx meters)	2.4		
Eroding Bank Length (approx meters)	170		
Channel Location	Left Hand Channel near top of island		
Bank Location	Left Hand Bank then Right Hand Bank		
Special Location Instructions	GPS Marked @ top/bottom of site

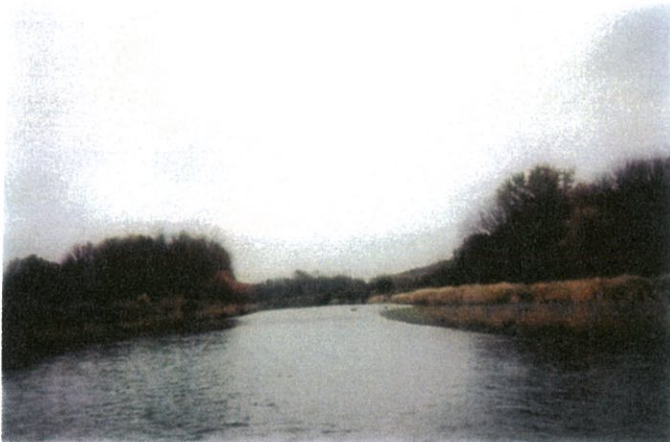
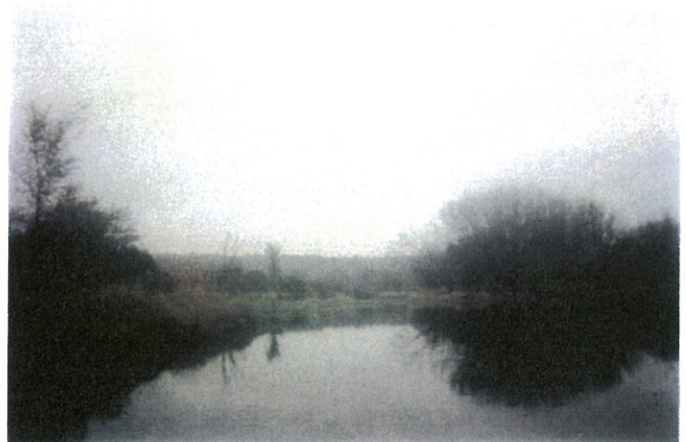
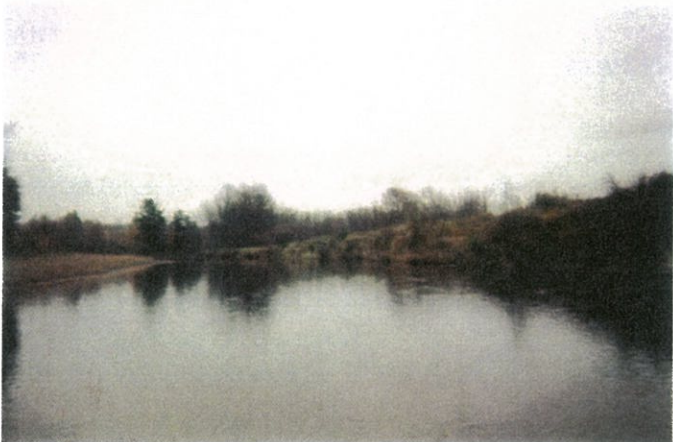
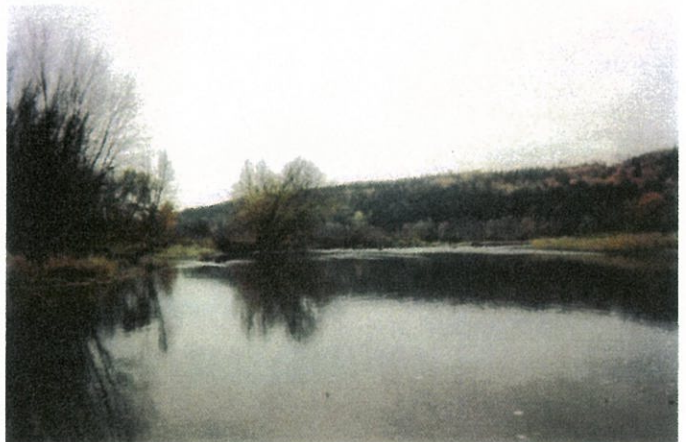
NWAJ Eroding Bank Survey, ETF Project 2004/2005			
Eroding Bank Number	ER-27		
General Location	Top of Penniac Island (at split)		
GPS Coordinates	Northerly	46	01.829
	Westerly	66	35.017
Erosion Severity	Moderate		
Recommended Remedial Action	Trees/Shrubs		
Eroding Bank Height (approx meters)	2.4		
Eroding Bank Length (approx meters)	150		
Channel Location	Main and Left Hand Channel		
Bank Location	Main -Left Hand Bank, Left Hand Channel - Left Hand Bank		
Special Location Instructions	GPS Marked @ top of site

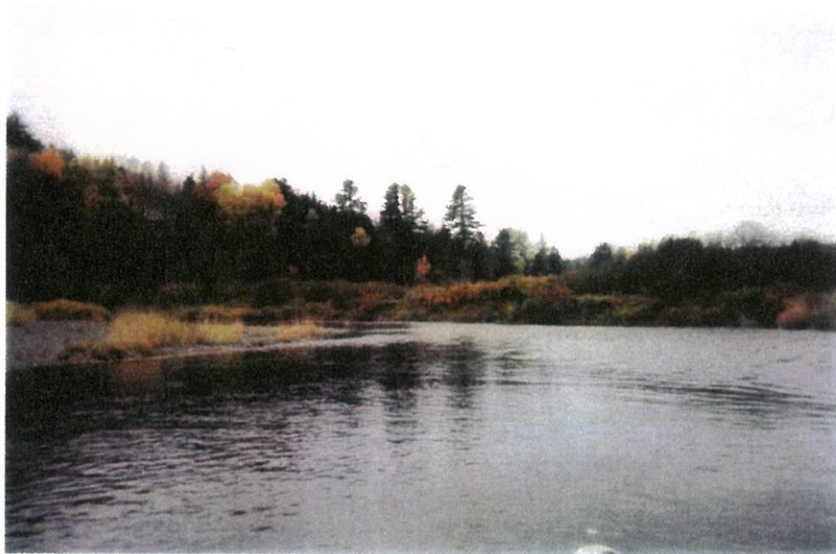
Photo # ER-28a

Eroding Bank Number	ER-28	
General Location	at Hwy 8	
GPS Coordinates	Northerly	46 01.758
	Westerly	66 35.355
Erosion Severity	Moderate to major	
Recommended Remedial Action	Trees/Shrubs, possibly Engineered	
Eroding Bank Height (approx meters)	3	
Eroding Bank Length (approx meters)	120	
Channel Location	Right Hand Channel	
Bank Location	Right Hand Bank	
Special Location Instructions	GPS Marked @ top of site

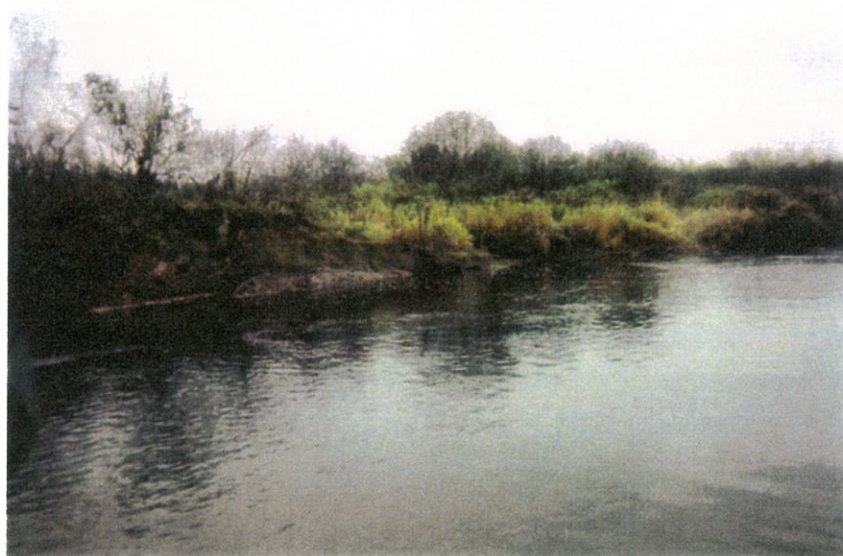
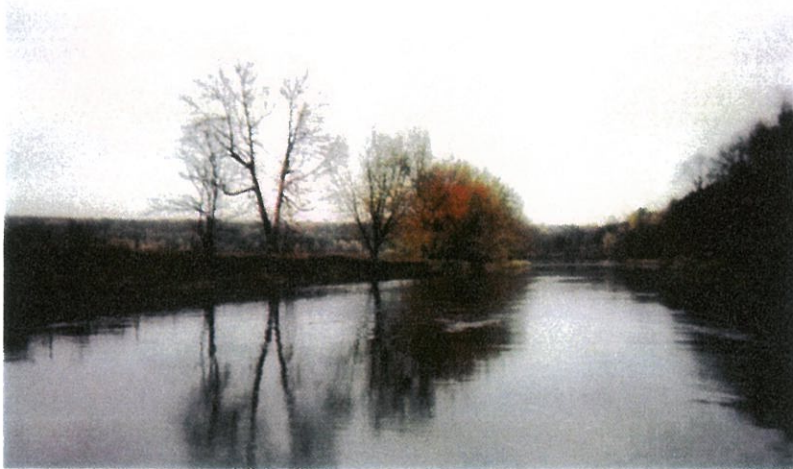
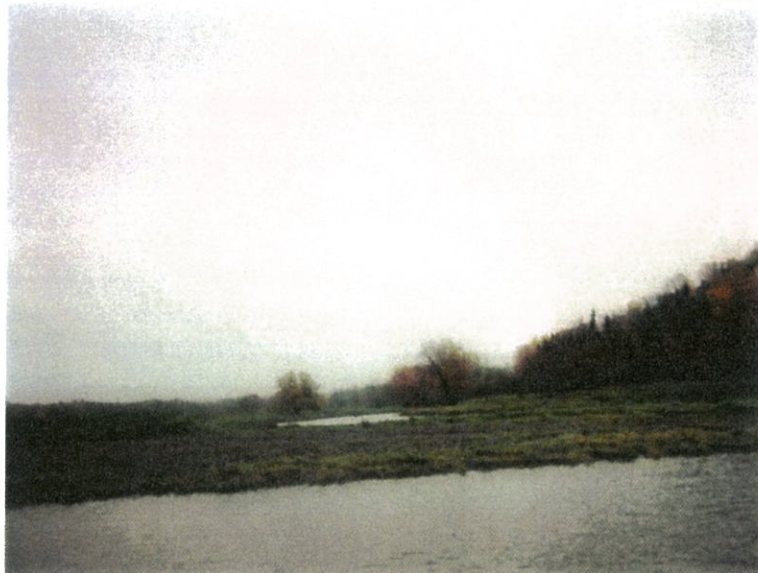
Eroding Bank Number:	ER-29		
General Location:	Long stretch ending bottom of Penniac Island	Start	End
GPS Coordinates:	Northerly	46 01.636	01.191
	Westerly	66 35.287	34.706
Erosion Severity:	Moderate, minor in small places		
Recommended Remedial Action:	Trees/Shrubs		
Eroding Bank Height (approx meters):	1 to 2		
Eroding Bank Length (approx meters):	1 142		
Channel Location:	Right Hand Channel		
Bank Location:	Both sides, also RHB of LHC re-joining at bottom of P. Island		
Special Location Instructions:	GPS Marked @ top/bottom

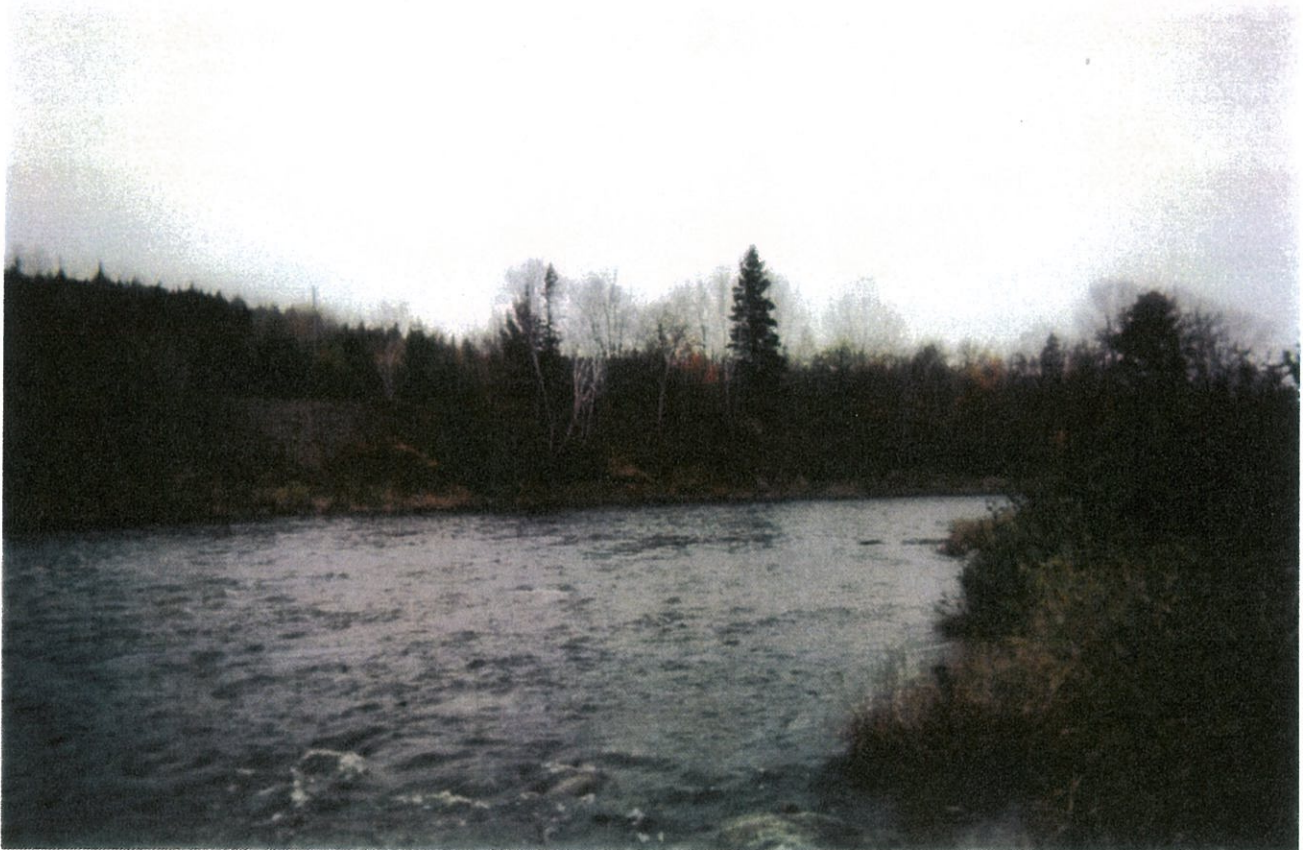
Photo # ER-30

Eroding Bank Number:	ER-30		
General Location:	Sewage lagoon – Stanley		
GPS Coordinates:	Northerly	46	16.840
	Westerly	66	44.092
Erosion Severity:	Major		
Recommended Remedial Action:	Engineered?		
Eroding Bank Height (approx meters):	4.2 (stable) and 1.2 erosion under trees		
Eroding Bank Length (approx meters):	45 (stable) 8 m eroding under trees		
Channel Location:	Main		
Bank Location:	Right Hand Bank		
Special Location Instructions:	GPS marked at top of site. Appears to have been stable for > 25 years

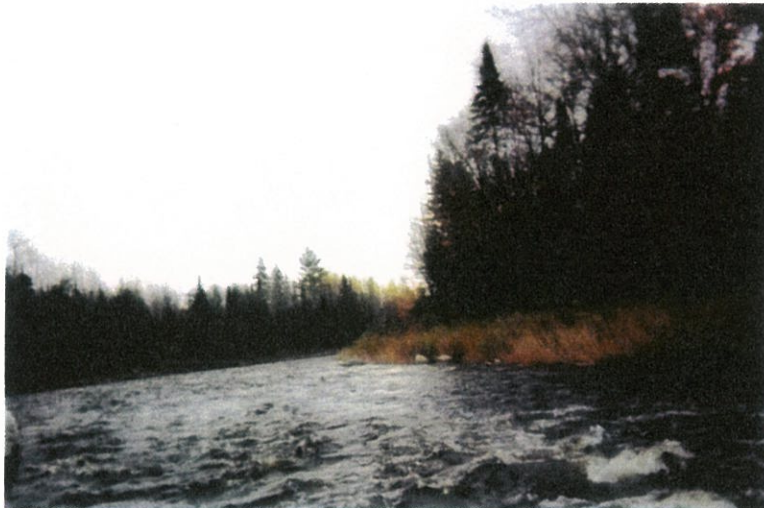
Photo # ER-32a

Nwai Eroding Bank Survey, ETF Project 2004/2005			
Eroding Bank Number:	ER-32		
General Location:	Near camps		
GPS Coordinates:	Northerly	46	16.346
	Westerly	66	42.519
Erosion Severity:	Moderate		
Recommended Remedial Action:	Trees/shrubs		
Eroding Bank Height (approx meters):	3.9		
Eroding Bank Length (approx meters):	3		
Channel Location:	Main		
Bank Location:	Left Hand Bank		
Special Location Instructions:	GPS Marked at site

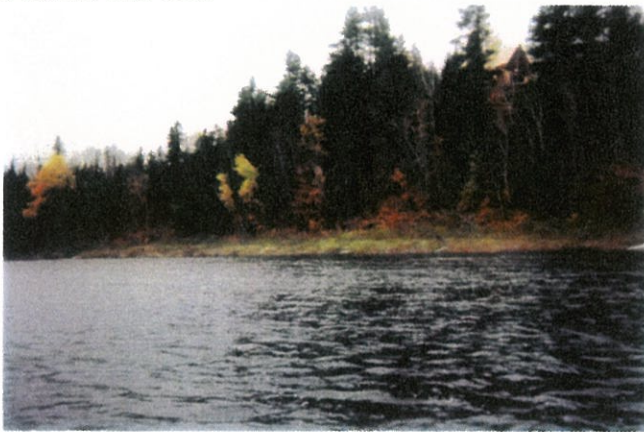
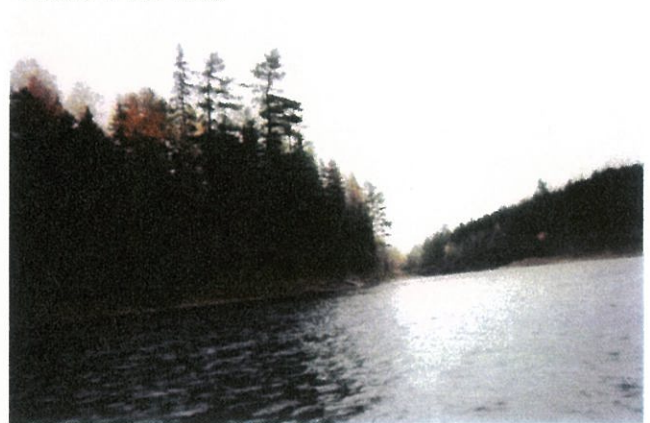
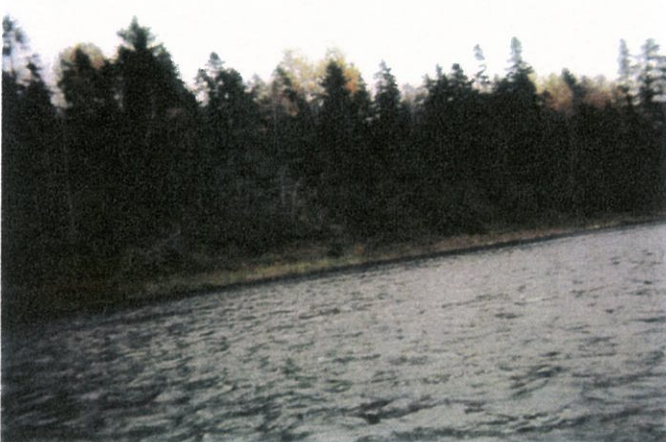
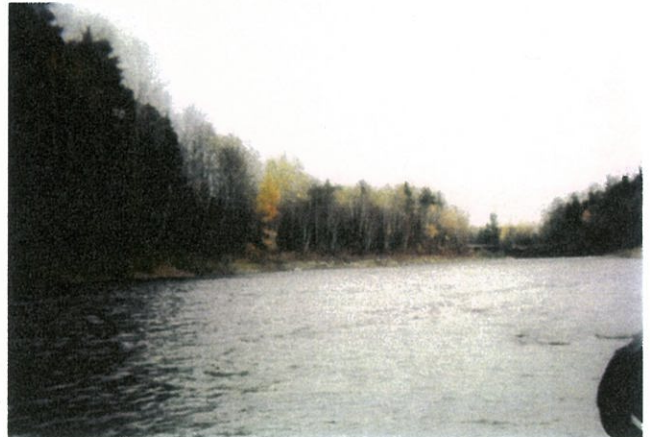
NWA I Eroding Bank Survey, ETF Project 2004/2005				
Eroding Bank Number:	ER-33			
General Location:		Start	End	
GPS Coordinates:	Northerly	46	16.335	16.200
	Westerly	66	40.698	40.413
Erosion Severity:	Minor			
Recommended Remedial Action:	Trees?, Additional filter fabric			
Eroding Bank Height (approx meters):	1.8			
Eroding Bank Length (approx meters):	480			
Channel Location:	Main			
Bank Location:	Left Hand Bank			
Special Location Instructions:	Can't save "major" upper end -- potential for more erosion

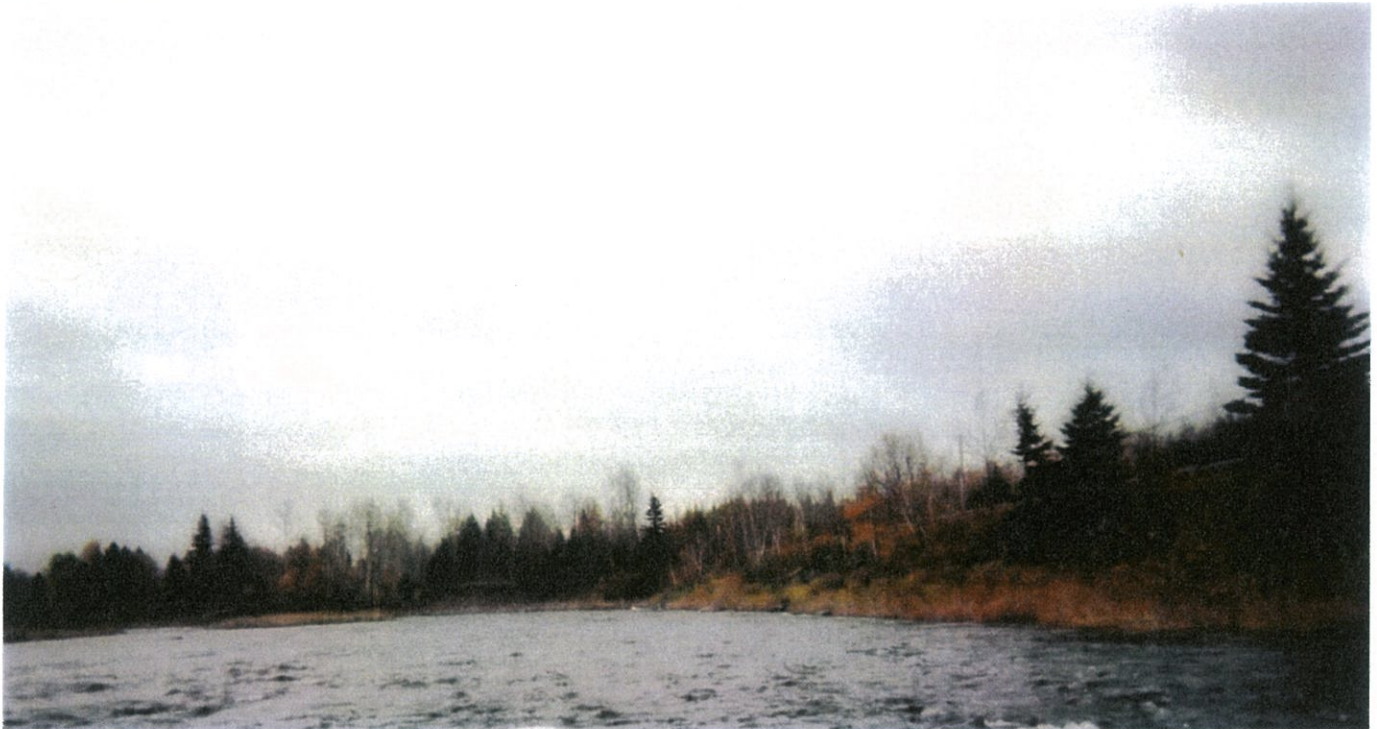
Photo ER-34

NWAJ Eroding Bank Survey, ETF Project 2004/2005			
Eroding Bank Number:	ER-34		
General Location:	Beside Hwy 107 @ MacGlaggon Straight		
GPS Coordinates:	Northerly	46	16.087
	Westerly	66	39.716
Erosion Severity:	Major		
Recommended Remedial Action:	Engineered		
Eroding Bank Height (approx meters):	1.5 – 3		
Eroding Bank Length (approx meters):	40		
Channel Location:	Main		
Bank Location:	Right Hand Bank		
Special Location Instructions:	GPS Marked at site

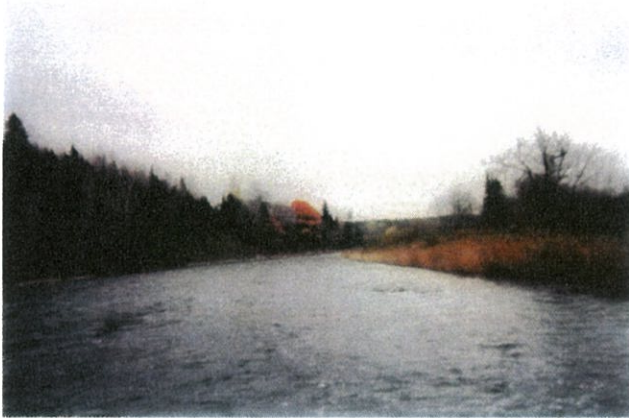
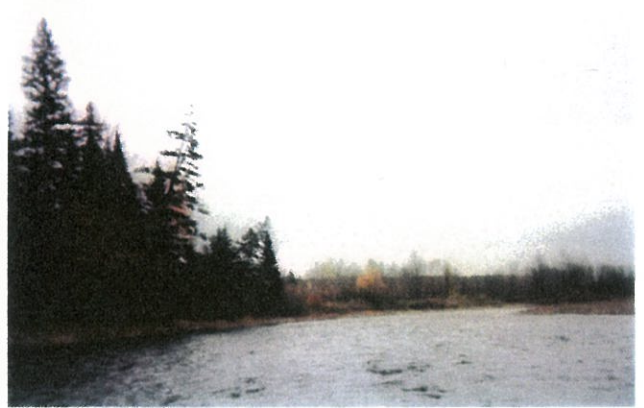
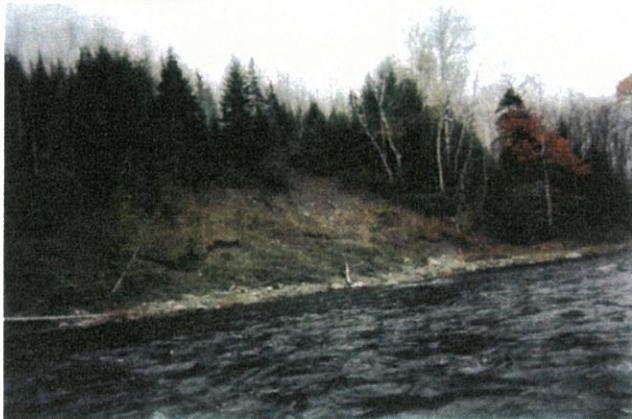
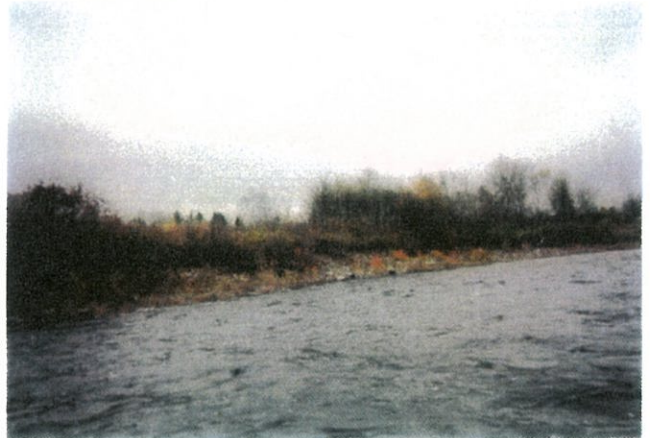
NWAJ Eroding Bank Survey, ETF Project 2004/2005	
Eroding Bank Number:	ER-35
General Location:	Above confluence of Cross Creek Stream
GPS Coordinates:	Northerly 46 16.112 Westerly 66 38.808
Erosion Severity:	Major at top 15m and Minor for bottom 30m
Recommended Remedial Action:	Engineered/trees
Eroding Bank Height (approx meters):	6
Eroding Bank Length (approx meters):	15 with 30 minor below
Channel Location:	Main
Bank Location:	Left Hand Bank
Special Location Instructions:	GPS Marked at site

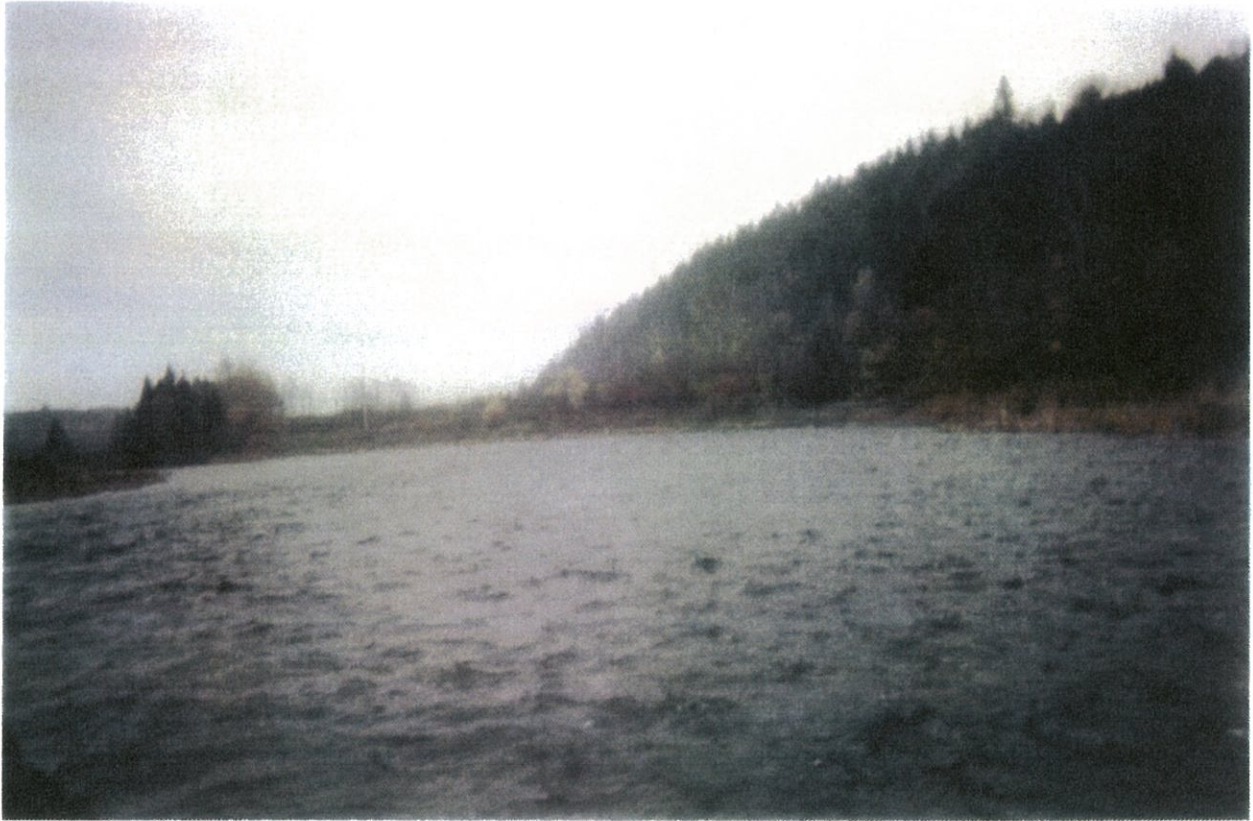
Photo # ER-36

NWA I Eroding Bank Survey, ETF Project 2004/2005			
Eroding Bank Number:	ER-36		
General Location:	Coulters Pool		
GPS Coordinates:	Northerly	46	15.837
	Westerly	66	38.650
Erosion Severity:	Moderate		
Recommended Remedial Action:	Trees, maybe engineered		
Eroding Bank Height (approx meters):	2		
Eroding Bank Length (approx meters):	60		
Channel Location:	Main		
Bank Location:	Right Hand Bank		
Special Location Instructions:	GPS Marked at site

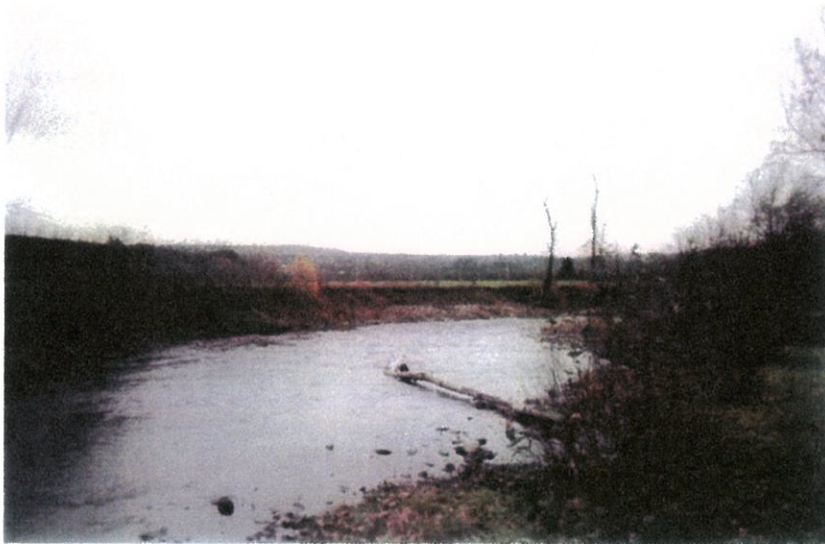
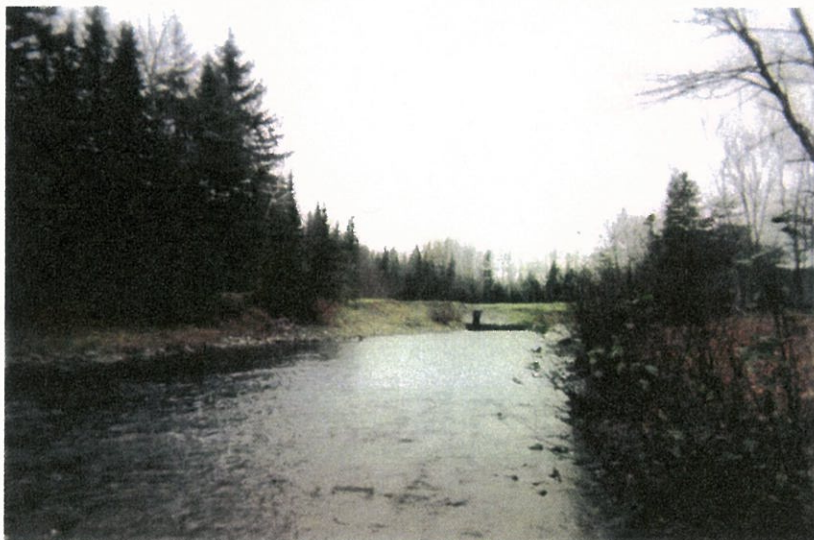
Eroding Bank Number:	39
General Location:	Farm land
GPS Coordinates:	Northerly 46 10.952
	Westerly 66 38.013
Erosion Severity:	Moderate with Major area at end of RHB-RHC
Recommended Remedial Action:	Shrubs
Eroding Bank Height (approx meters):	0.6-2.1
Eroding Bank Length (approx meters):	LHB, LHC = 30 and RHC, RHB = 60
Channel Location:	Left Hand Channel and Right Hand Channel
Bank Location:	(LHC) Left Hand Bank and (RHC) Right Hand Bank
Special Location Instructions:
