Soil Erosion Survey of the Nashwaak River and the Tay, Penniac and Cross Creek Streams

The New Brunswick Department of the Environment and Local Government
P.O. Box 6000
Fredericton, NB
E3B 5H1
March, 2005

The Nashwaak Watershed Association Inc.
P.O. Box 20037
Fredericton, NB
E6B 6Y8

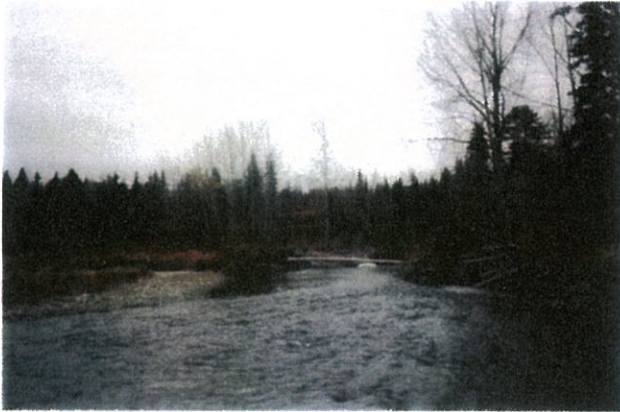
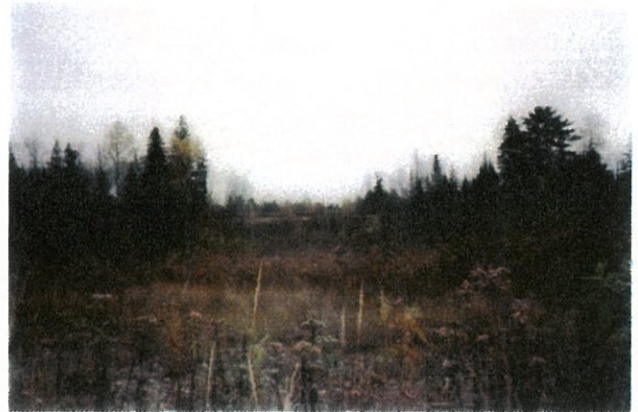
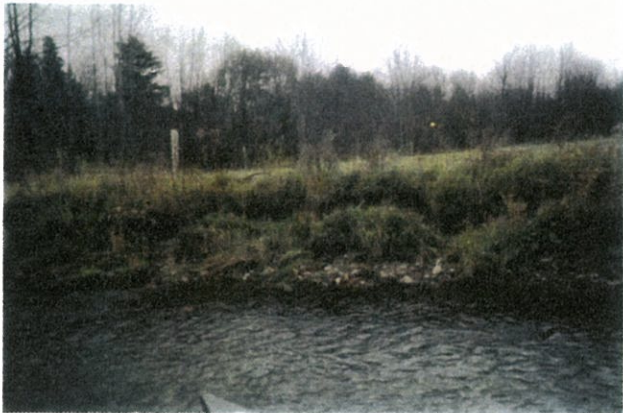
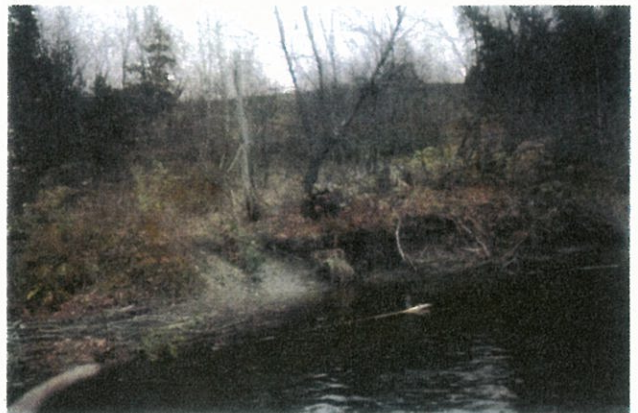
NWAJ Eroding Bank Survey, ETF Project 2004/2005	
Eroding Bank Number:	41
General Location:	Oxbow turn at Englist Settlement Road
GPS Coordinates:	Northerly 46 10.999 Westerly 66 37.462
Erosion Severity:	RHB = Minor, LHC-LHB = Major
Recommended Remedial Action:	Shrubs and Engineered
Eroding Bank Height (approx meters):	0.91 (RHB), 10.7 (LHB)
Eroding Bank Length (approx meters):	RHB = 51.8, LHB=12.2
Channel Location:	Mainstem Tay
Bank Location:	Right Hand Bank and Left Hand Bank
Special Location Instructions:

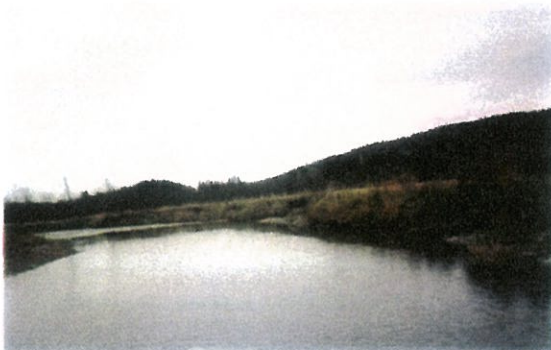
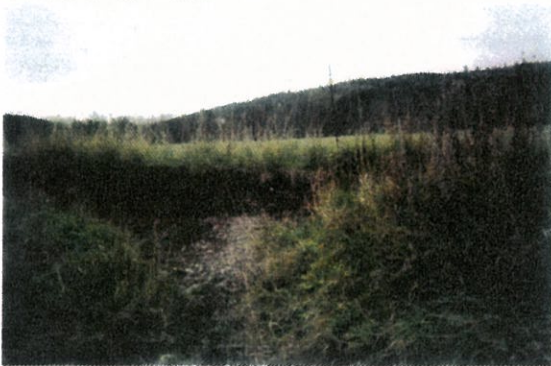
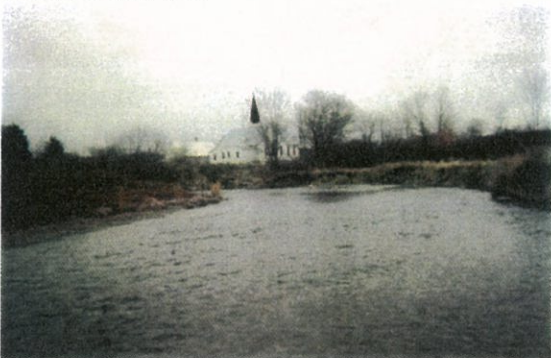
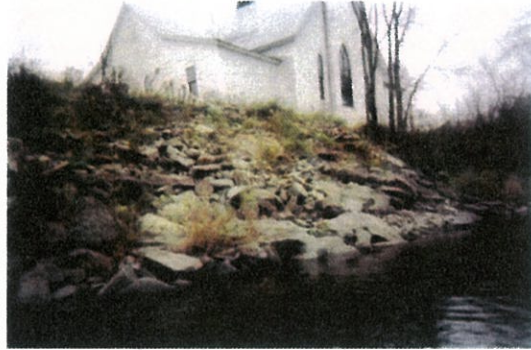
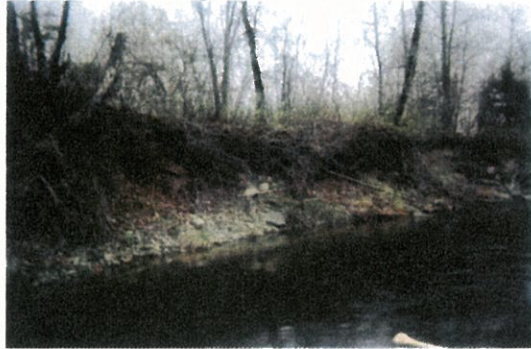
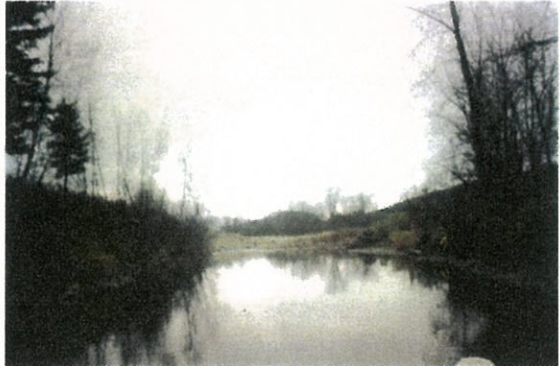
NWA I Eroding Bank Survey, ETF Project 2004/2005			
Eroding Bank Number:	42		
General Location:	Church		
GPS Coordinates:	Northerly	46	10.961
	Westerly	66	37.355
Erosion Severity:	Moderate, Major on bank next to church		
Recommended Remedial Action:	Shrubs/engineered		
Eroding Bank Height (approx meters):	3.1		
Eroding Bank Length (approx meters):	LHB =150, RHB = 180		
Channel Location:	Main Tay River		
Bank Location:	LHB and RHB and LHB again		
Special Location Instructions:

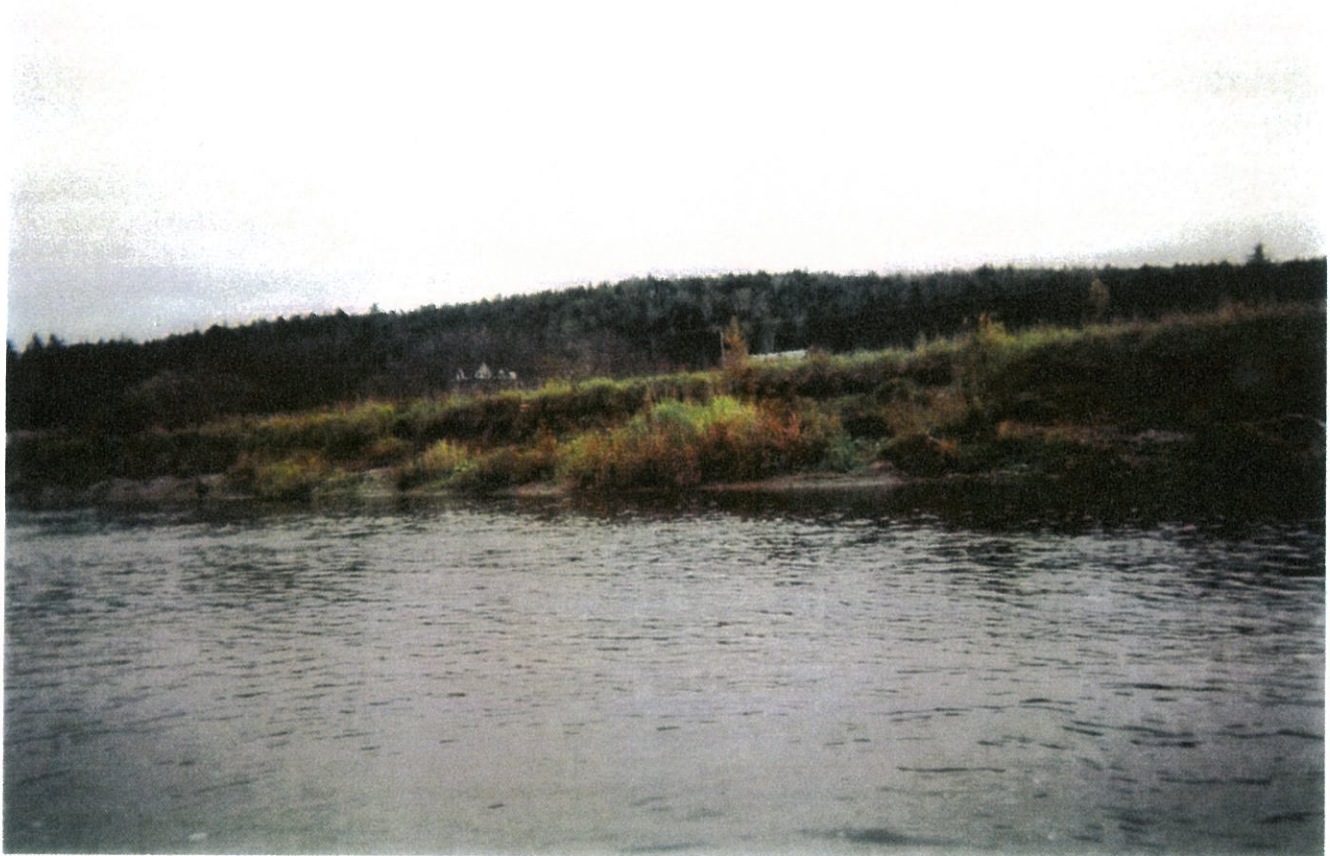
Photo ER-43

NWA I Eroding Bank Survey, ETF Project 2004/2005			
Eroding Bank Number:	43		
General Location:	Mouth of Tay River		
GPS Coordinates:	Northerly	46	10.715
	Westerly	66	37.165
Erosion Severity:	Moderate		
Recommended Remedial Action:	Shrubs		
Eroding Bank Height (approx meters):	1.5		
Eroding Bank Length (approx meters):	61		
Channel Location:	Main Nashwaak		
Bank Location:	Right Hand Bank		
Special Location Instructions:

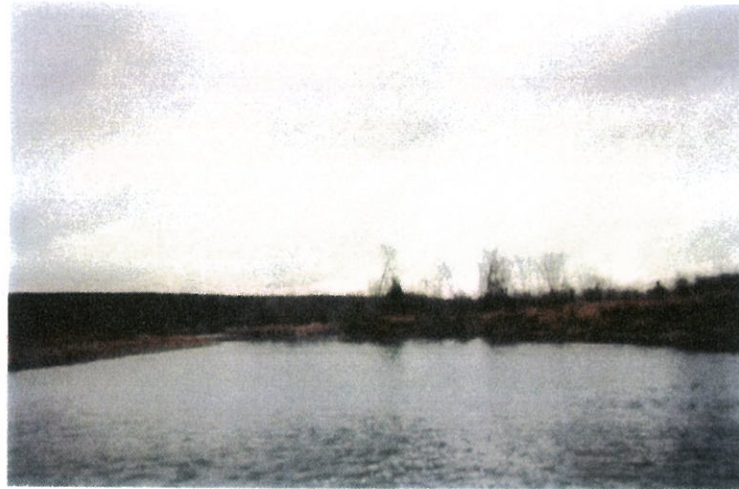
Photo # Er-45b

NWA I Eroding Bank Survey, ETF Project 2004/2005				
Eroding Bank Number:	45			
General Location:	Bottom of 1st island after mouth of Tay	Start	End	
GPS Coordinates:	Northerly	46	10.099	09.819
	Westerly	66	36.928	36.668
Erosion Severity:	Major/Moderate			
Recommended Remedial Action:	Trees/shrubs			
Eroding Bank Height (approx meters):	2.1			
Eroding Bank Length (approx meters):	482			
Channel Location:	Main			
Bank Location:	Right Hand Bank then Left Hand Bank around bend			
Special Location Instructions:	Some rip rap on LHB working well, railbed along major erosion

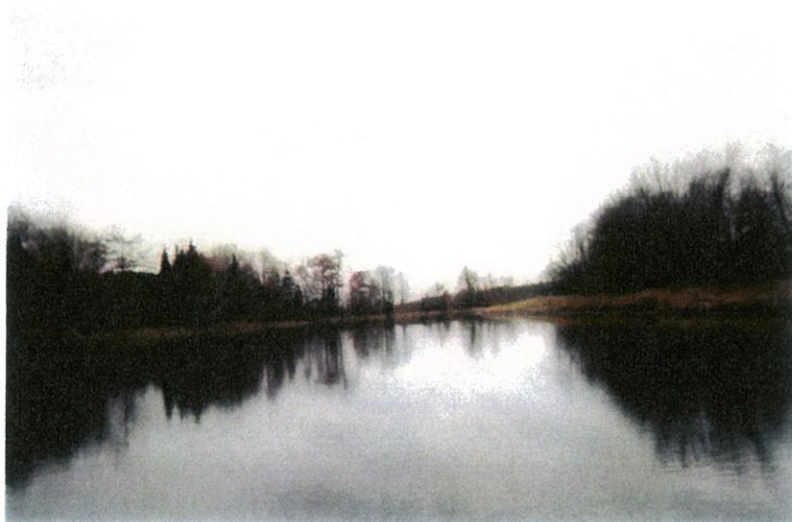
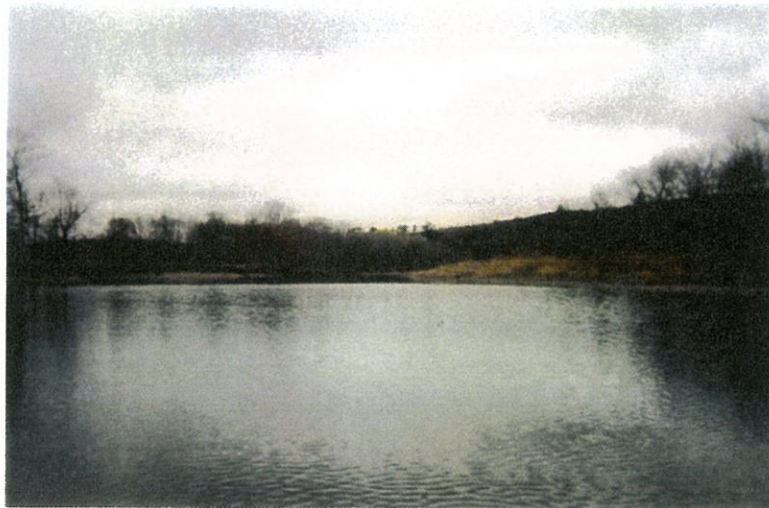
Eroding Bank Number:	46		
General Location:	Above Sterling's Warf		
GPS Coordinates:	Northerly	46 09.665	09.473
	Westerly	66 36.562	36.793
Erosion Severity:	Minor for forest stretch then Moderate for field		
Recommended Remedial Action:	Trees/shrubs		
Eroding Bank Height (approx meters):	2.4		
Eroding Bank Length (approx meters):	530		
Channel Location:	Main		
Bank Location:	Left Hand Bank		
Special Location Instructions:

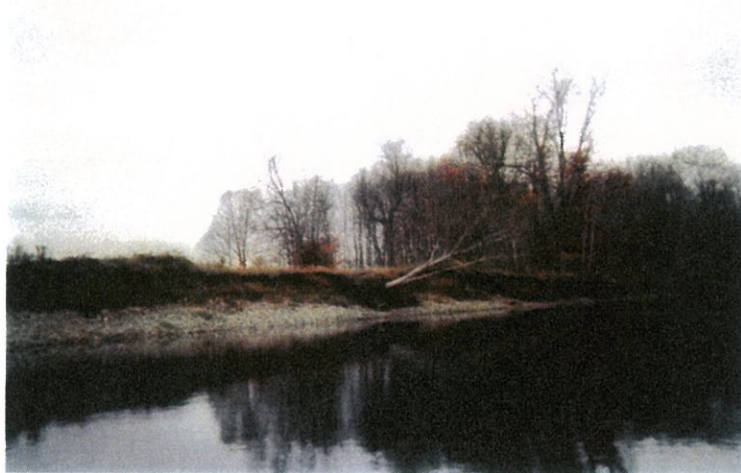
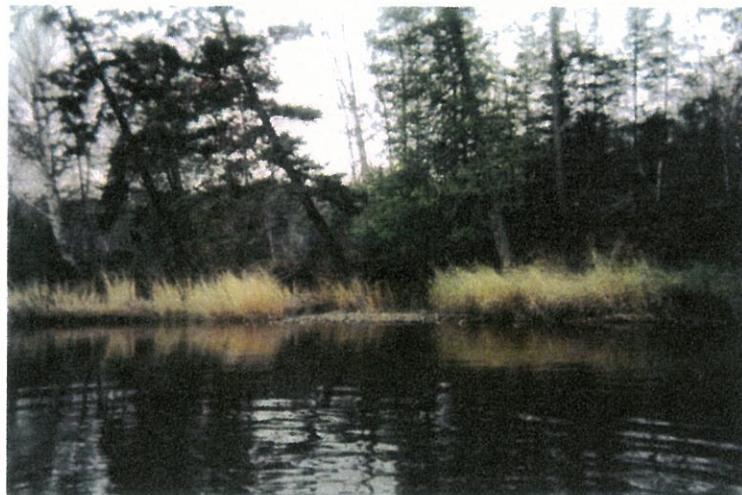
NWAJ Eroding Bank Survey, ETF Project 2004/2005			
Eroding Bank Number:	47		
General Location:	Above Dunbar Brook		
GPS Coordinates:	Northerly	46	08.647
	Westerly	66	36.653
Erosion Severity:	Moderate		
Recommended Remedial Action:	Trees/shrubs		
Eroding Bank Height (approx meters):	1.2-1.5		
Eroding Bank Length (approx meters):	137		
Channel Location:	Main		
Bank Location:	Left Hand Bank		
Special Location Instructions:

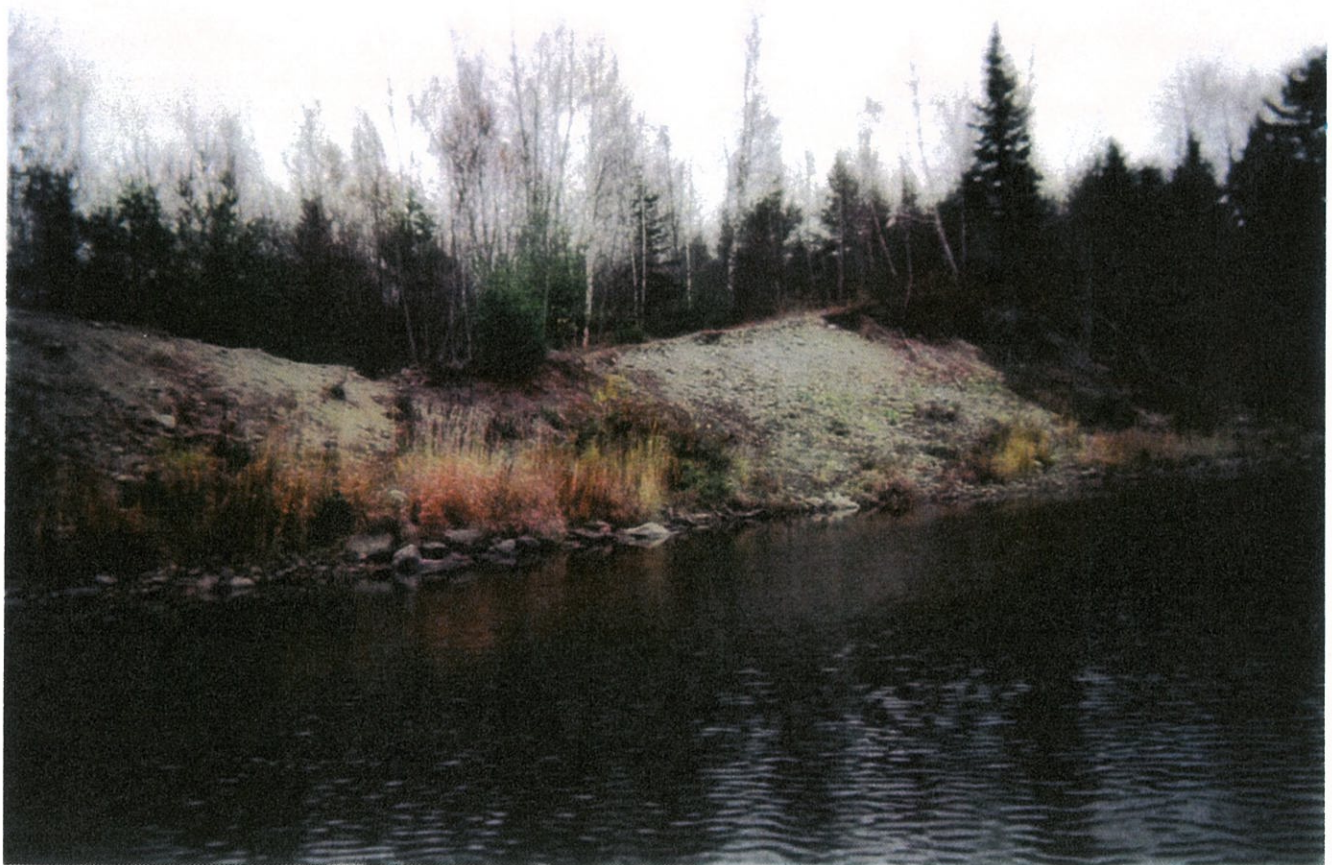
Photo # ER-48

NWA I Eroding Bank Survey, ETF Project 2004/2005			
Eroding Bank Number:	48		
General Location:	Upstream from Durham Bridge		
GPS Coordinates:	Northerly	46	07.859
	Westerly	66	36.722
Erosion Severity:	Major		
Recommended Remedial Action:	Engineered		
Eroding Bank Height (approx meters):	4.6-7.6		
Eroding Bank Length (approx meters):	12		
Channel Location:	Left Hand Channel		
Bank Location:	Left Hand Bank		
Special Location Instructions:

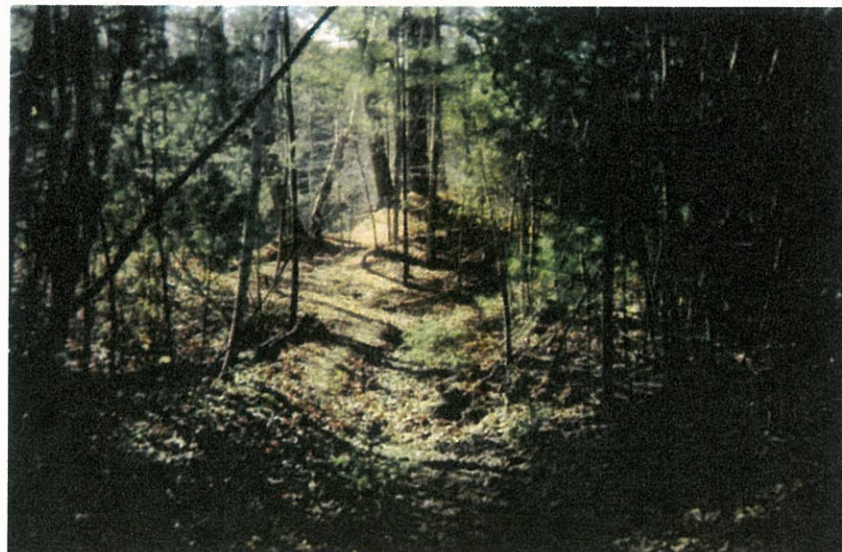
Photo # ER-50b

NWAJ Eroding Bank Survey, ETF Project 2004/2005			
Eroding Bank Number:	50		
General Location:	Near closed gas station approx 1 km above Marysville Bridge		
GPS Coordinates:	Northerly	45	59.502
	Westerly	66	34.654
Erosion Severity:	Moderate		
Recommended Remedial Action:	Rocks for channel running down eroding bank		
Eroding Bank Height (approx meters):	0.8		
Eroding Bank Length (approx meters):	2		
Channel Location:	Main		
Bank Location:	Right Hand Bank		
Special Location Instructions:

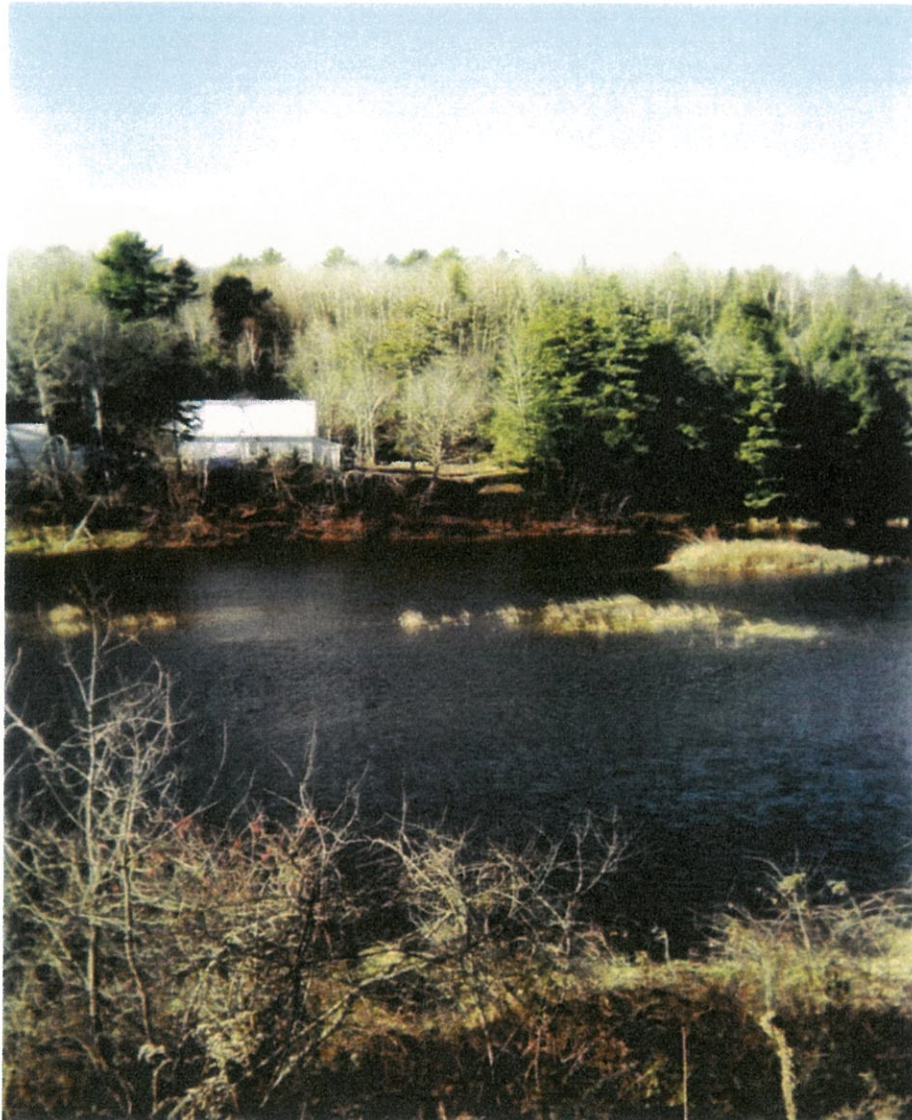
Photo # ER-51

Eroding Bank Number:	51
General Location:	400 m downstream from Penniac Bridge
GPS Coordinates:	Northerly 46 00.080
	Westerly 66 34.593
Erosion Severity:	Major
Recommended Remedial Action:	Trees and shrubs
Eroding Bank Height (approx meters):	4
Eroding Bank Length (approx meters):	10
Channel Location:	Main
Bank Location:	Right Hand Bank
Special Location Instructions:

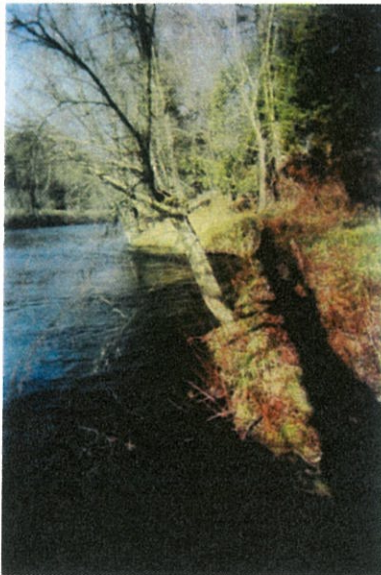
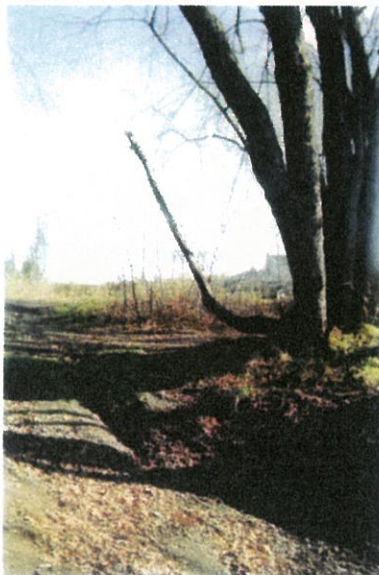
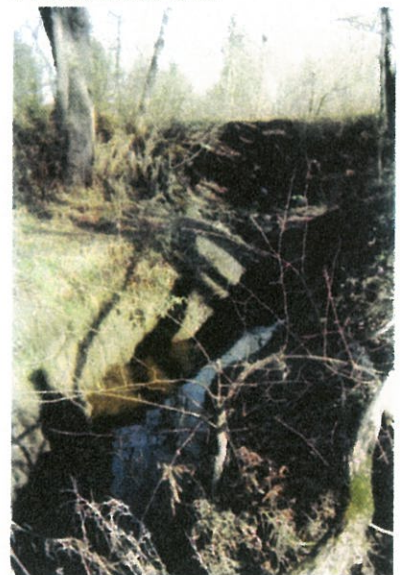
Eroding Bank Number:	52
General Location:	Just below Penniac Bridge
GPS Coordinates:	Northerly 46 00.399
	Westerly 66 34.792
Erosion Severity:	Moderate-Major
Recommended Remedial Action:	Trees/Shrubs/Engineered?
Eroding Bank Height (approx meters):	1 -- 2
Eroding Bank Length (approx meters):	12.5
Channel Location:	Left Hand Channel
Bank Location:	Left Hand Bank
Special Location Instructions:	Large culvert has extremely eroded gully.

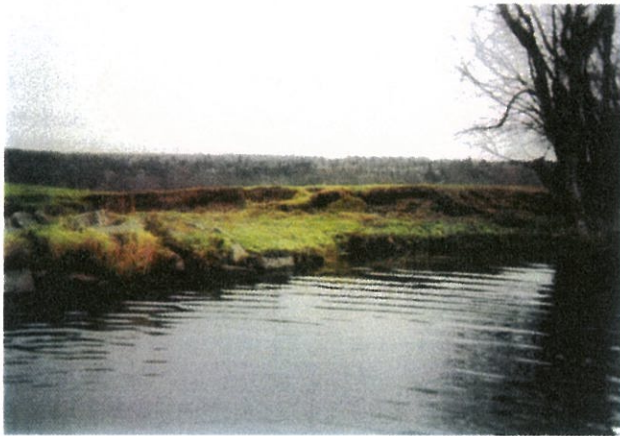
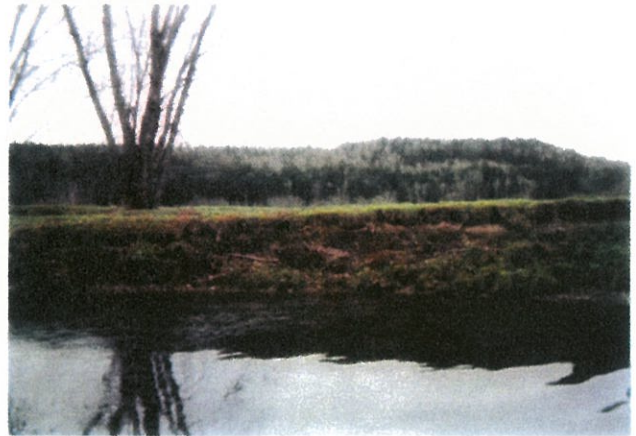
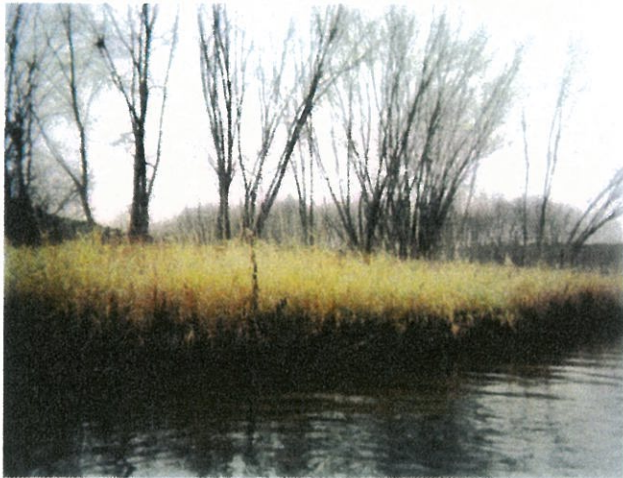
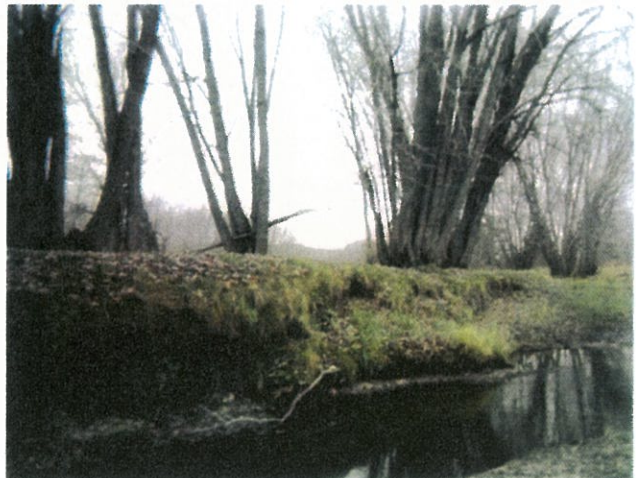
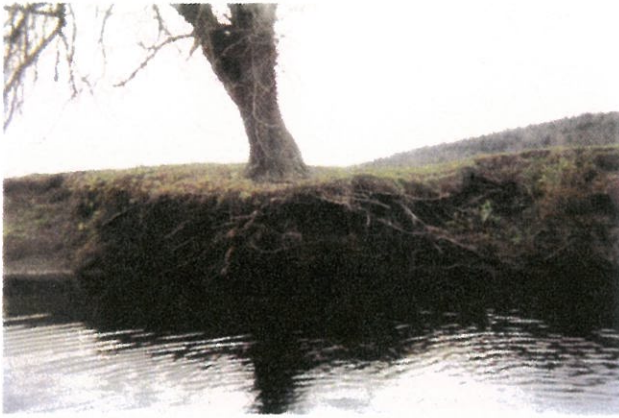
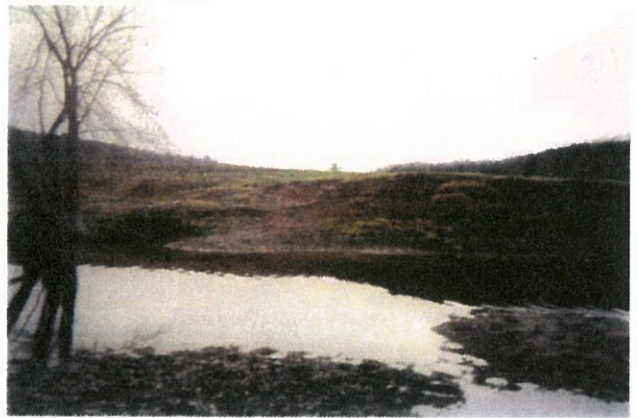
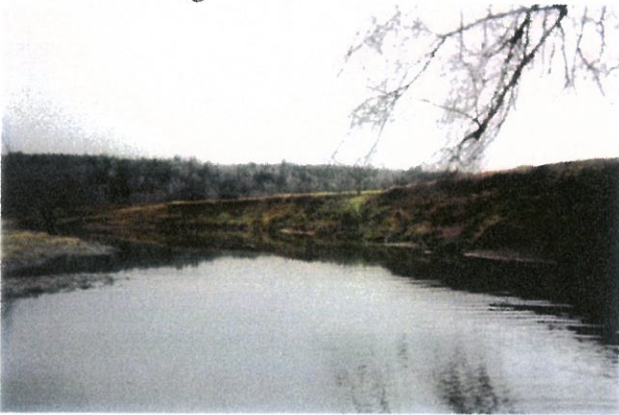
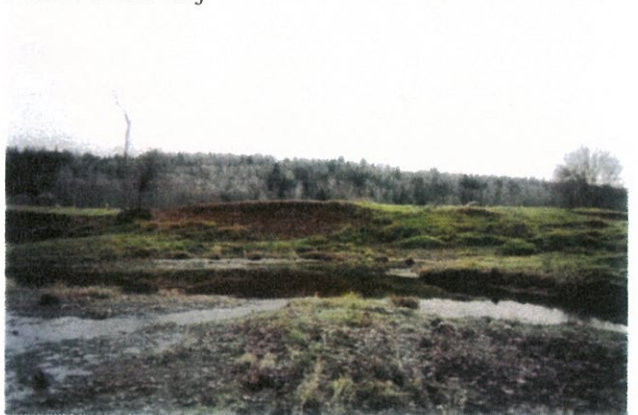
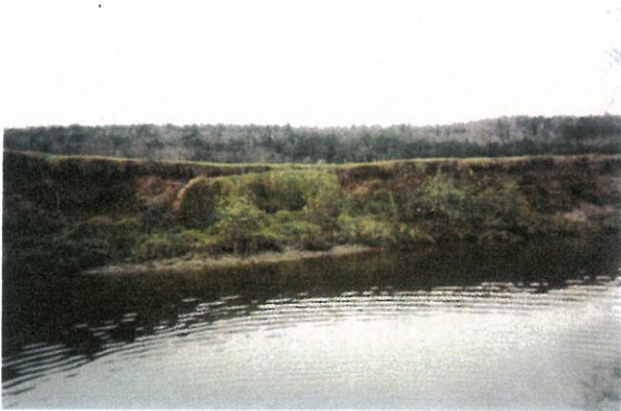
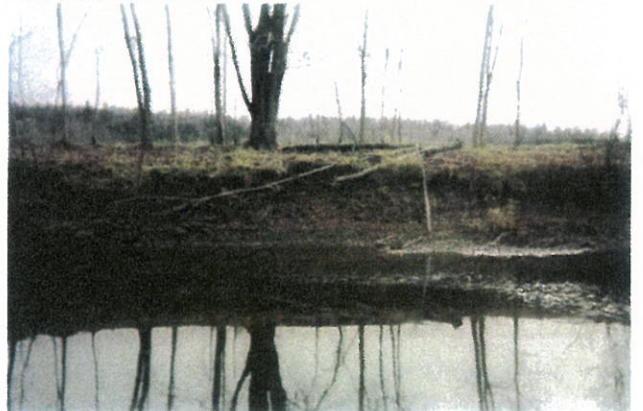
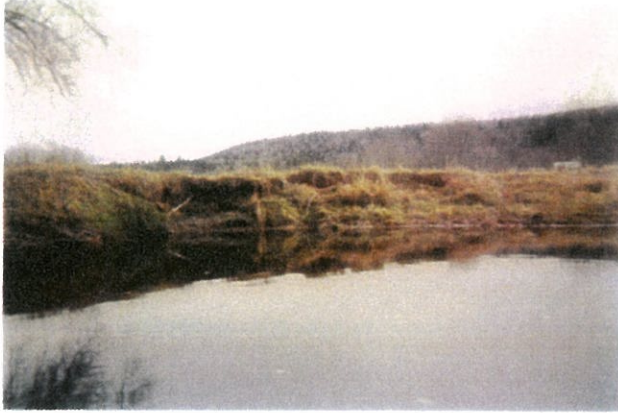
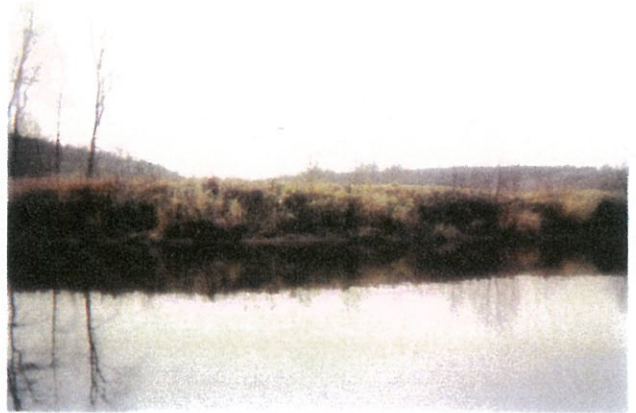
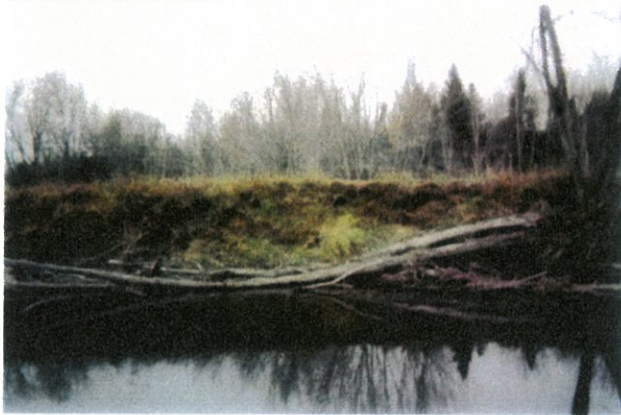
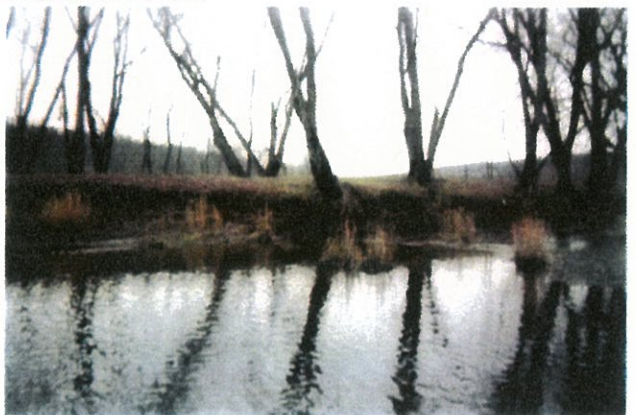
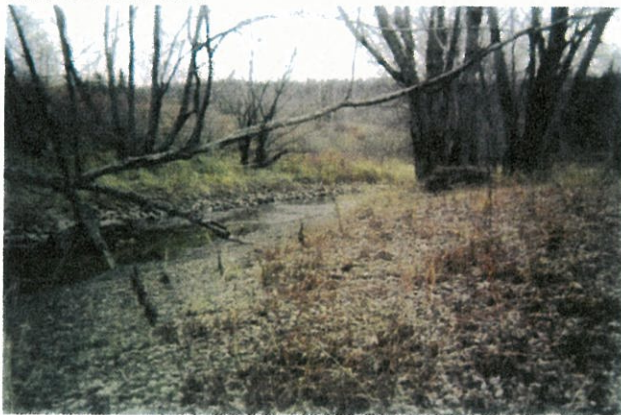
NWAJ Eroding Bank Survey, ETF Project 2004/2005			
Eroding Bank Number:	53		
General Location:	Left Hand Channel around Penniac Island		
Channel Location:	Left hand Channel		
GPS Coordinates	Northerly	46 01.775	01.817
	Westerly	66 34.962	34.440
Erosion Severity:	Major, Moderate and Minor		
Recommended Remedial Action:	Trees and Shrubs		
Eroding Bank Height (approx meters):	<1m to 4m		
Eroding Bank Length (approx meters):	?		
Bank Location:	Both banks intermittently, majority eroded		
Special Location Instructions:	Long and varied site, many areas of severe erosion

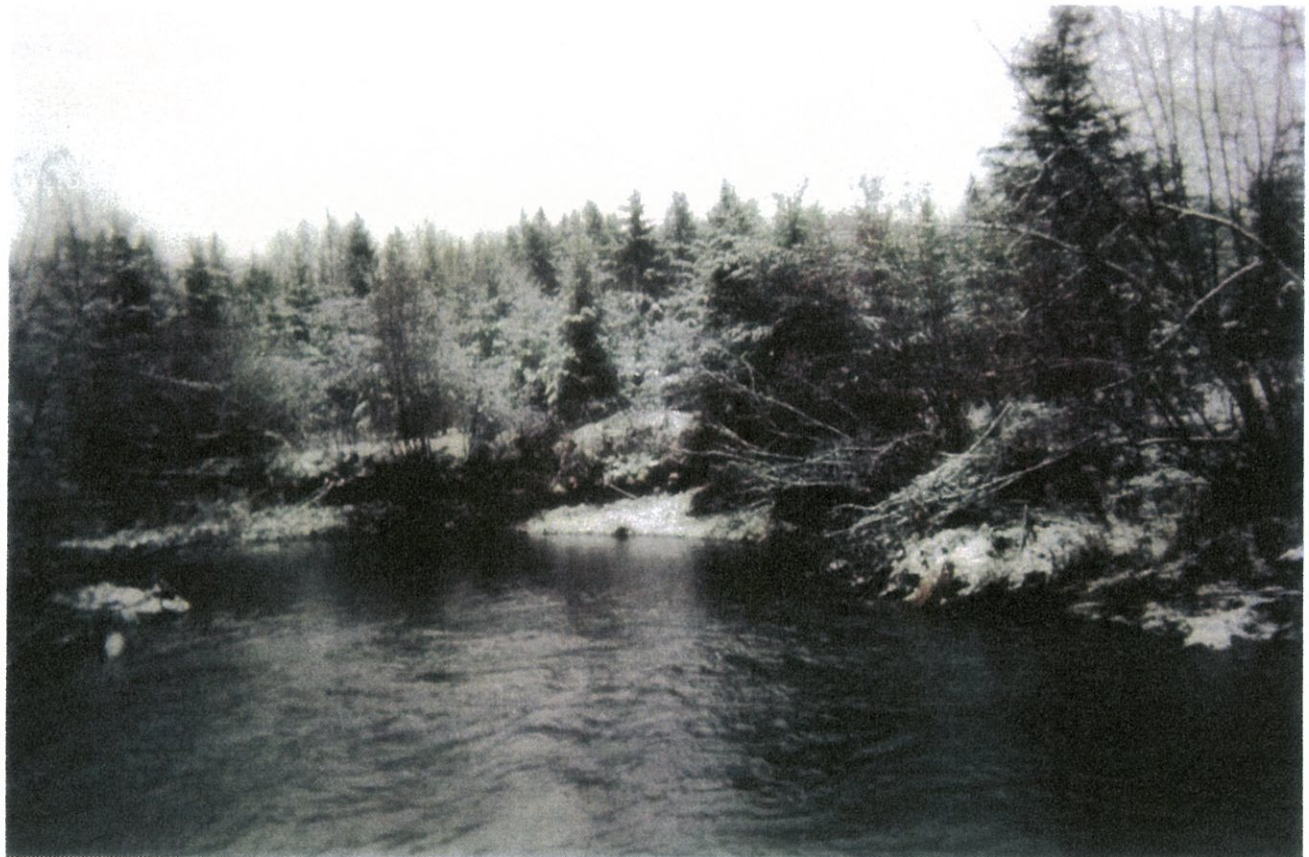
Photo # 60

NWA I Eroding Bank Survey, ETF Project 2004/2005			
Eroding Bank Number:	60		
General Location:	Below Harry Allen Bridge		
GPS Coordinates:	Northerly	46	02.707
	Westerly	66	32.451
Erosion Severity:	Moderate		
Recommended Remedial Action:	Trees		
Eroding Bank Height (approx meters):	2.5		
Eroding Bank Length (approx meters):	20		
Channel Location:	Penniac Stream		
Bank Location:	Left Hand Bank		
Special Location Instructions:

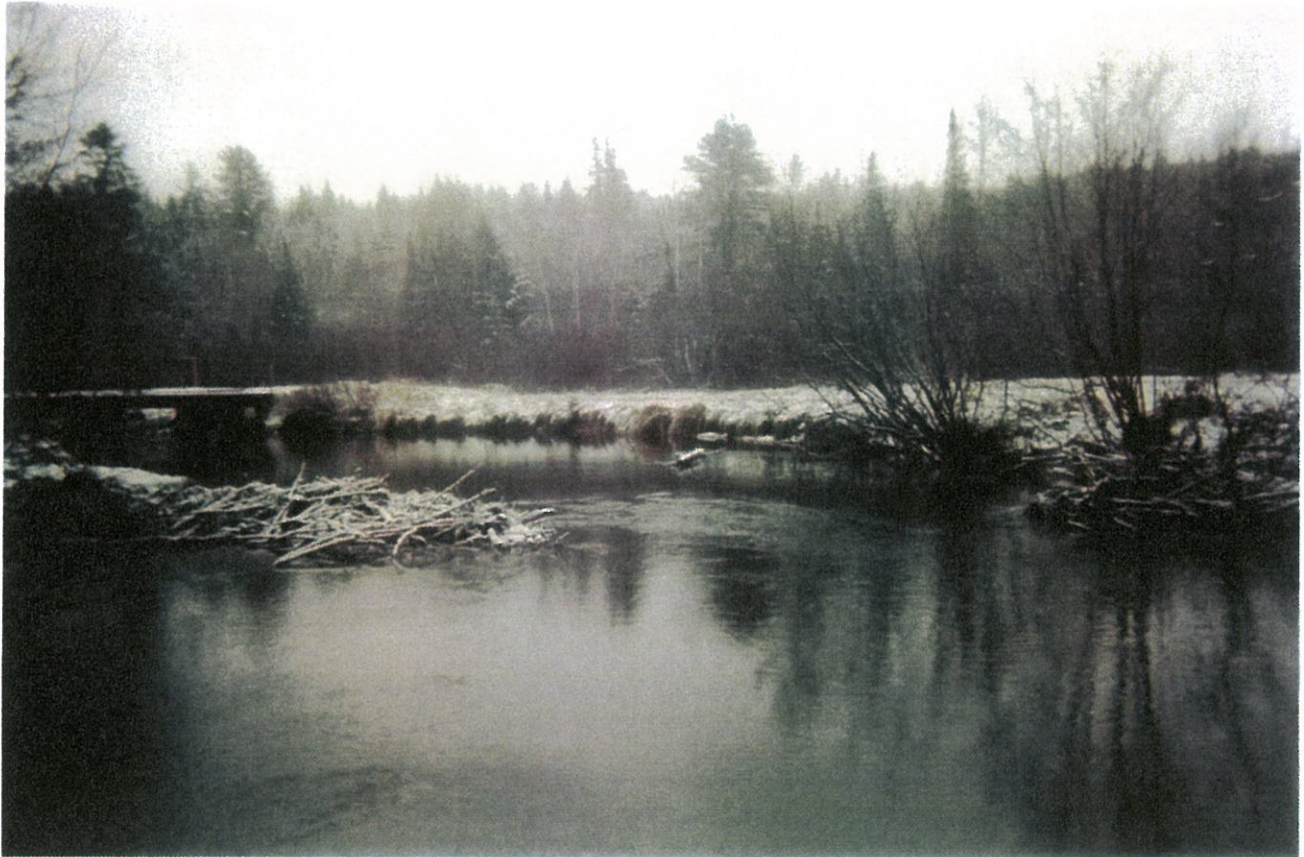
Photo # 63

NWAJ Eroding Bank Survey, ETF Project 2004/2005			
Eroding Bank Number:	63		
General Location:	Farmers Bridge Site		
GPS Coordinates:	Northerly	46	02.466
	Westerly	66	33.279
Erosion Severity:	Minor		
Recommended Remedial Action:	Trees/Shrubs		
Eroding Bank Height (approx meters):	0.6		
Eroding Bank Length (approx meters):	10		
Channel Location:	Main Penniac		
Bank Location:	Left Hand Bank		
Special Location Instructions:

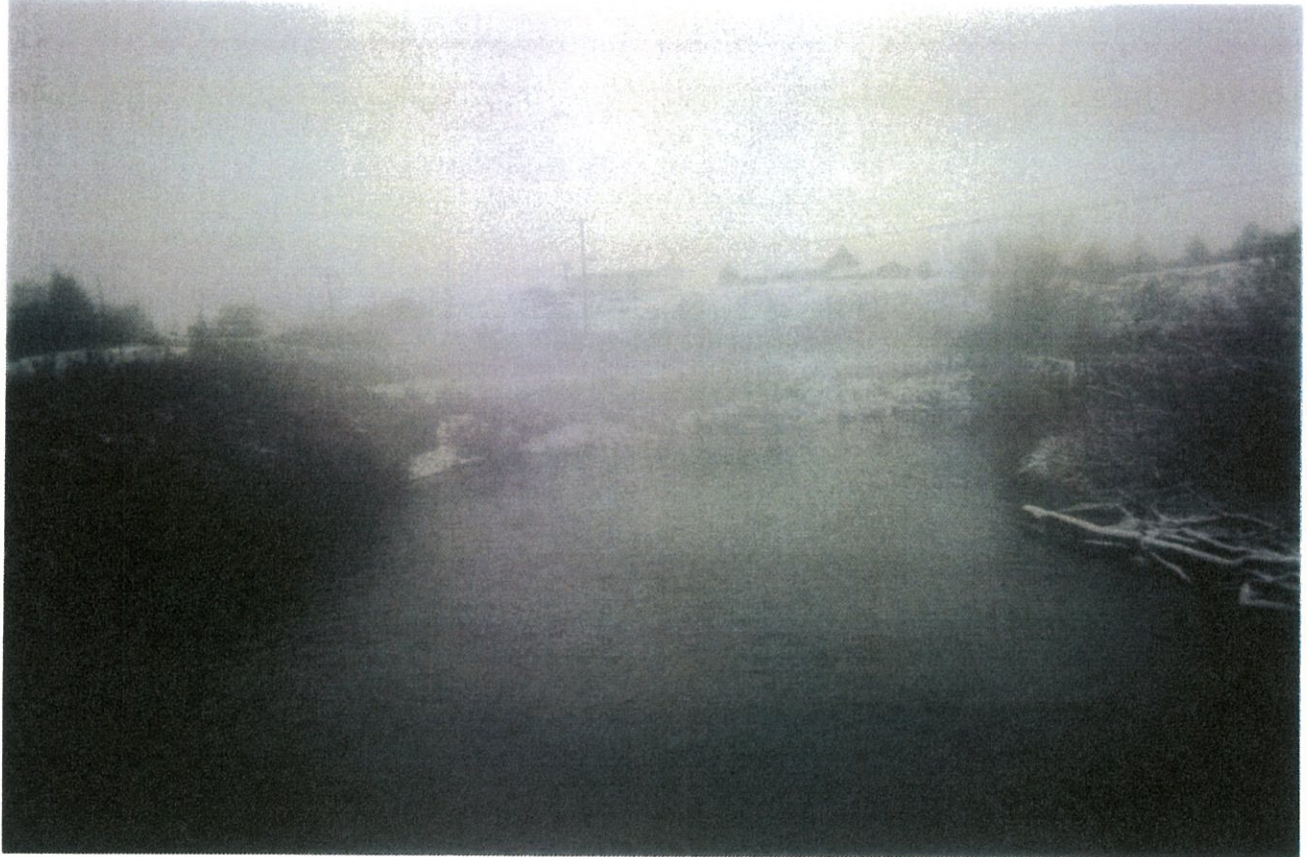
Photo # ER-64

Eroding Bank Number:	64		
General Location:	Just above sharp stream turn beside road		
GPS Coordinates:	Northerly	46	2.500
	Westerly	66	33.36
Erosion Severity:	Moderate		
Recommended Remedial Action:	Trees/Shrubs		
Eroding Bank Height (approx meters):	1.2		
Eroding Bank Length (approx meters):	15		
Channel Location:	Main Penniac		
Bank Location:	Left Hand Bank		
Special Location Instructions:

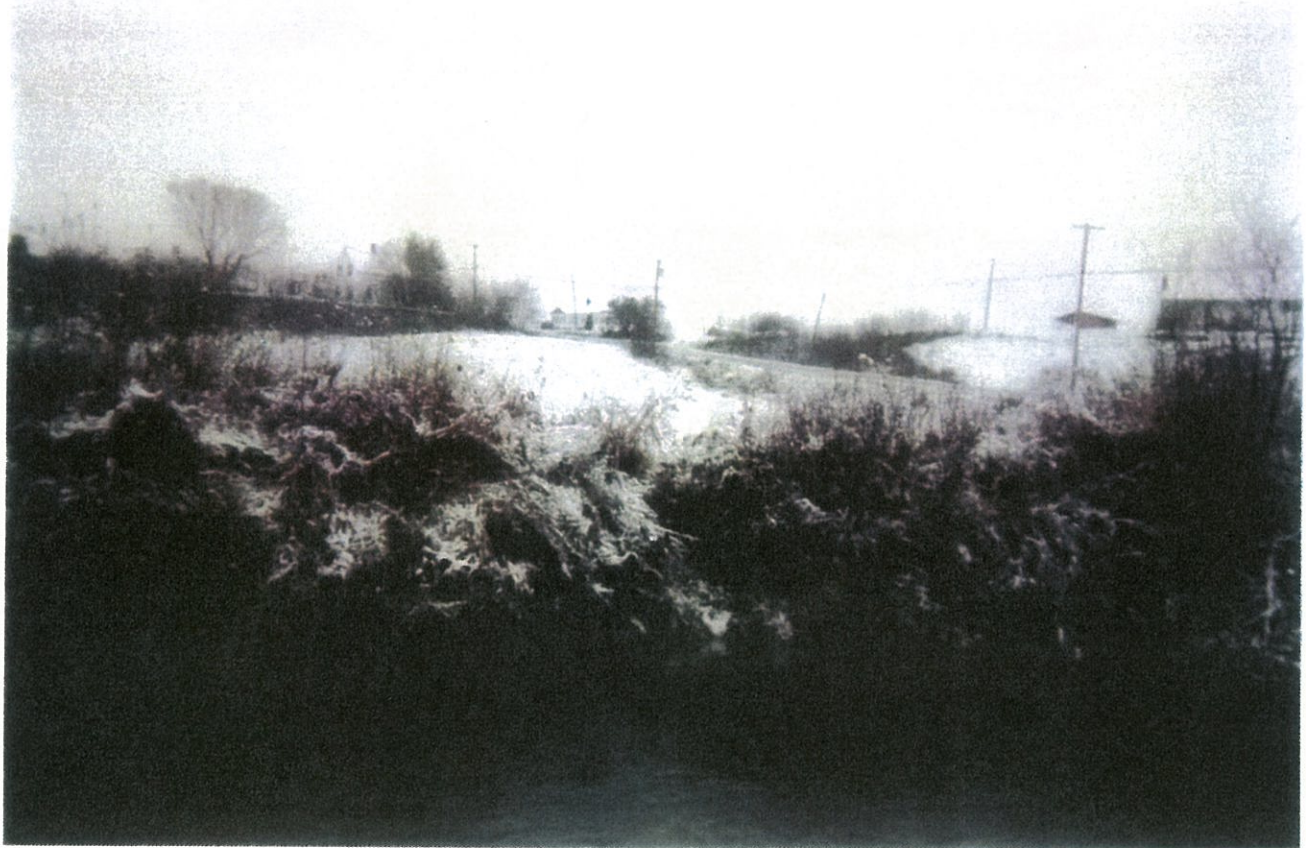
Photo # Er-65

NWA I Eroding Bank Survey, ETF Project 2004/2005			
Eroding Bank Number:	65		
General Location:			
GPS Coordinates:	Northerly	46	02.487
	Westerly	66	33.417
Erosion Severity:	Minor		
Recommended Remedial Action:	Shrubs		
Eroding Bank Height (approx meters):	0.3		
Eroding Bank Length (approx meters):	61		
Channel Location:	Main Penniac		
Bank Location:	Right Hand Bank		
Special Location Instructions:

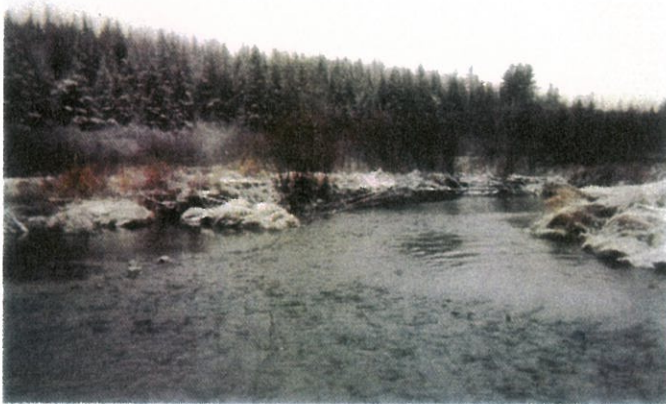
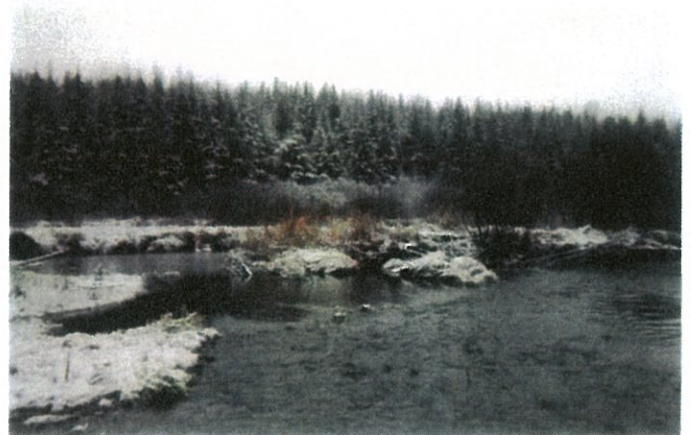
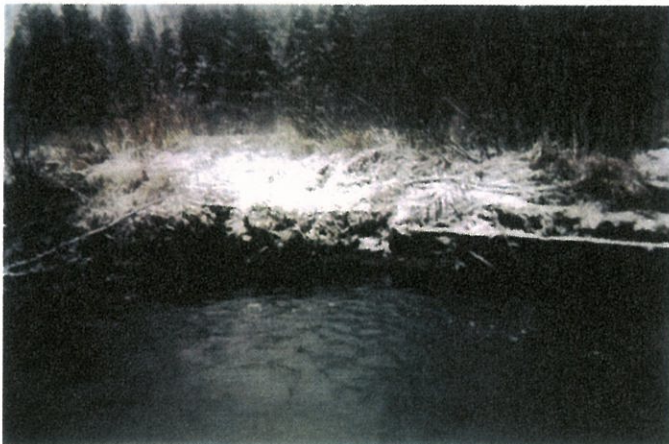
NWAJ Eroding Bank Survey, ETF Project 2004/2005			
Eroding Bank Number:	66		
General Location:			
GPS Coordinates:	Northerly	46	02.437
	Westerly	66	33.408
Erosion Severity:	Moderate		
Recommended Remedial Action:	Trees and Shrubs		
Eroding Bank Height (approx meters):	0.3-0.6		
Eroding Bank Length (approx meters):	9		
Channel Location:	Main Penniac		
Bank Location:	Left Hand Bank		
Special Location Instructions:

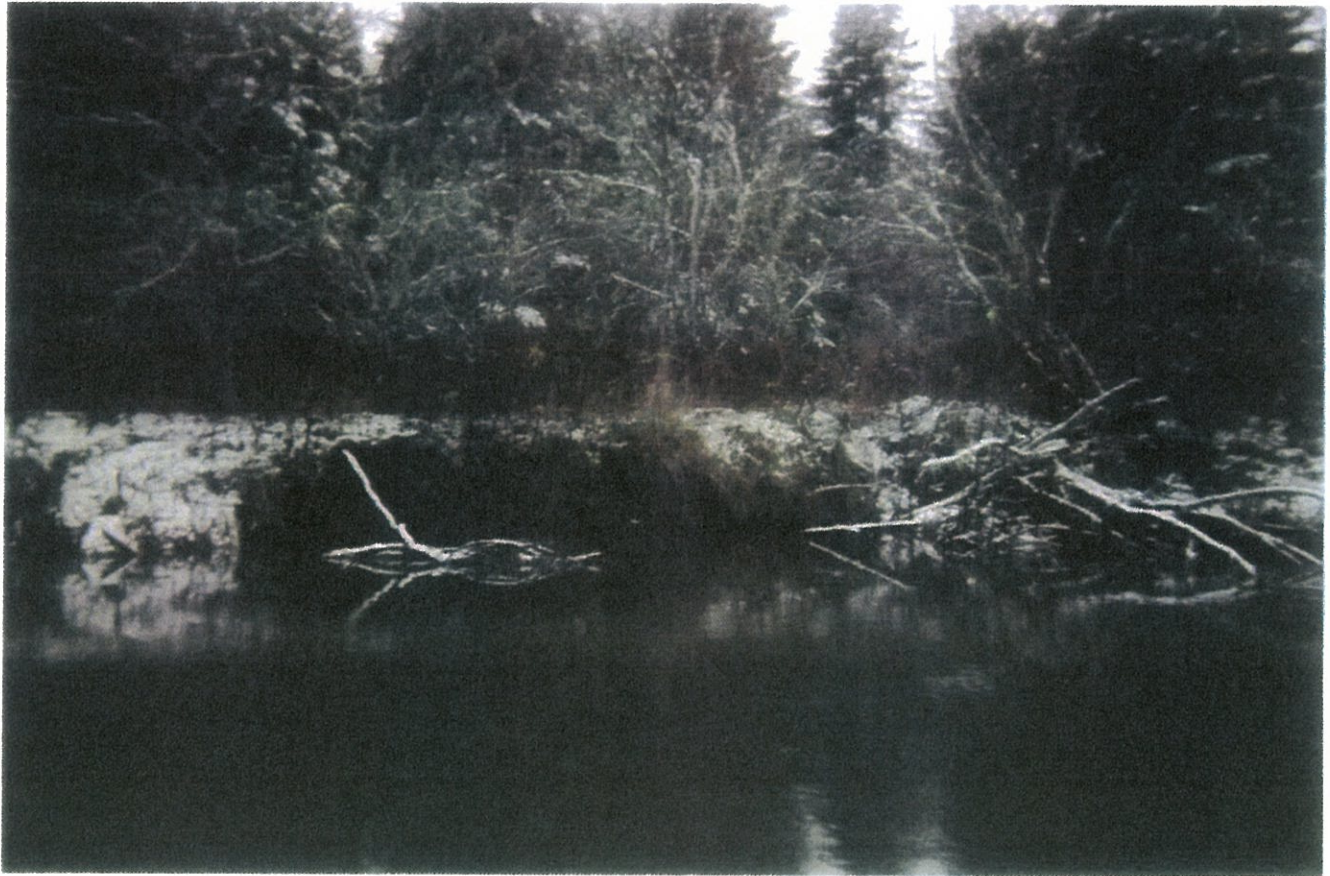
Photo # ER68

NWA I Eroding Bank Survey, ETF Project 2004/2005			
Eroding Bank Number:	68		
General Location:			
GPS Coordinates:	Northerly	46	02.381
	Westerly	66	33.537
Erosion Severity:	Moderate		
Recommended Remedial Action:	Trees/Shrubs		
Eroding Bank Height (approx meters):	0.9		
Eroding Bank Length (approx meters):	5		
Channel Location:	Main Penniac		
Bank Location:	Right Hand Bank		
Special Location Instructions:

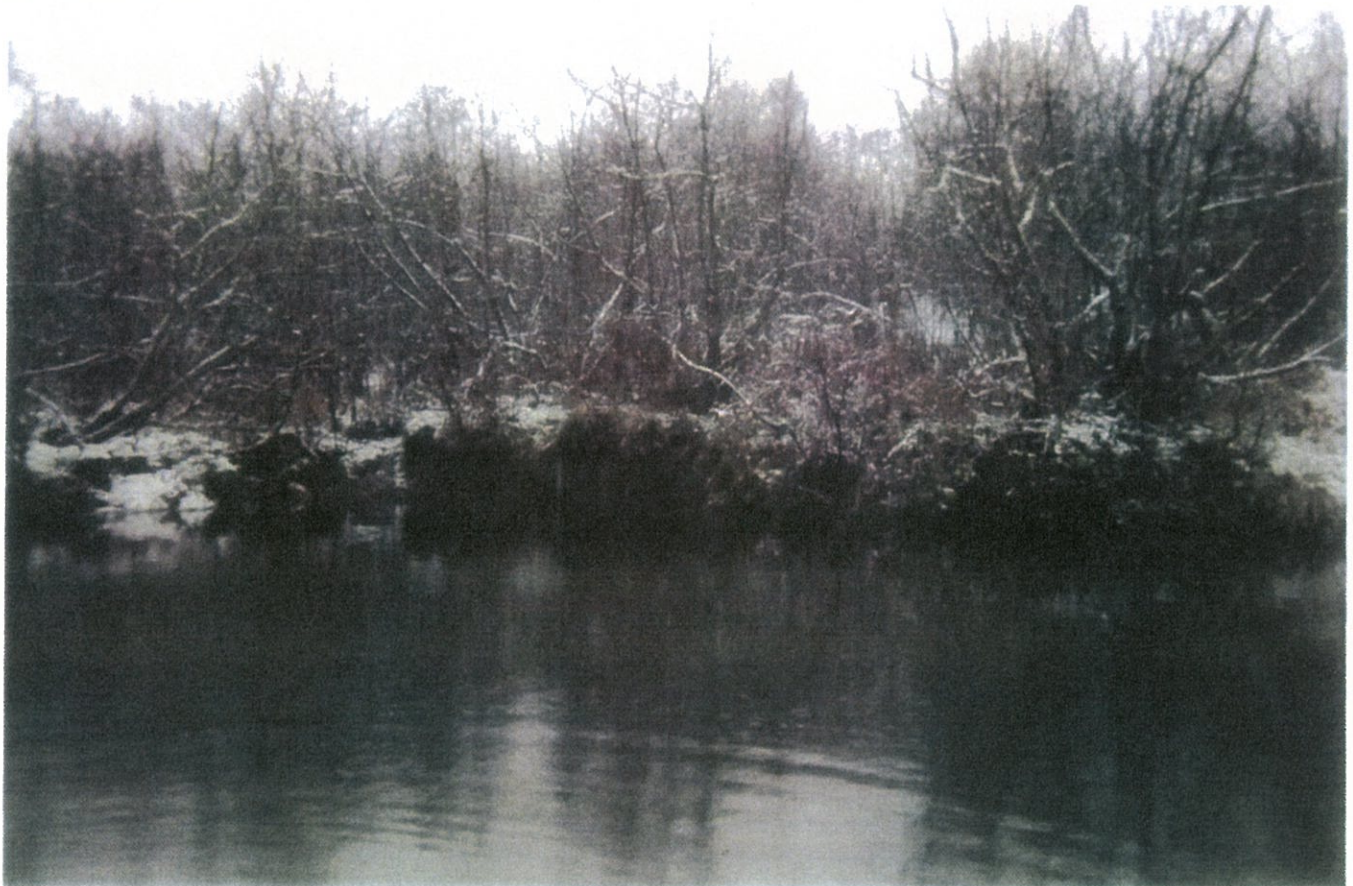
Photo # ER-69

NWAJ Eroding Bank Survey, ETF Project 2004/2005			
Eroding Bank Number:	69		
General Location:			
GPS Coordinates:	Northerly	46	02.369
	Westerly	66	33.632
Erosion Severity:	Moderate		
Recommended Remedial Action:	Trees/Shrubs		
Eroding Bank Height (approx meters):	0.4		
Eroding Bank Length (approx meters):	6		
Channel Location:	Main Penniac		
Bank Location:	Right Hand Bank		
Special Location Instructions:
