Soil Erosion Survey of the Nashwaak River and the Tay, Penniac and Cross Creek Streams

The New Brunswick Department of the Environment and Local Government
P.O. Box 6000
Fredericton, NB
E3B 5H1
March, 2005

The Nashwaak Watershed Association Inc.
P.O. Box 20037
Fredericton, NB
E6B 6Y8

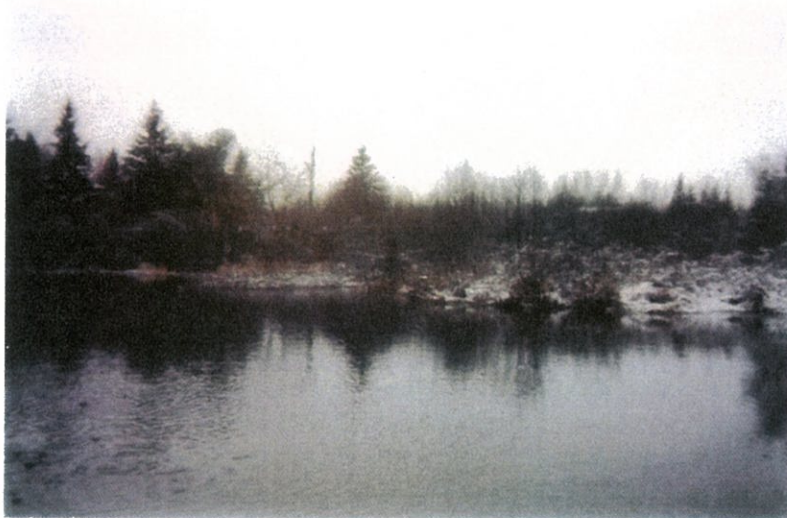
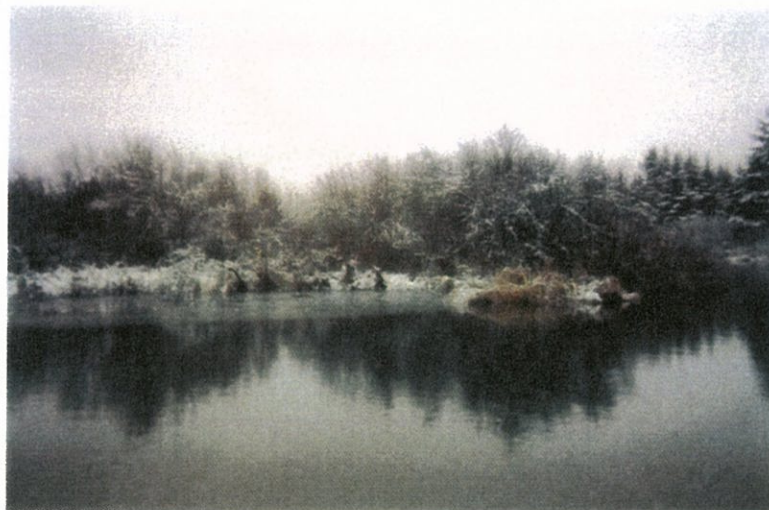
NWAJ Eroding Bank Survey, ETF Project 2004/2005			
Eroding Bank Number:	70		
General Location:			
GPS Coordinates:	Northerly	46	02.310
	Westerly	66	33.627
Erosion Severity:	Minor		
Recommended Remedial Action:	Shrubs, trees		
Eroding Bank Height (approx meters):	0.6		
Eroding Bank Length (approx meters):	45		
Channel Location:	Penniack Stream		
Bank Location:	Right Hand Bank		
Special Location Instructions:

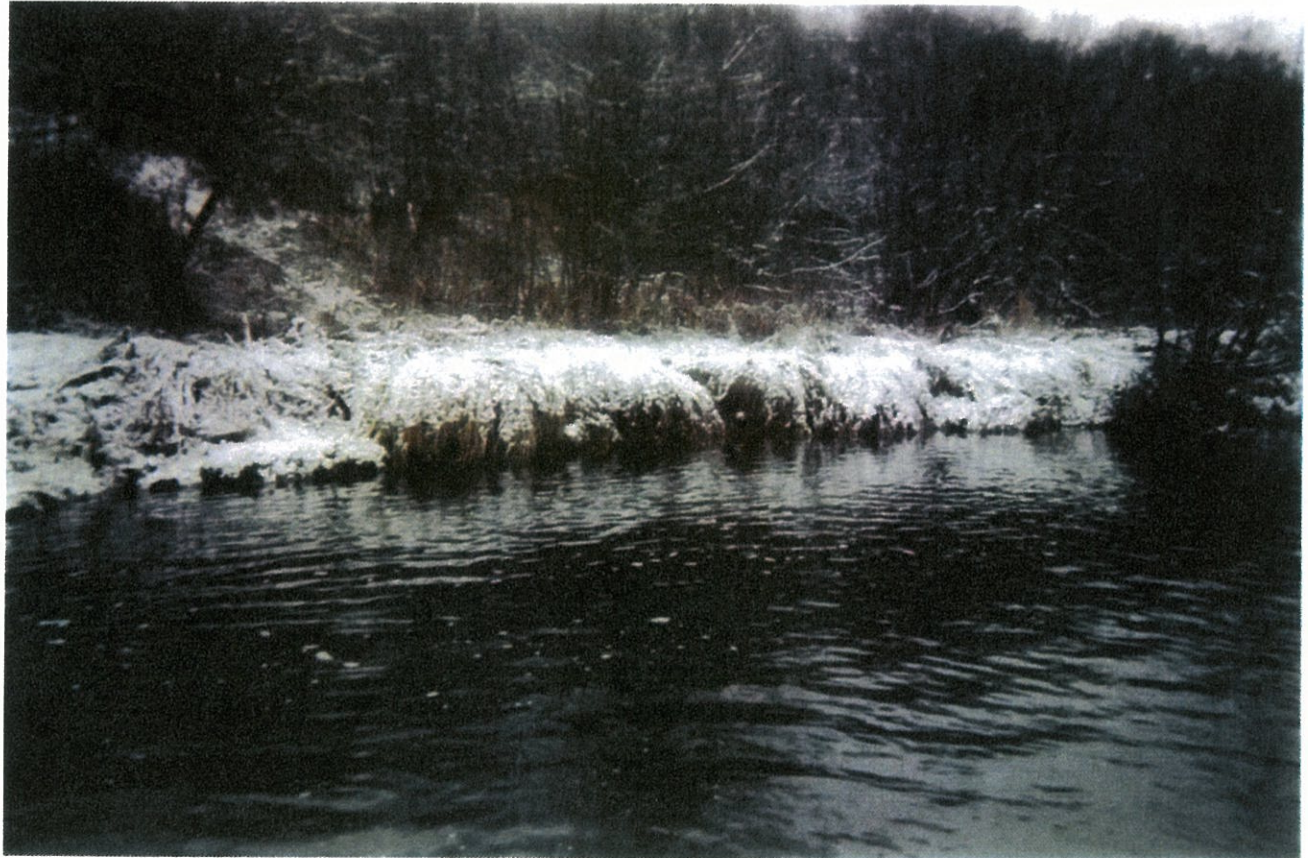
Photo # ER-71

NWA I Eroding Bank Survey, ETF Project 2004/2005			
Eroding Bank Number:	71		
General Location:			
GPS Coordinates:	Northerly	46	02.184
	Westerly	66	34.126
Erosion Severity:	Minor		
Recommended Remedial Action:	Shrubs		
Eroding Bank Height (approx meters):	0.3		
Eroding Bank Length (approx meters):	6		
Channel Location:	Main Penniac		
Bank Location:	Right Hand Bank		
Special Location Instructions:

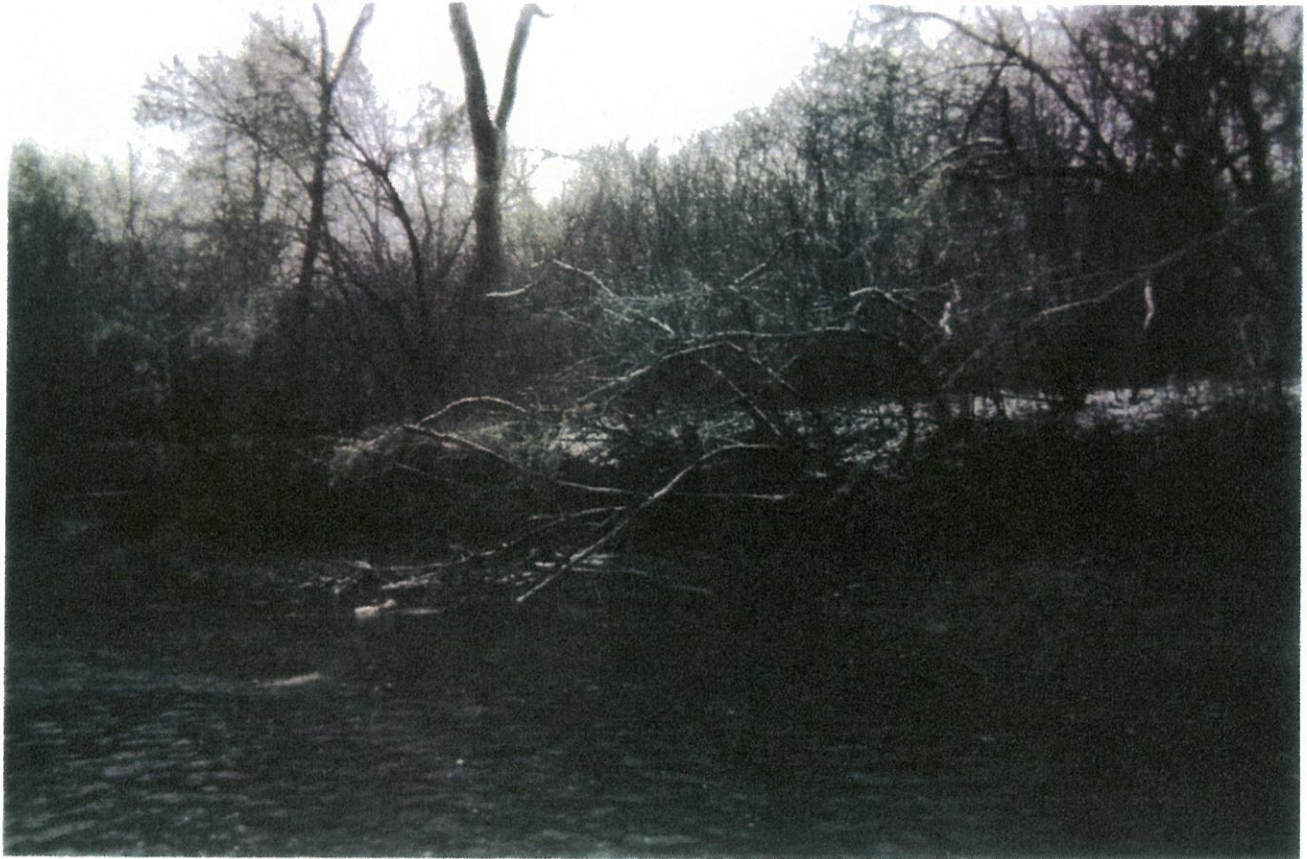
Photo # ER-72

NWA I Eroding Bank Survey, ETF Project 2004/2005			
Eroding Bank Number:	72		
General Location:			
GPS Coordinates:	Northerly	46	01.992
	Westerly	66	34.256
Erosion Severity:	Moderate		
Recommended Remedial Action:	Engineered		
Eroding Bank Height (approx meters):	1.5		
Eroding Bank Length (approx meters):	60		
Channel Location:	Penniack Stream		
Bank Location:	Right Hand Bank		
Special Location Instructions:

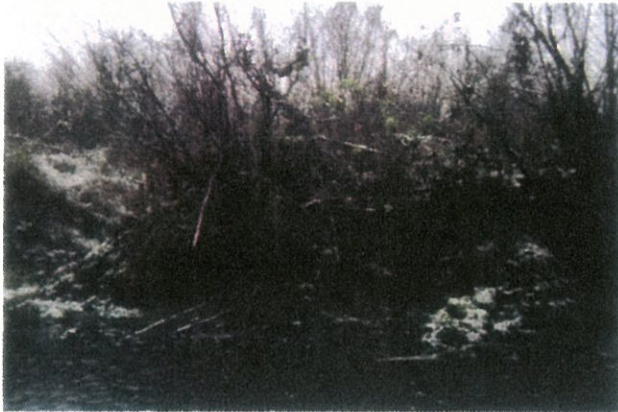
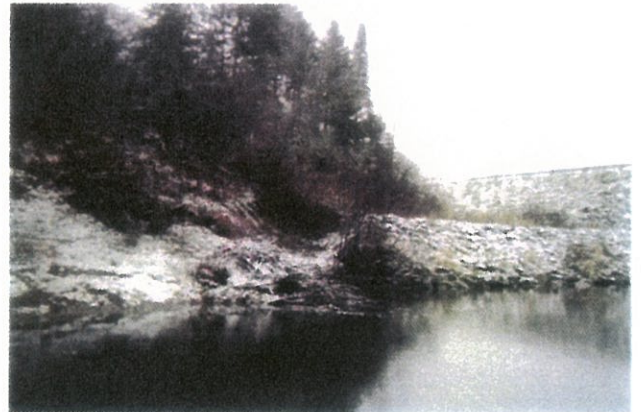
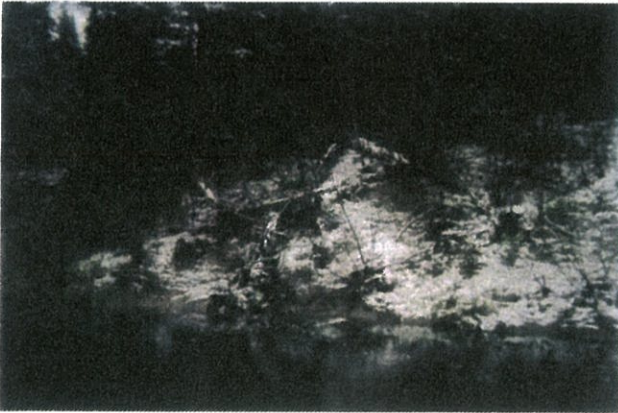
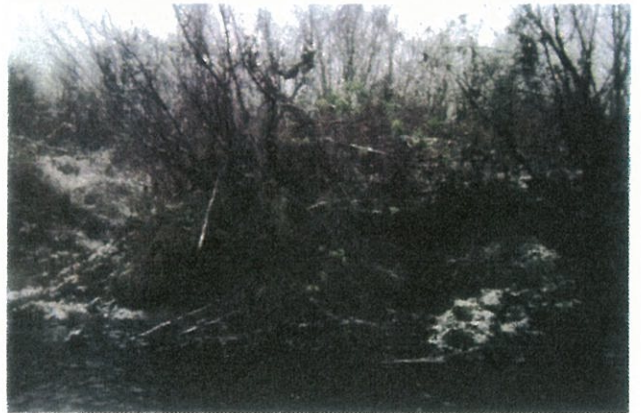
NWA I Eroding Bank Survey, ETF Project 2004/2005			
Eroding Bank Number:	73		
General Location:			
GPS Coordinates:	Northerly	46	01.931
	Westerly	66	34.232
Erosion Severity:	Moderate		
Recommended Remedial Action:	Trees/Shrubs		
Eroding Bank Height (approx meters):	1.8		
Eroding Bank Length (approx meters):	30		
Channel Location:	Main Penniac		
Bank Location:	Right Hand Bank		
Special Location Instructions:

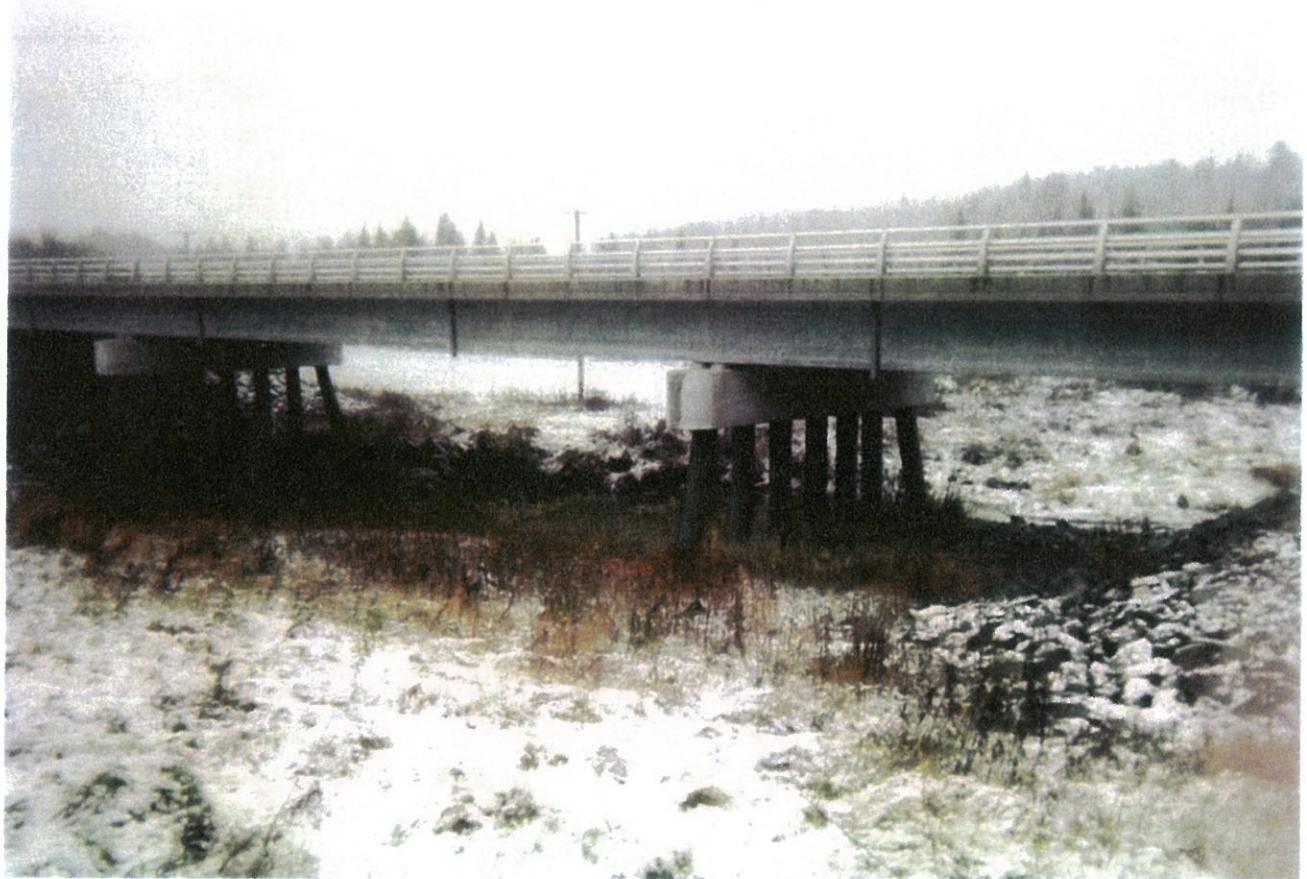
Photo # ER-74

NWAJ Eroding Bank Survey, ETF Project 2004/2005			
Eroding Bank Number:	74		
General Location:	Bridge - Penniac Stream		
GPS Coordinates:	Northerly	46	01.855
	Westerly	66	34.299
Erosion Severity:	Moderate		
Recommended Remedial Action:	Trees/Shrubs		
Eroding Bank Height (approx meters):	0.6		
Eroding Bank Length (approx meters):	6		
Channel Location:	Main Penniac		
Bank Location:	Right Hand Bank		
Special Location Instructions:

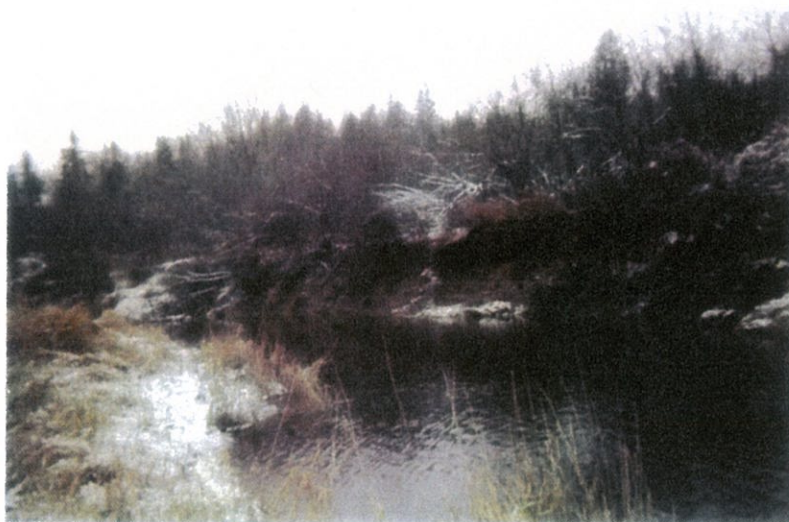
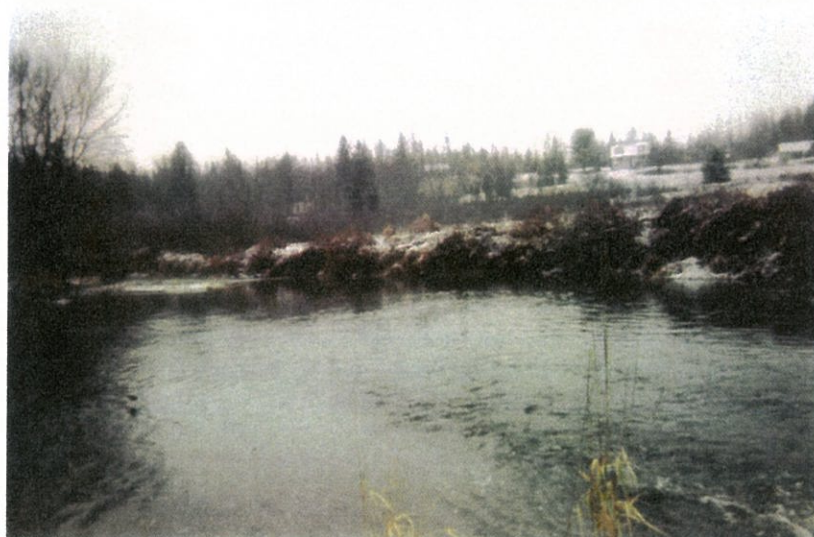
NWA I Eroding Bank Survey, ETF Project 2004/2005			
Eroding Bank Number:	75		
General Location:	Immediately below Hwy 628		
GPS Coordinates:	Northerly	46	01.880
	Westerly	66	34.288
Erosion Severity:	Moderate		
Recommended Remedial Action:	Trees/Shrubs		
Eroding Bank Height (approx meters):	1.5		
Eroding Bank Length (approx meters):	45		
Channel Location:	Main Penniac		
Bank Location:	Right Hand Bank		
Special Location Instructions:

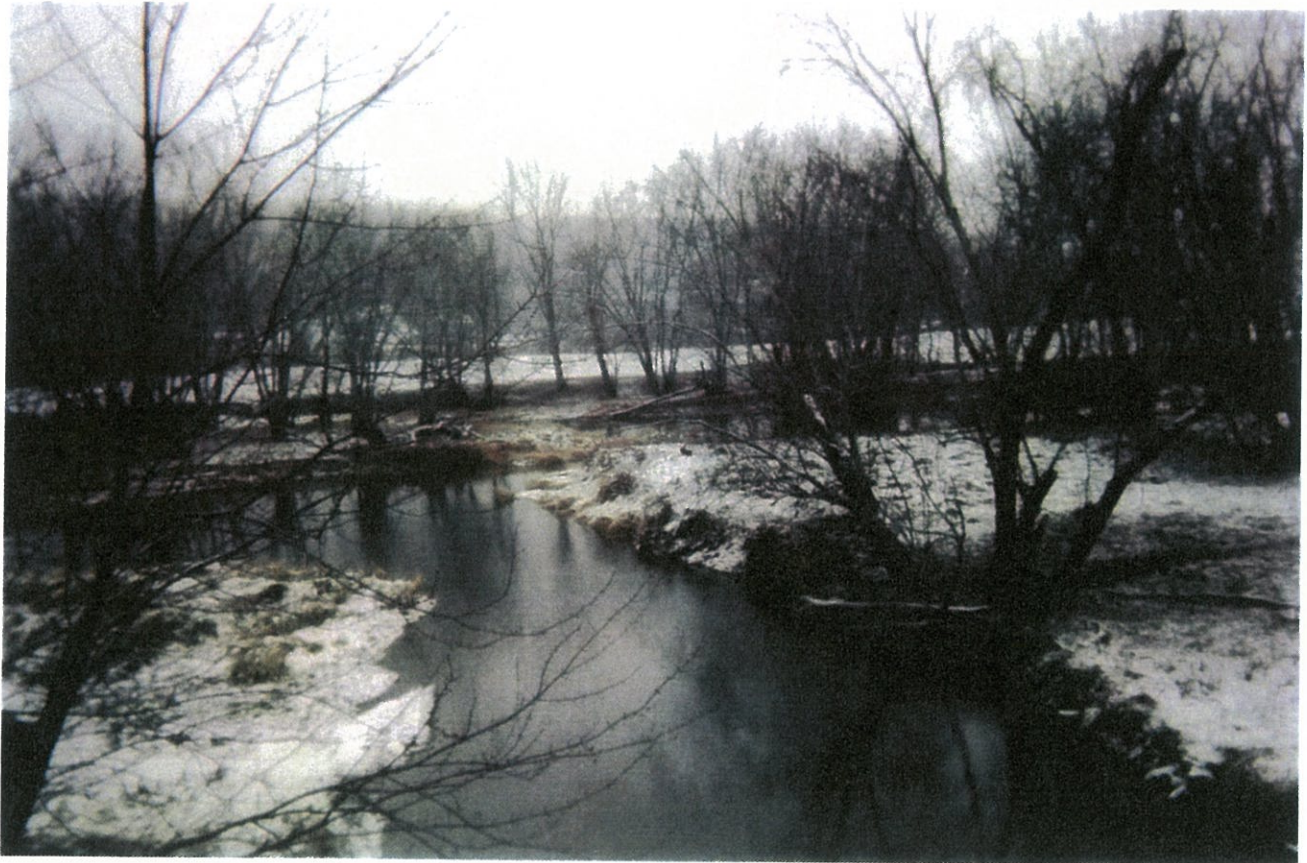
Photo # ER-76

NWA I Eroding Bank Survey, ETF Project 2004/2005			
Eroding Bank Number	76		
General Location	Mouth of Penniac		
GPS Coordinates	Northerly	46	01.869
	Westerly	66	34.426
Erosion Severity	Moderate		
Recommended Remedial Action	Trees/Shrubs		
Eroding Bank Height (approx meters)	1		
Eroding Bank Length (approx meters)	LHB = 30, RHB = 80		
Channel Location	Main Penniac		
Bank Location	Left Hand Bank and Right Hand Bank		
Special Location Instructions

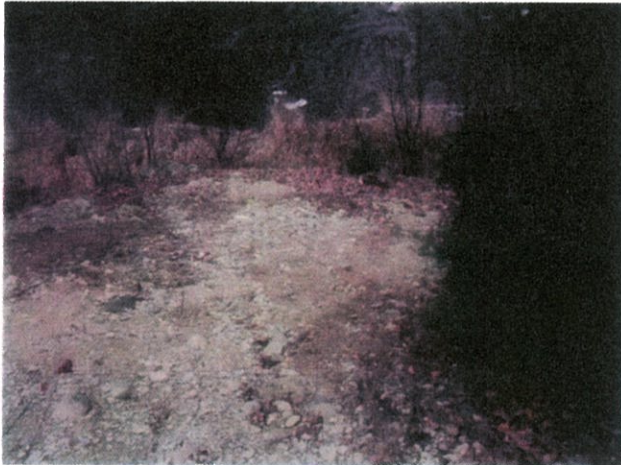
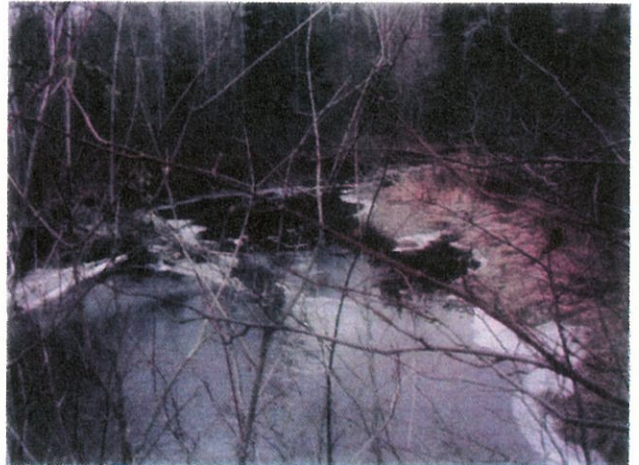
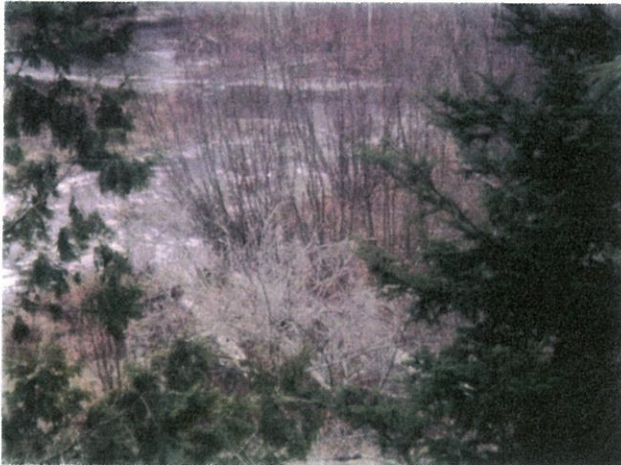
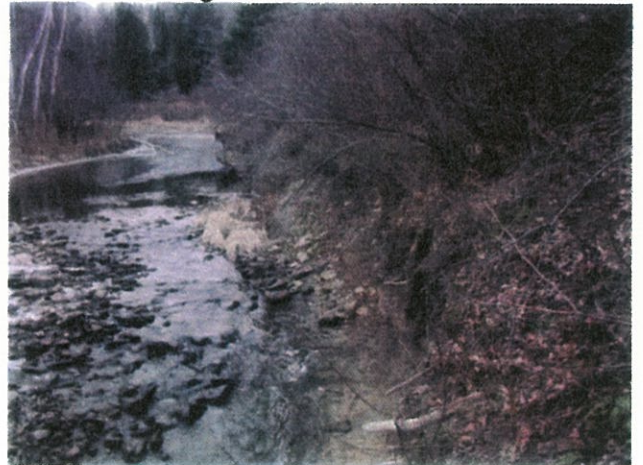
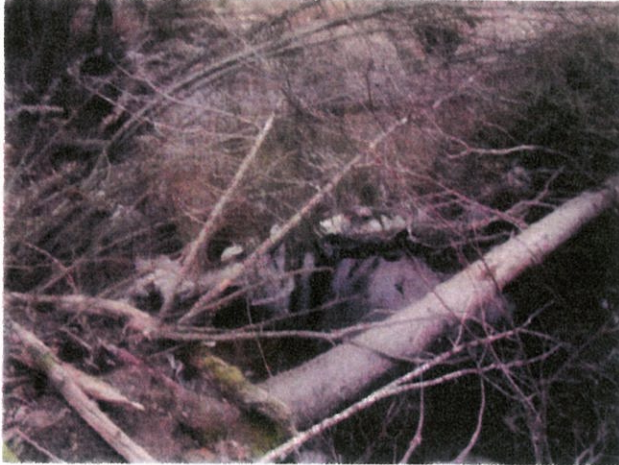
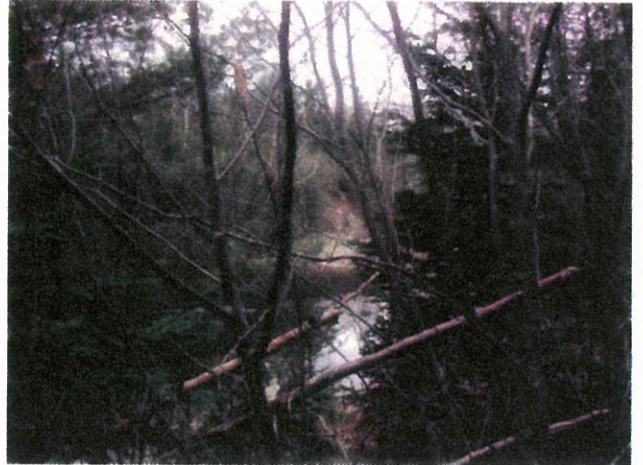
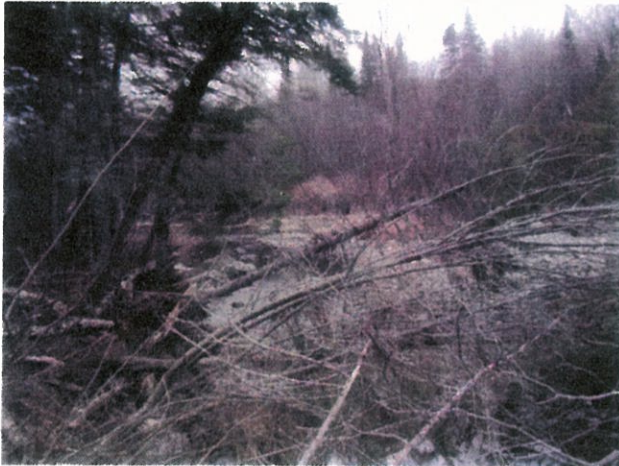
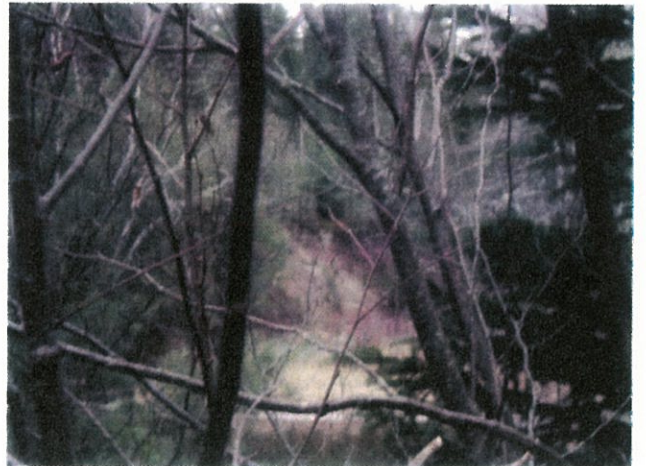
NWAJ Eroding Bank Survey, ETF Project 2004/2005			
Eroding Bank Number:	77		
General Location:	Above Hwy # Cross Creek Station Road		
GPS Coordinates:	Northerly	46	16.169
	Westerly	66	38.410
Erosion Severity:	Moderate to Major		
Recommended Remedial Action:	Engineered		
Eroding Bank Height (approx meters):	1-7		
Eroding Bank Length (approx meters):	LHC = 75, RHC = 20		
Channel Location:	Cross Creek Stream LHC and RHC		
Bank Location:	Left Hand Bank and Right Hand Bank		
Special Location Instructions:

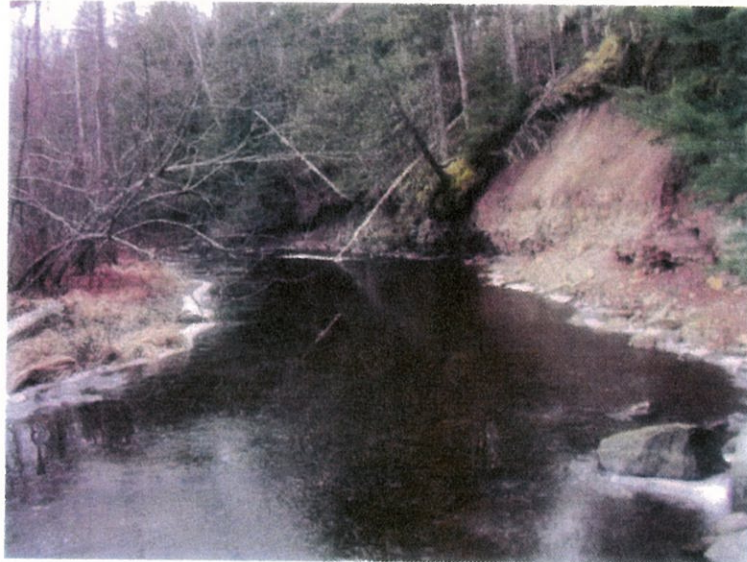
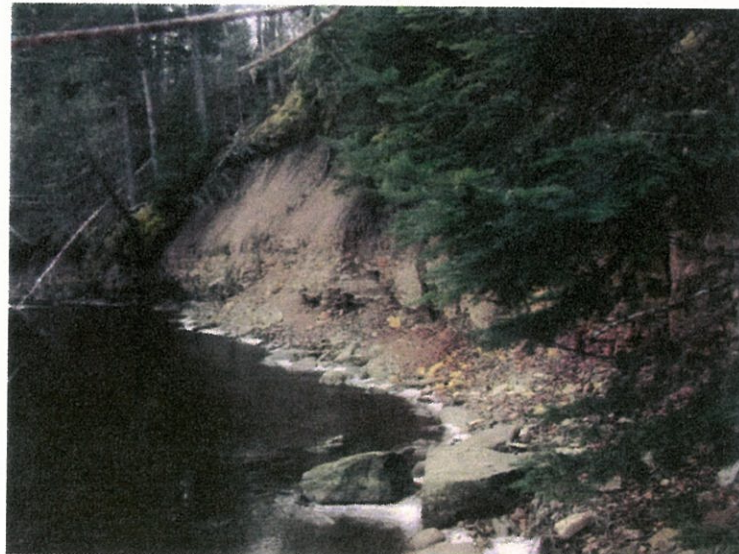
NWA I Eroding Bank Survey, ETF Project 2004/2005			
Eroding Bank Number:	78		
General Location:	Starts just below swimming hole		
GPS Coordinates:	Northerly	46	16.165
	Westerly	66	38.268
Erosion Severity:	Moderate to Major		
Recommended Remedial Action:	Engineered		
Eroding Bank Height (approx meters):	1-7		
Eroding Bank Length (approx meters):	100		
Channel Location:	Cross Creek Stream LHC		
Bank Location:	Left Hand Bank		
Special Location Instructions:

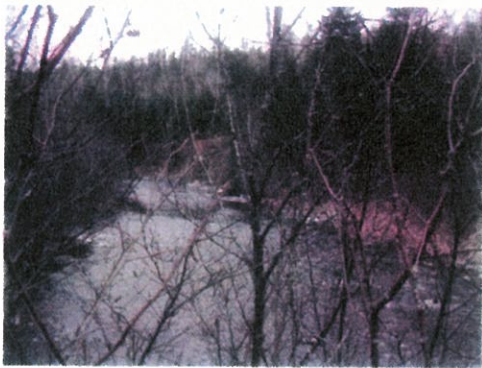
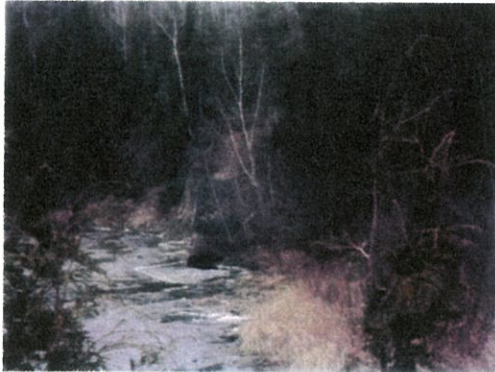
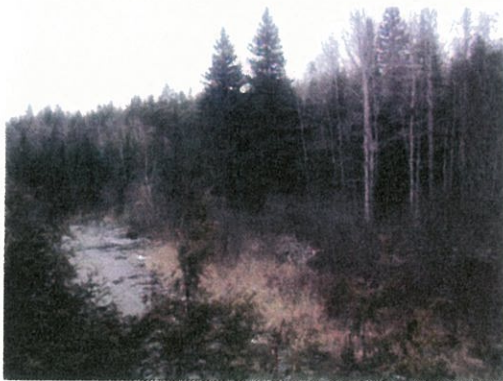
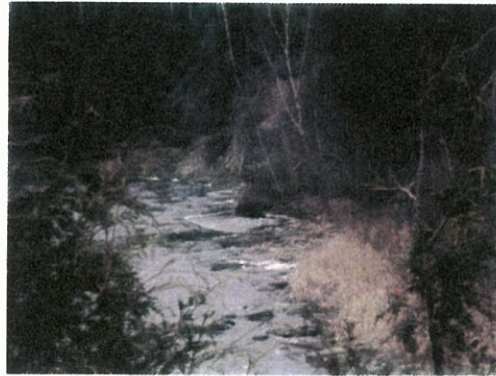
NWAJ Eroding Bank Survey, ETF Project 2004/2005			
Eroding Bank Number:	79		
General Location:	Above Train Bridge		
GPS Coordinates:	Northerly	46	16.327
	Westerly	66	38.059
Erosion Severity:	Major		
Recommended Remedial Action:	Engineered		
Eroding Bank Height (approx meters);	15		
Eroding Bank Length (approx meters);	20		
Channel Location:	Cross Creek Stream Left Hand Channel		
Bank Location:	Left Hand Bank		
Special Location Instructions:

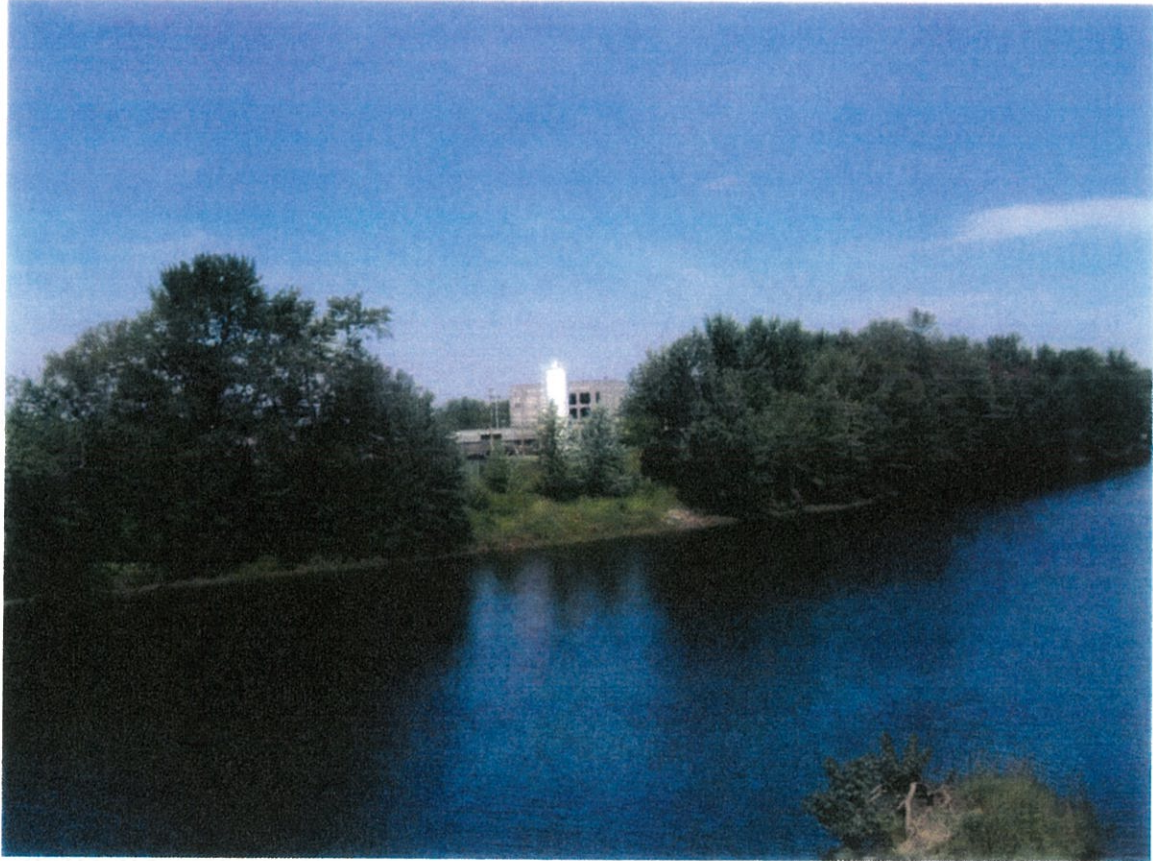
Photo # PS-1

NWA I Point Source Survey, ETF Project 2004/2005			
Point Source Number:	PS-1		
General Location:	Barkers Point		
GPS Coordinates:	Northerly	45	57.507
	Westerly	66	37.107
Point Source Type:	Fredericton WWTP		
Channel Location:	Main		
Bank Location:	RHB		
Special Location Instructions:

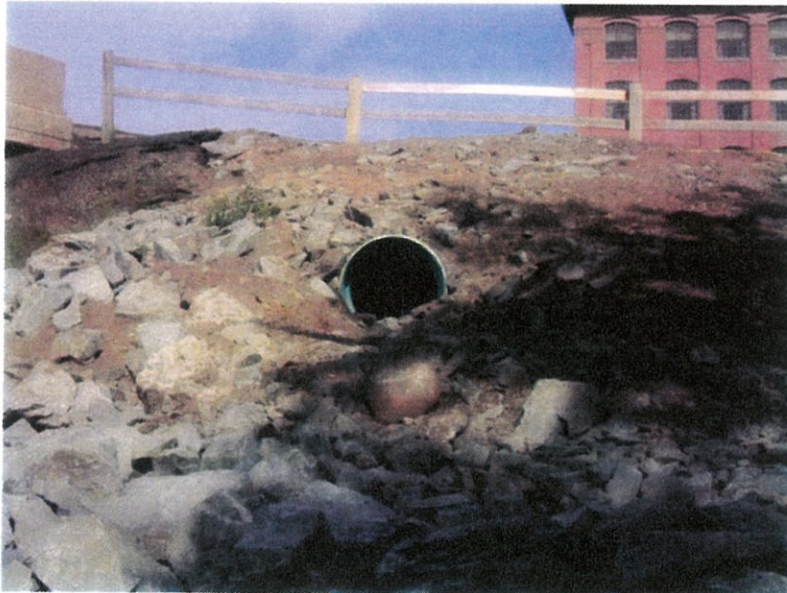
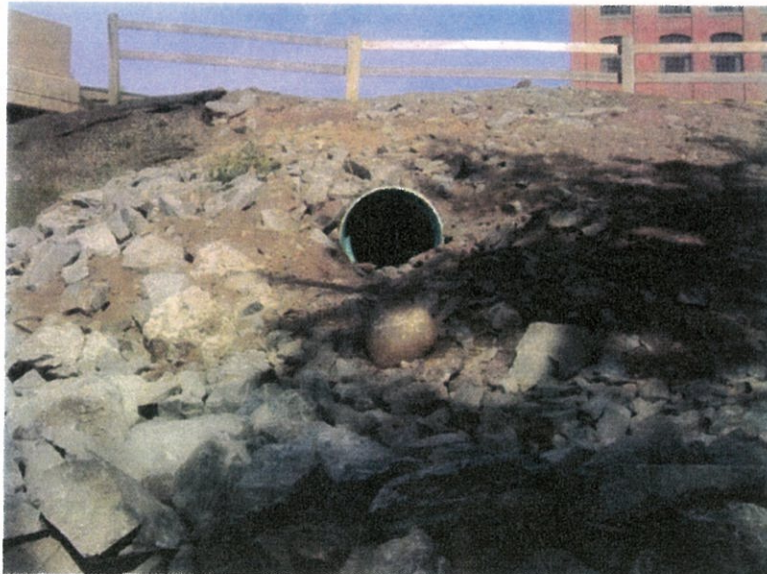
NWA Point Source Survey, ETF Project 2004/2005			
Point Source Number	PS-2		
General Location	Marysville		
GPS Coordinates	Bridge		
	Northerly	45	58.726
	Westerly	66	35.39
Point Source Type	600mm diameter storm		
Channel Location	outfall		
Bank Location	Main		
Special Location Instructions	LHB
